# **The design and installation of the PRACLAY In-Situ Experiment**

EURIDICE Report, ref. 13-129

1 September 2013

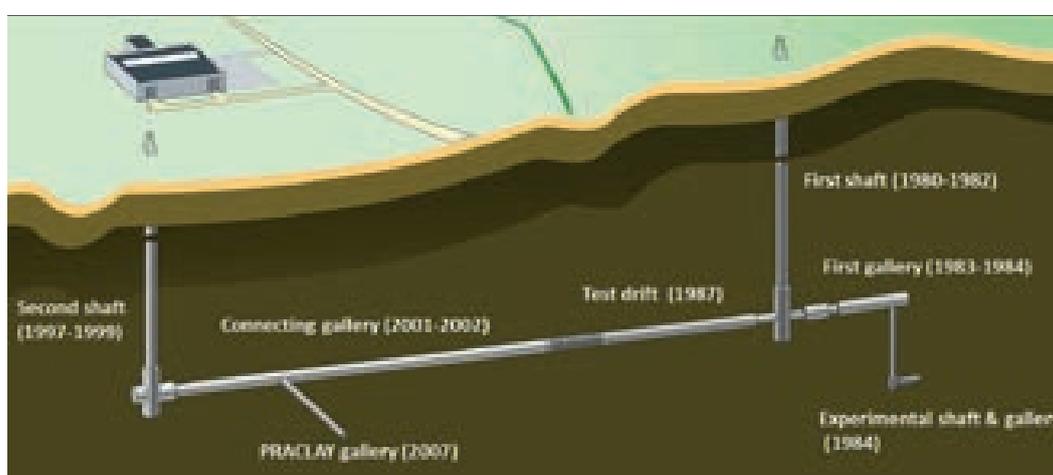
Figure 1-1 Construction history and layout of the HADES underground research facility.

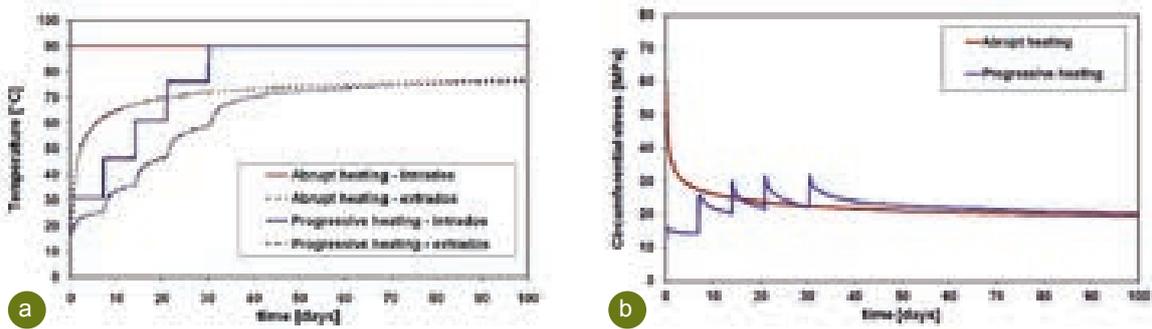
Figure 2-3 (a) The temperature at intrados and extrados of the gallery with abrupt and progressive heating; (b) Circumferential stresses at the lining extrados with abrupt and progressive heating.

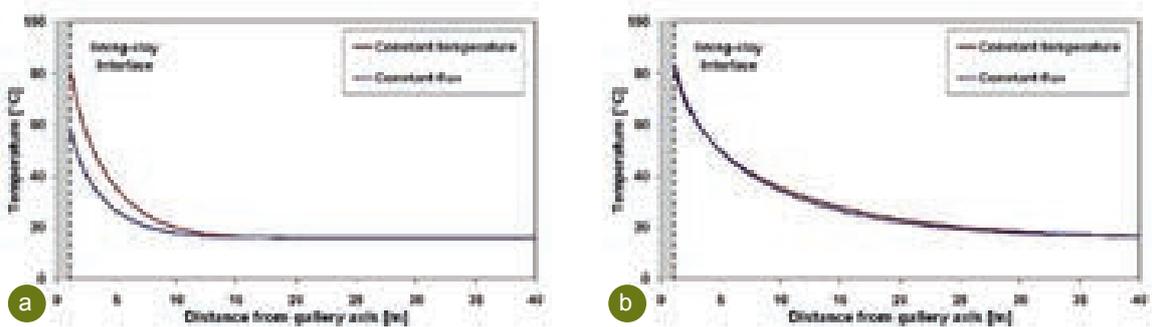
Two possible heat source terms were considered: a constant heat flux (250 W/m) and a variable heat flux ensuring a constant temperature (80°C) at the clay–lining interface (Figure 2-4). A variable flux ensuring a constant temperature is the most effective and a constant temperature may be advantageous for the subsequent interpretation of in-situ measurements and for the subsequent THM modelling, as the boundary conditions of the test are simpler to implement in models. It was therefore decided to use a heater that produced a near-constant temperature of 80°C at the clay–lining interface.

Figure 2-4 Radial temperature profiles in a midplane around the heated gallery for a constant temperature and a constant heat flux at the clay–lining interface: (a) after 1 year of heating; (b) after 10 years of heating.

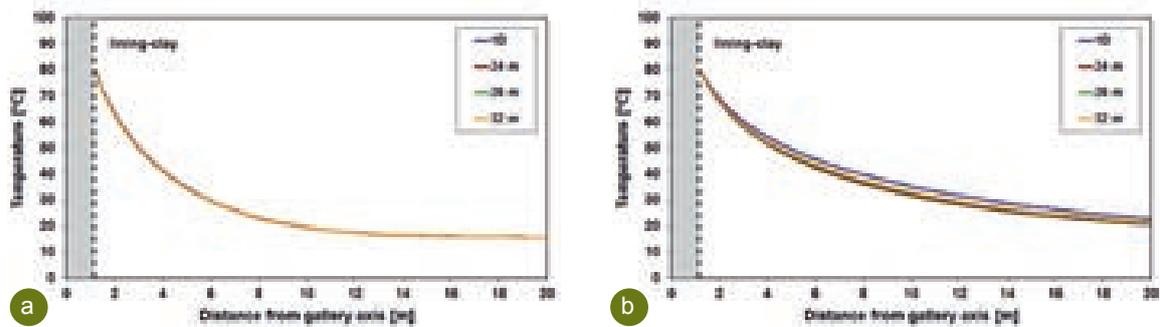
Subsequently the scoping calculations focused on optimising the length of the heated gallery section. Figure 2-5 shows the radial temperature profiles for different heated gallery lengths at the middle of the heated section using a variable heat source, ensuring a fixed temperature of 80°C at the clay–lining interface. No significant gain in representativeness is obtained by increasing the length from 24 to 32 m. The length of the heated gallery section was therefore set at 30 m. As such a central section is obtained that has uniform conditions in the longitudinal direction, i.e. that is unaffected by end effects.

Figure 2-5 Radial temperature profiles in a midplane around the heated gallery for a constant temperature and for different lengths of the heated gallery section (the 1D scenario which is more representative for an actual repository, is also included):  
(a) after 1 year of heating; (b) after 10 years of heating.

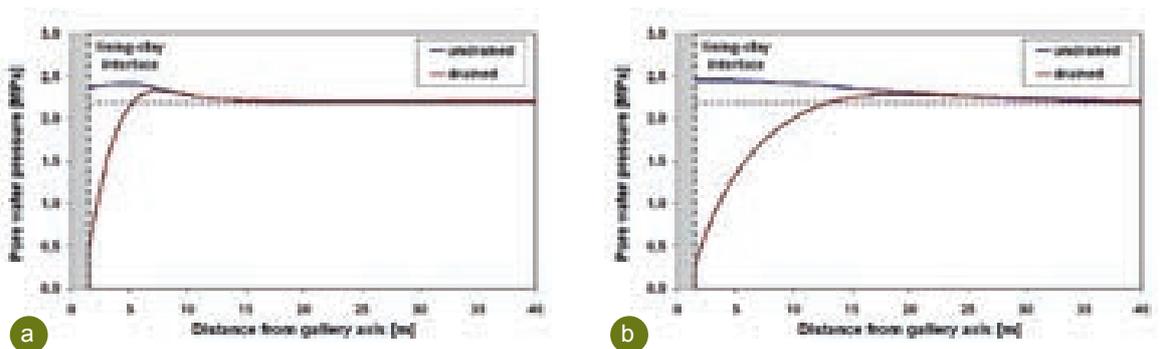
An important goal of the Heater Test is to verify that the pore water pressure increase during heating does not lead to liquefaction of the Boom Clay. Undrained boundary conditions during the Heater Test lead to higher pore water pressures in the clay and are therefore more critical than drained boundary conditions. Figure 2-6 shows the difference in pore water pressure around the gallery in the midplane of the heated section in scenarios where the gallery is drained and undrained. The overpressure is much more pronounced when the gallery is undrained. The components inside the heated section of the PRACLAY gallery are thus to be saturated as much as possible to create an undrained boundary.

Figure 2-6 Pore water pressure profiles in a midplane around the heated gallery in scenarios where the gallery is drained and undrained:  
(a) after 1 year of heating; (b) after 10 years of heating.

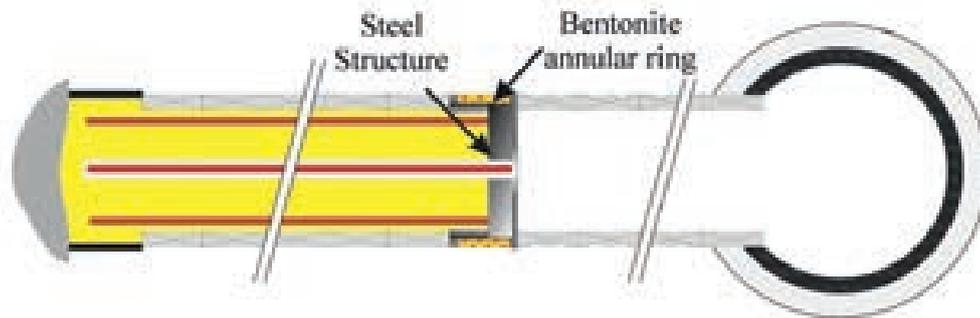
A quasi-impermeable boundary is required at the intersection between the heated and non-heated sections of the PRACLAY gallery. This is achieved by fitting a hydraulic seal, which has to not only close the PRACLAY gallery, but also hydraulically cut off the heated section from the rest of the gallery. The hydraulic seal consists of a stainless steel structure closing off the heated part of the gallery from the rest of the underground infrastructure and an annular bentonite ring placed against the clay (Figure 2-7). Bentonite has a very low hydraulic conductivity and swells when it is hydrated. The swelling pressure exerted by the hydrated bentonite on the clay will lower the hydraulic conductivity of the clay around the seal.

Figure 2-7 The hydraulic seal closing off the heated part of the PRACLAY gallery consists of a stainless steel structure and an annular bentonite ring.

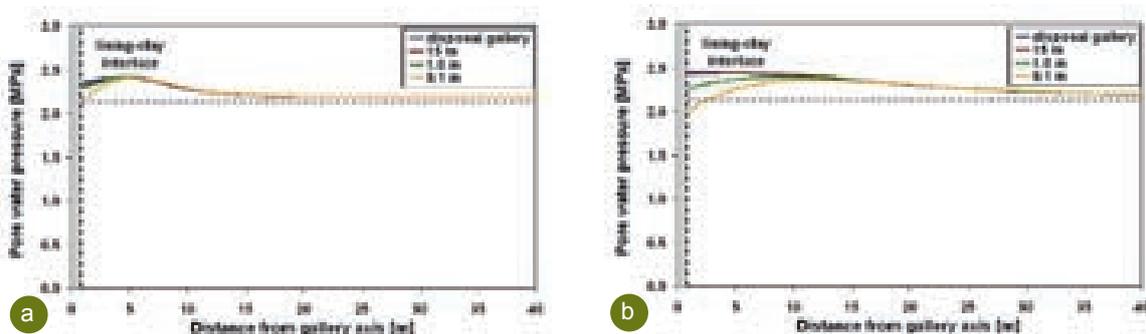
Figure 2-8 shows the pore water pressure profiles in the midplane of the heated section for different seal lengths and for an impermeable disposal gallery (representing undrained conditions). It was concluded from these figures that a length of 1 m for the seal was sufficiently effective and that the gain in representativity obtained by further increasing the seal length was outweighed by the extra cost and complexity of a larger seal.

Figure 2-8 Pore water pressure profiles in a midplane around the heated gallery for different lengths of hydraulic seal (the reference case of an impermeable disposal gallery is also included): (a) after 1 year of heating; (b) after 10 years of heating.

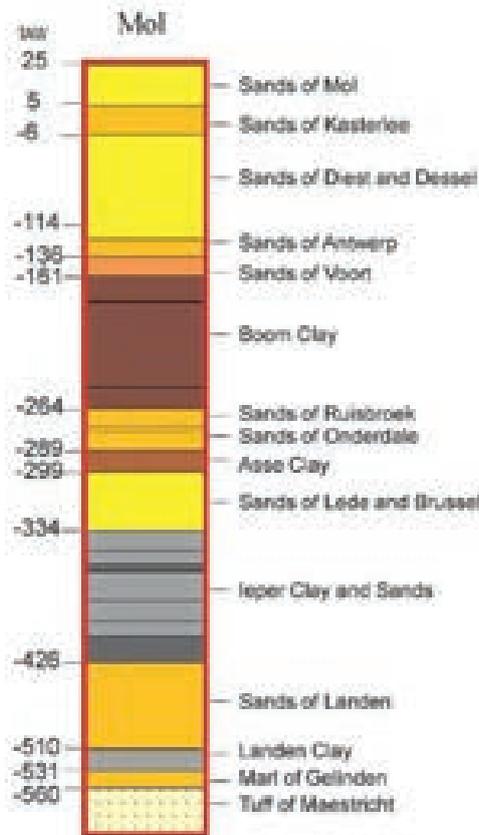
Figure 2-2: Stratigraphy under the site of Mol.

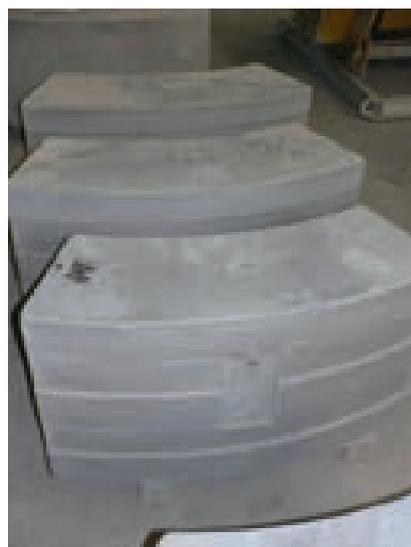
Figure 2-5: Grooved segments (the square opening in the segment extrados is for the installation of a pressure cell).

The radial pressure exerted on the gallery lining is measured by pressure cells that are mounted in the segments after the segment has been unmoulded. Therefore an opening was left in the segment extrados when casting the segment, into which the pressure cell was subsequently placed (Figure 5-8). The load cells to measure the circumferential stresses in the lining were cast in concrete segments 100 mm thick (Figure 5-9). These segments were placed between two segments during the installation of the lining. The configuration of the pressure and load cells is shown in Figure 5-3.

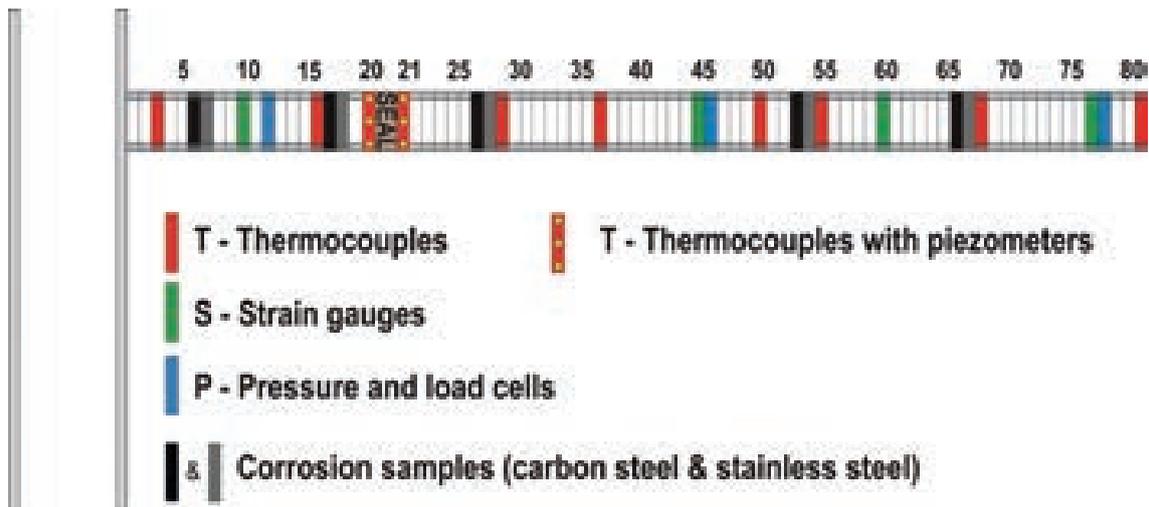
Figure 2-13: Instrumentation of the PRACLAY gallery lining.

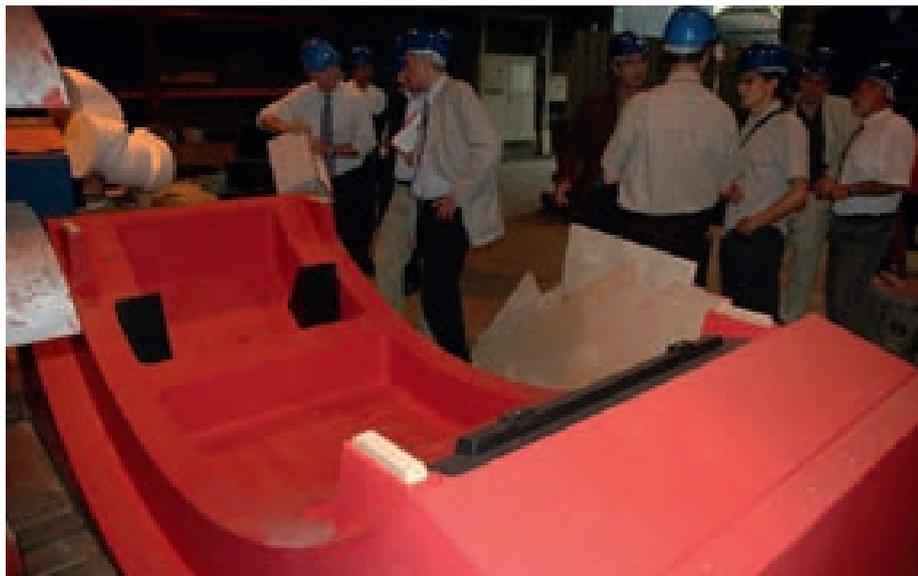
Figure 5-1: Wooden positive moulds for the construction of the reinforcement ring.

Wooden positive moulds were first constructed (Figure 5-1). These were made larger than the designed size to compensate for the shrinkage of steel. Then the negative moulds were made in sand and the segments were cast. After production the segments were sandblasted and machined. Finally, the ring was assembled and milled as a whole (Figure 5-2).

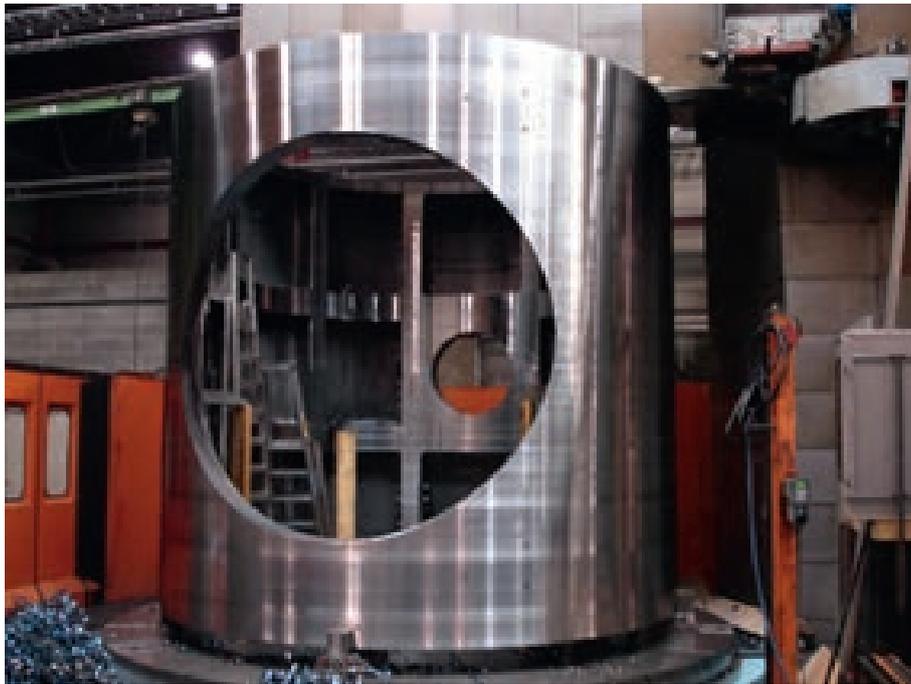
Figure 5-2: Test assembly of the reinforcement ring.

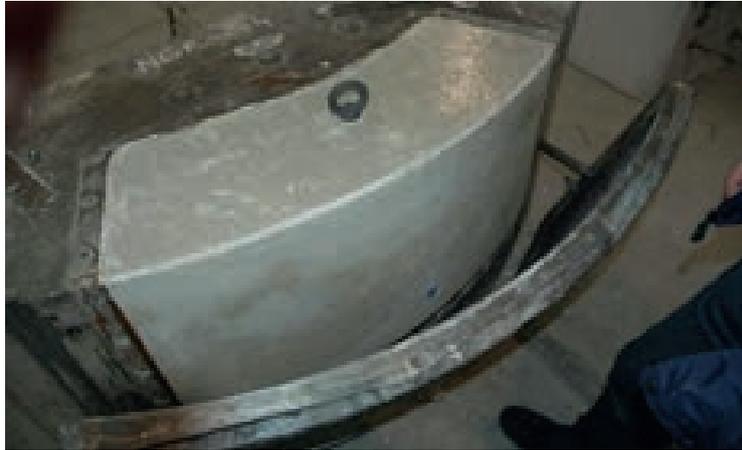
Figure 5-5: Fabricated concrete segment block in BUCHAN mould.

The lining segments of the C80/95 type were manufactured by BUCHAN using BUCHAN moulds (Figure 5-5). These moulds were made of reinforced concrete, except their extrados, which was made of a removable steel framework. The surfaces between ordinary segments mutually and between ordinary segments and counter keys were made flat, while the surfaces between the keys and their counter keys were made slightly helical. A test assembly of two wedge block rings was carried out at BUCHAN and inspected by EURIDICE on 14.09.2006 prior to starting full-scale fabrication (Figure 5-6).

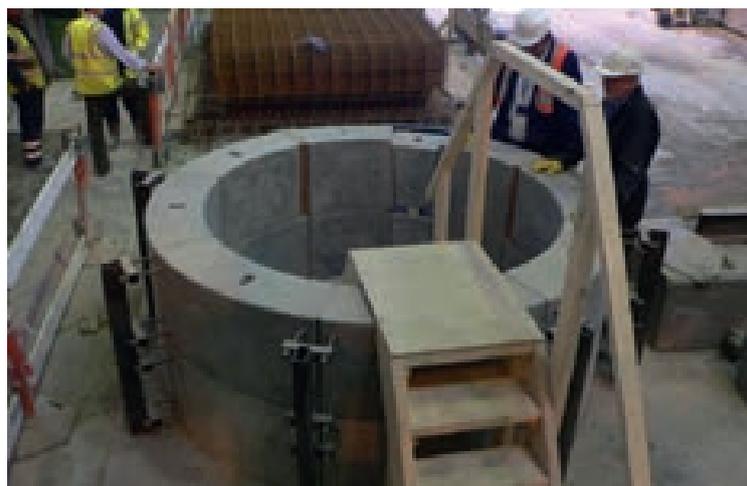
Figure 5-6: Test assembly of two wedge block rings.

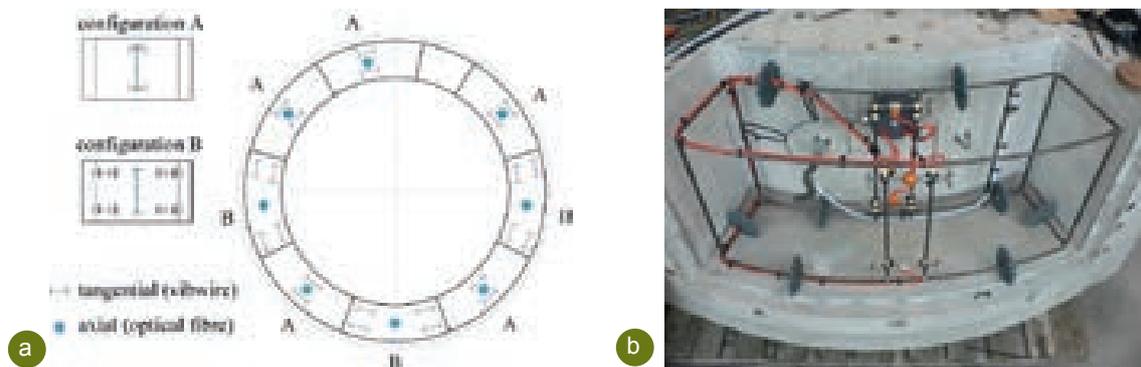
Figure 5-7: (a) Configuration of strain gauges embedded in the lining; (b) Support case placed in the segment mould for the installation of the strain gauges.

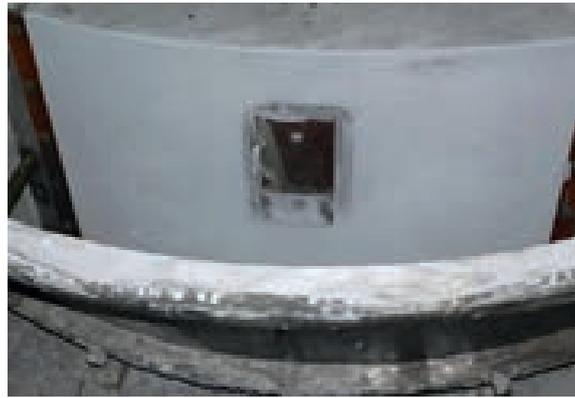
Figure 5-8: Opening in the segment extrados for pressure cell.

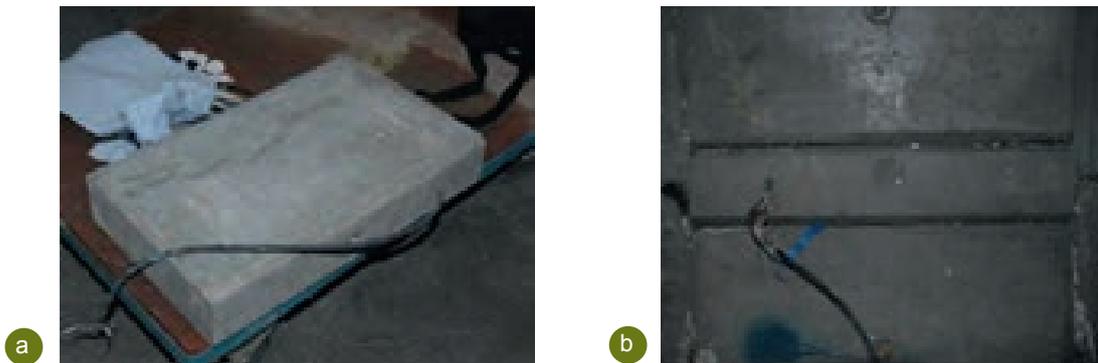
Figure 5-9: (a) 100 mm thick lining segment containing a load cell;  
(b) lining segment containing the load cell in the lining ring.

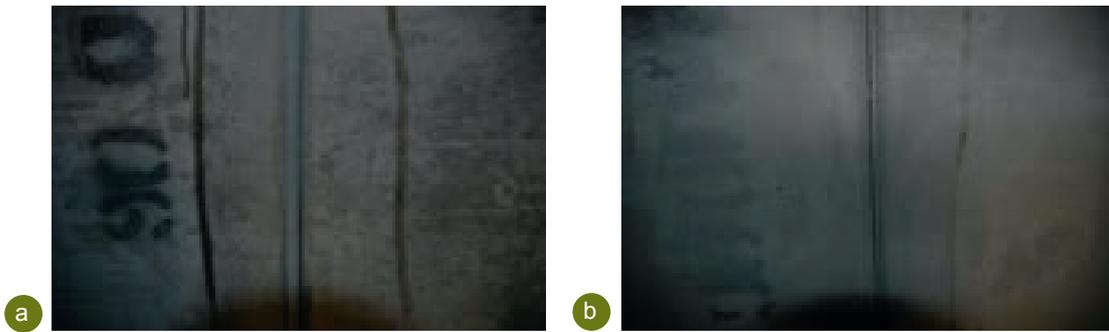
Figure 5-10: (a) 8 mm thick silicon rubber sheet and (b) 3 mm thick polyethylene sheet placed between the rings.

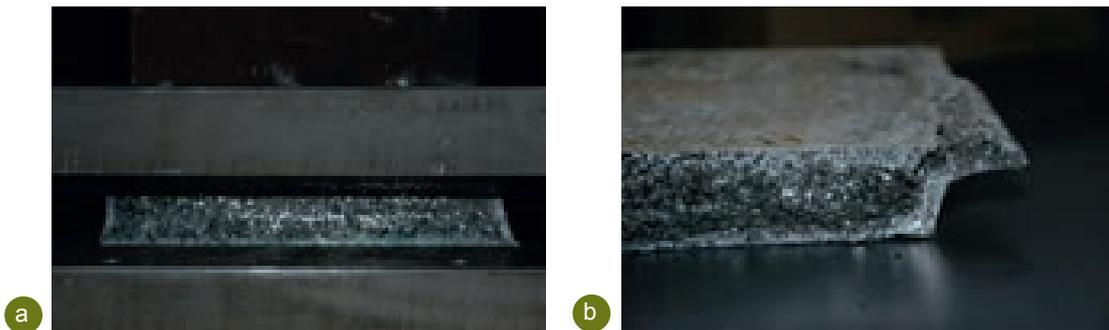
Figure 5-12: Load test with fixed load cell head (a) and with rotating load cell head on metal foam samples (b).

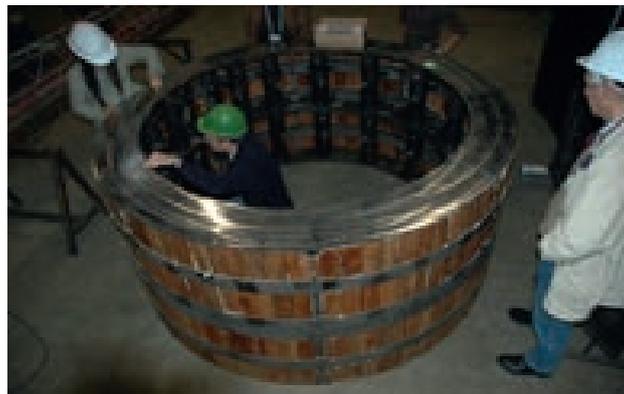
Figure 5-14: Test assembly of the alternative lining.

The segments of the alternative lining were fabricated by SMET Tunnelling. A test assembly on the surface was carried out and inspected by EURIDICE on 28.09.2007 (Figure 5-14).

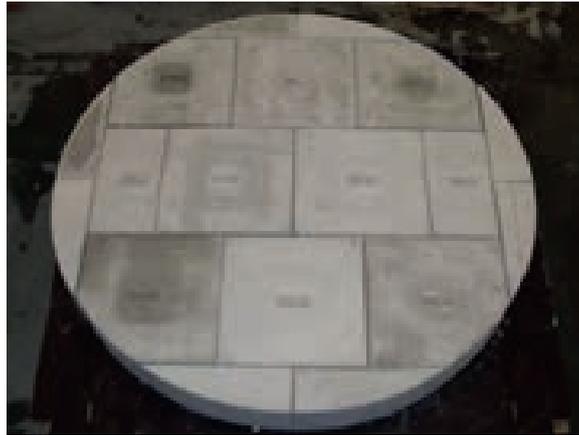
Figure 5-15: Test assembly of the wall of compressive concrete installed at the end of the PRACLAY gallery.

The final excavation front is reinforced with a steel mesh (150x150 mm, Ø12 mm), which is subsequently shotcreted with C30/37 concrete. A 250 mm thick layer of compressive material is placed between the end plug and the shield to allow for some compression of the end plug (Figure 5-15) [9]. In that way the axial stresses in the PRACLAY gallery are limited. The compressive material is held together by a 10 mm thick steel plate, supported by steel profiles (HEB 100).

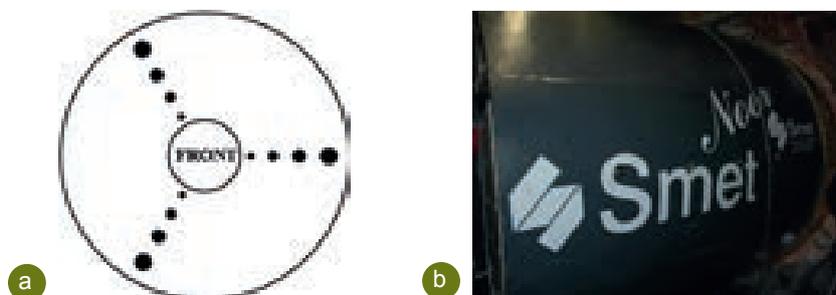
Figure 5-19: Openings in the shield to measure the convergence of the clay.

12 small openings in the shield were provided to enable the measurement of the convergence of the clay around the shield. The openings are grouped into three sections, 120° apart, and located at an axial distance of respectively 500, 910, 1320 and 1730 mm from the rear end of the shield. A schematic overview of this configuration and a picture of one line of openings are shown in Figure 5-19. Optical laser distance sensors continuously measured the distance to the clay formation. The position and the roll of the shield were determined by a tachymeter placed in the Connecting gallery in front of the entrance of the PRACLAY gallery and mirrors placed on the tunnelling shield. Also the thrust forces and the stroke of the hydraulic jacks were measured. In summary, the following parameters were continuously monitored and recorded every 30 seconds:

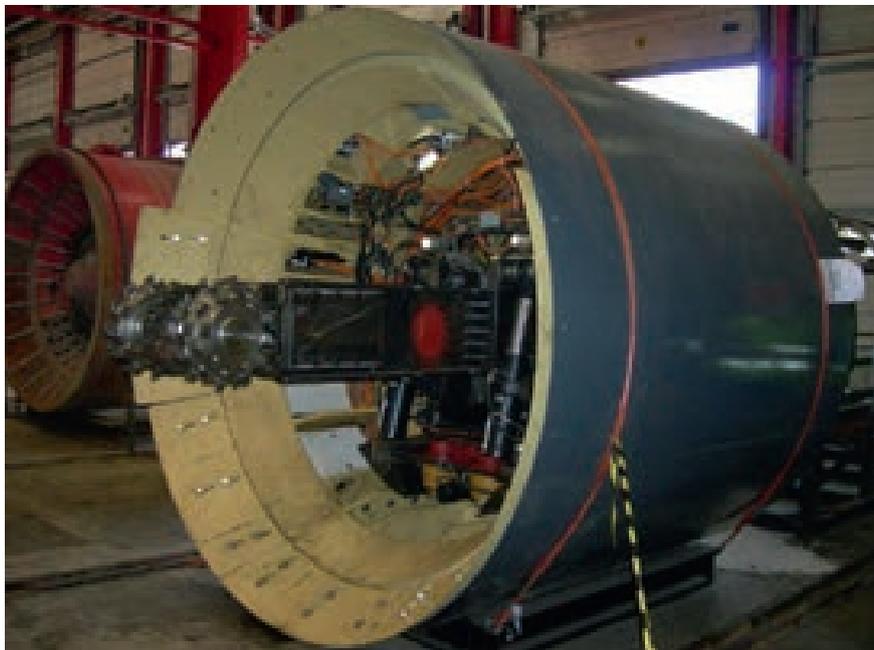
Figure 5-21: On-surface test assembly of the tunnelling machine.

Prior to being transported to the underground laboratory, all tunnelling equipment (shield, roadheader, erector, rail tracks and hydraulics) was assembled on the surface to check all the functions and the geometry of the machinery, separately and as a whole, and to provide an opportunity to make the necessary adjustments prior to starting the work. The test assembly was particularly essential, as the limited volume of the Connecting gallery was going to make underground assembly of the tunnelling machine one of the most difficult steps of the project. Important tests were the manipulation of a lining segment and the insertion of a key into the corresponding pocket of the shield.

The assembly of the tunnelling machine was checked and approved by EURIDICE on 24.05.2007 (Figure 5-21).

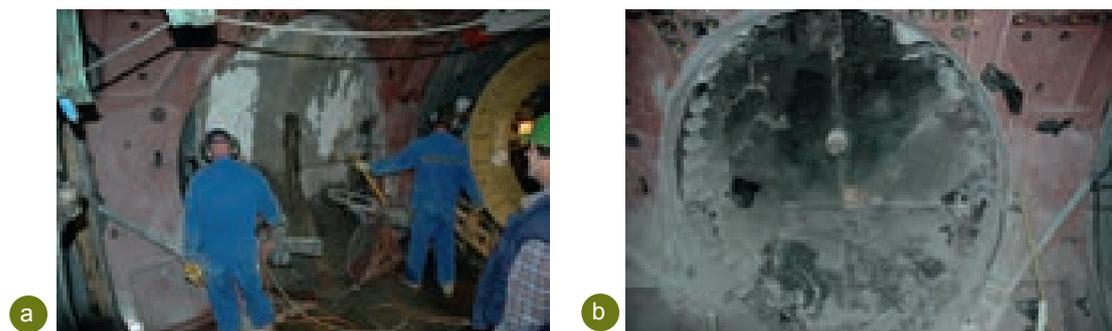
Figure 5-24: Cutting of the lining of the Connecting gallery to make the opening for the PRACLAY gallery.

On 01.10.2007 and 02.10.2007 the opening for the PRACLAY gallery was made in the eastern side of lining rings 32 to 34 of the Connecting gallery (Figure 5-24). The cradle carrying the machine was then positioned into the large opening of the reinforcement ring (Figure 5-25). The other parts of the equipment were installed stepwise during the start-up phase when the required space was made available.

Figure 6-2 shows the stress change measured by the strain gauges placed on the reinforcement ring. A clear change in stresses can be observed on 01.10.2007 when the lining of the Connecting gallery was cut (Figure 5-24). A second abrupt change occurs as the excavation starts on 04.10.2007. By the end of the excavation work the stresses in the steel reinforcement ring are stabilised.

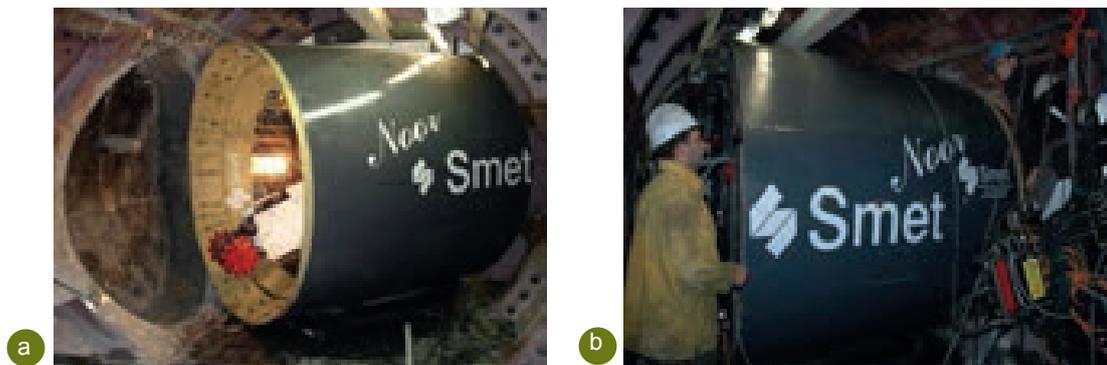
Figure 5-25: Positioning of the tunnelling machine into the large opening of the reinforcement ring.

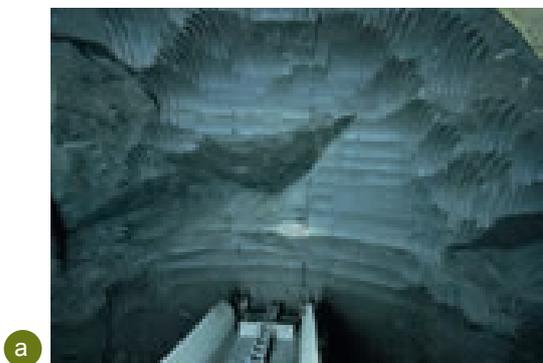
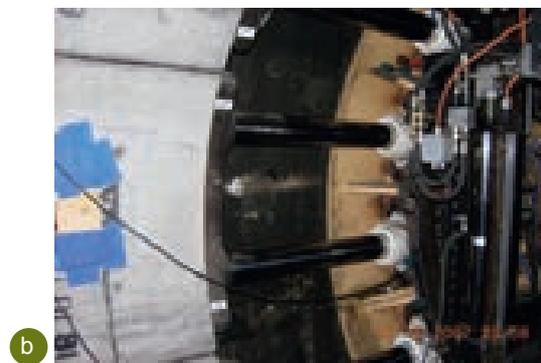
Figure 5-28: Excavation cycle: (a) drilling the clay front; (b) pushing the shield forward against the already built lining; (c) removal of the clay cuttings to the rear end of the tunnelling machine; (d) evacuation of the clay by wagons.

- *Excavation of the clay over a distance of half a metre*, the total length of the unsupported zone thus being 0.6 metres. This entails several iterations of the following three steps (Figure 5-28):
  - > excavation of the Boom Clay by the roadheader over a distance of ca. 20 cm, with simultaneous evacuation of the clay by the conveyor of the roadheader and direct loading into wagons that are pushed by hand on the rail tracks built at the rear of the tunnelling machine as it progresses;
  - > forward movement of the shield, pushed by the jacks on the already installed lining, with simultaneous smooth trimming of the excavated profile by the cutting edge, the cuttings falling onto the bottom of the gallery. The shield can be steered by the jacks;
  - > evacuation of the cuttings being scooped onto the head of the roadheader.

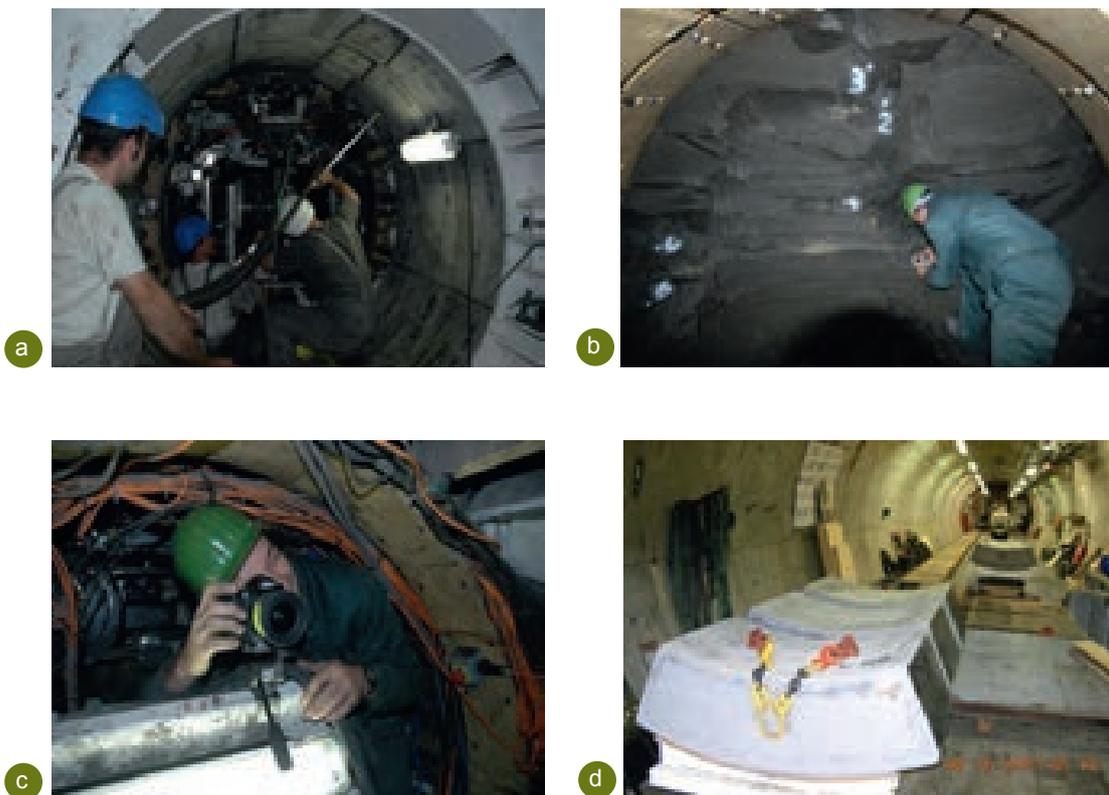
Figure 5-29: (a) Measuring the excavated diameter; (b) observations at the excavation front; (c) taking pictures of the excavation front; (d) transporting the segments to the front.

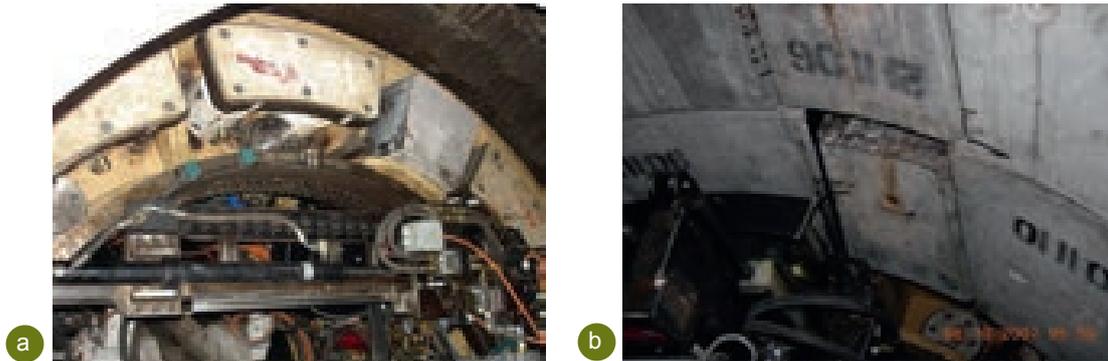
Figure 5-30: Insertion of the key segment: (a) the key segment is placed in a key holder in the tunnelling machine; (b) the key segment placed inside the lining ring.

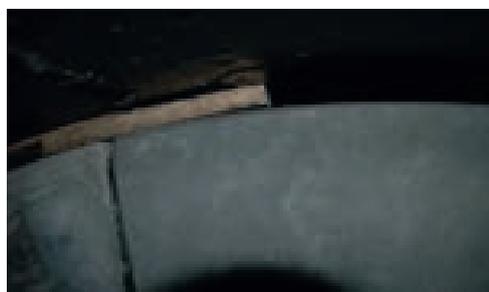
Figure 5-31: Gap between clay sidewall and lining ring 12 because of the excessively large overexcavation at the top.

When the excavation was started, all cutting edges were moved out over 60 mm. This corresponded to an additional overexcavation of 51 mm on diameter on top of the overexcavation of 30 mm on diameter resulting from the geometry of the shield (Figure 2-11). In the start-up zone, the convergence of the clay between its excavation and the installation of the lining was influenced by the altered stress conditions near the crossing. Beyond the start-up zone, horizontal convergence was in line with the predictions. In contrast, vertical convergence was 20 to 30 mm less than expected. As a consequence of the smaller vertical convergence, the overexcavation at the top and at the bottom was too large (Figure 5-31). Therefore the upper cutting edge was moved to 45 mm after the construction of ring 13. Overexcavation at the top and to a lower extent at the bottom still remained too large, however. The top cutting edge was further brought back to 30 mm and the lower cutting edge to 45 mm for the excavation of rings 33 to 81. By doing so the shield cut a slightly elliptical profile in order to end up with a more circular profile behind the shield. A more detailed discussion on the observed clay convergence can be found in section 6.3.

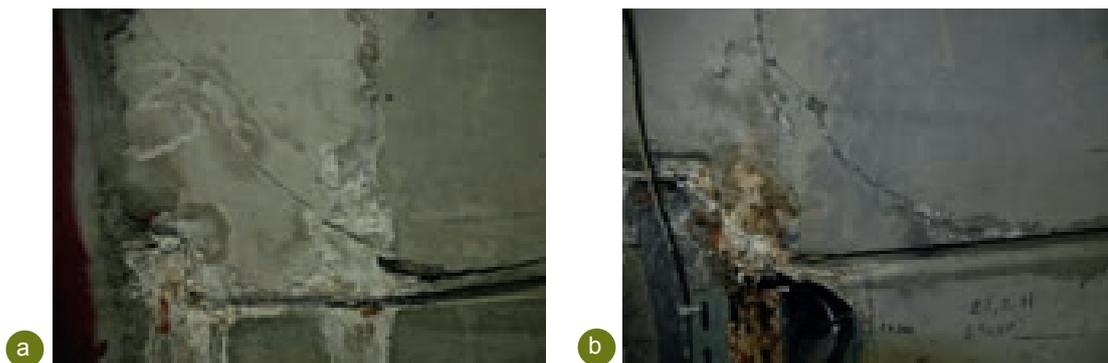
Figure 5-32: Crack in the lining of the Connecting gallery after cutting the opening for the PRACLAY gallery: (a) ring 31; (b) ring 30.

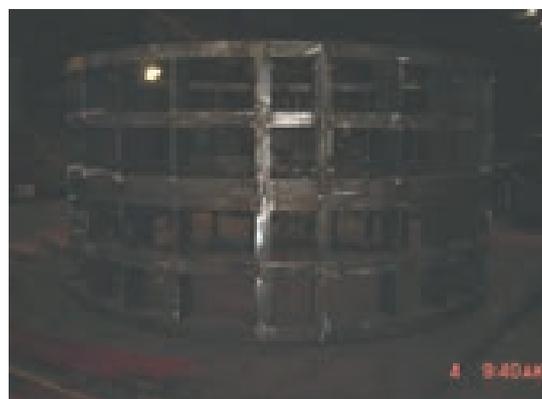
Figure 5-33: Additional reinforcement rings.

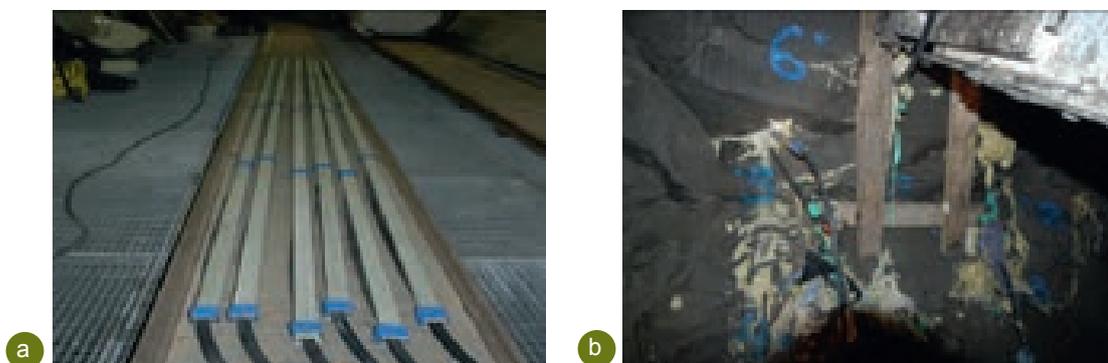
Figure 5-35: Anchors (a) were installed during the stop-and-go test to stabilise the excavation front (b).

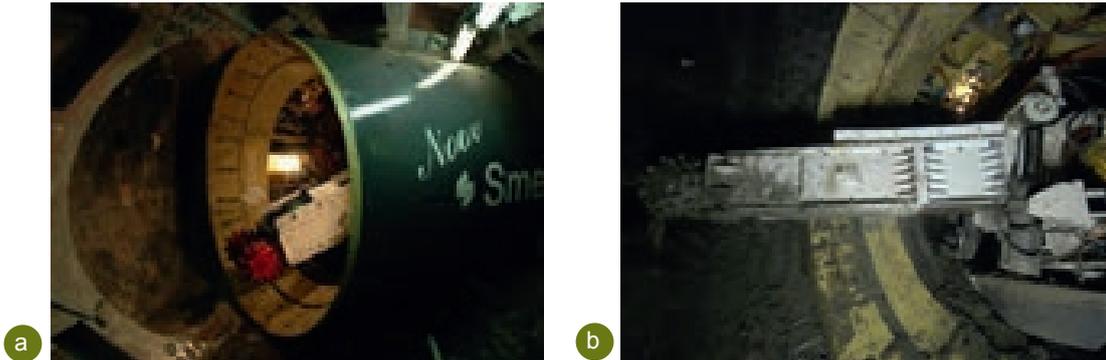
Figure 5-36: To achieve the larger excavated diameter of the end plug, the roadheader was extended: (a) picture of the roadheader at the beginning of the excavation work; (b) picture of the extended roadheader.

Upon completion of the excavation work, the tunnelling shield remained in place and all recoverable components were removed. The diameter of the end plug was designed to be 1 m larger than the diameter of the PRACLAY gallery (cf. section 2.3.5). To achieve this, the roadheader was extended to reach a wider excavation area (Figure 5-36).

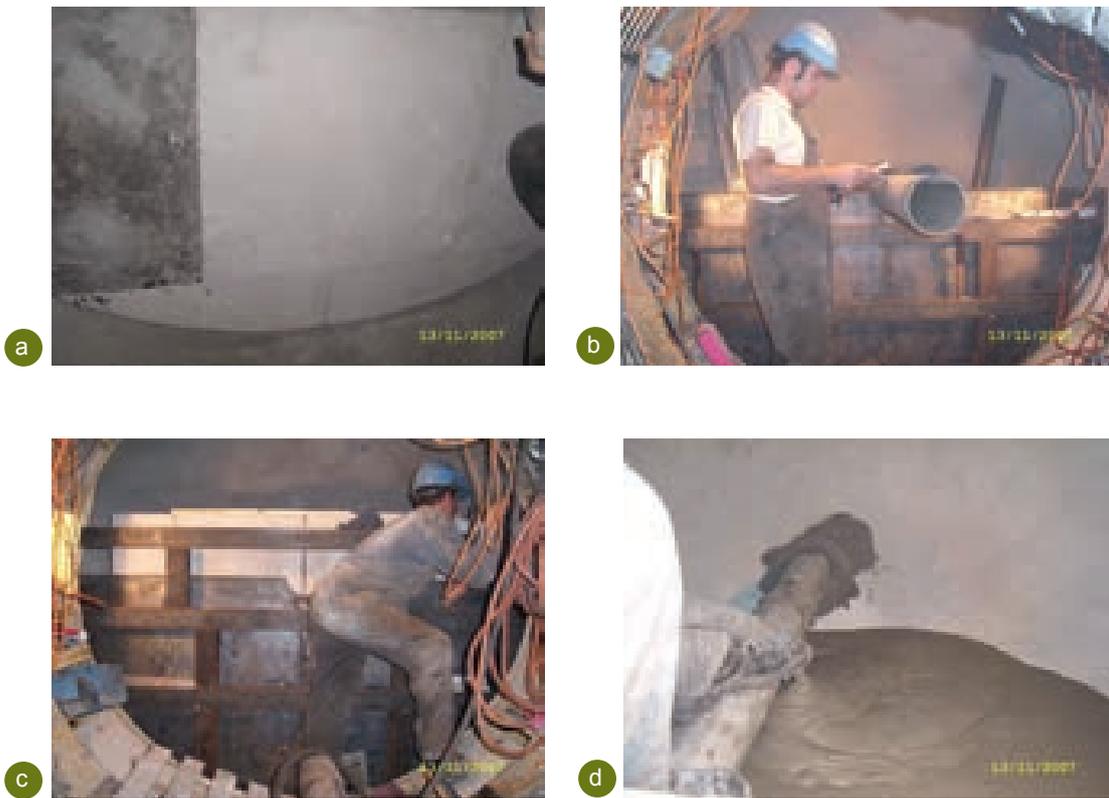
Figure 5-38: A wall of compressive blocks was built and the space behind it filled with concrete. A tube was placed in the centre for the subsequent installation of an instrumented borehole.

Once the final face was excavated, the excavation front was reinforced with a steel mesh (150x150 mm, Ø12 mm), which was subsequently shotcreted with C30/37 concrete (Figure 5-37). Then a 250 mm thick wall consisting of compressive blocks was built in front of the tunnelling shield. The purpose of the compressive wall is to allow some axial movement of the plug without influencing the PRACLAY gallery itself (cf. section 2.3.5). The compressive material is held together by a 10 mm thick steel plate, supported by steel profiles (HEB 100) (Figure 5-39). In the centre of the wall a tube was placed for the subsequent installation of a piezometer (Figure 5-38). Before finishing the complete construction of the compressive wall, the space behind the wall was filled with concrete (Figure 5-40).

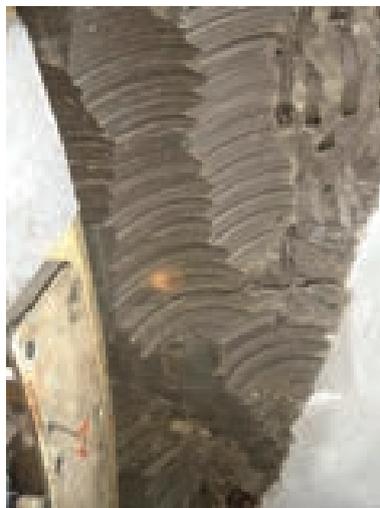
Figure 5-42: Excessively large overexcavation due to the action radius of the roadheader being too wide.

- > incorporating an automated system to adjust the position of the cutting edges
- The action radius of the roadheader was too wide.* The roadheader sometimes excavated outside the design diameter, resulting in undesirable overexcavation (Figure 5-42).

- > automatically limiting the action radius of the roadheader

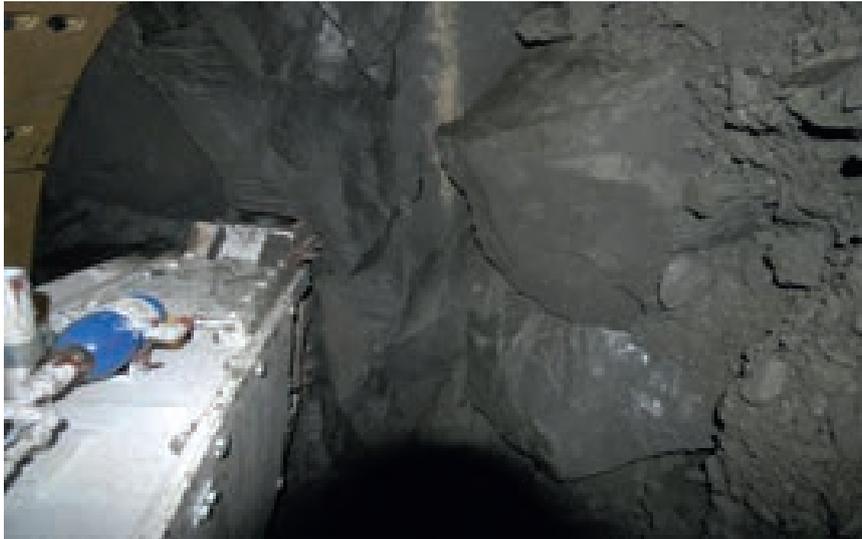
Figure 5-43: Risk of clay block coming off the excavation front.

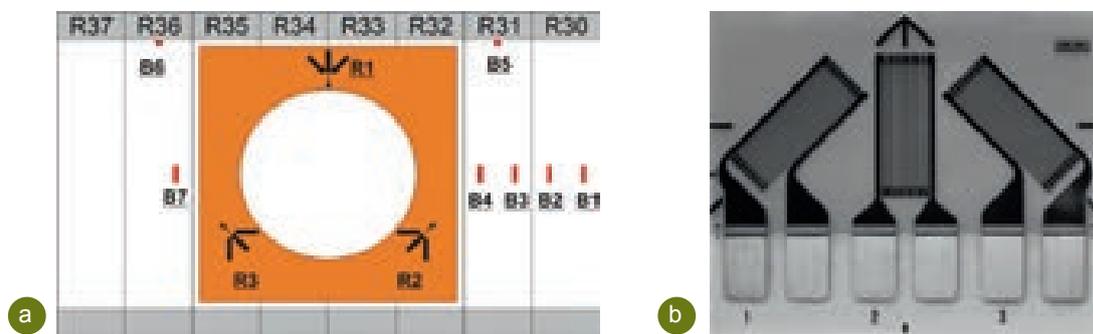
Figure 6-1: (a) Strain gauges on the steel reinforcement ring and the lining of the Connecting gallery around the opening for the PRACLAY gallery; (b) Rectangular rosette configuration of the strain gauges placed on the reinforcement ring.

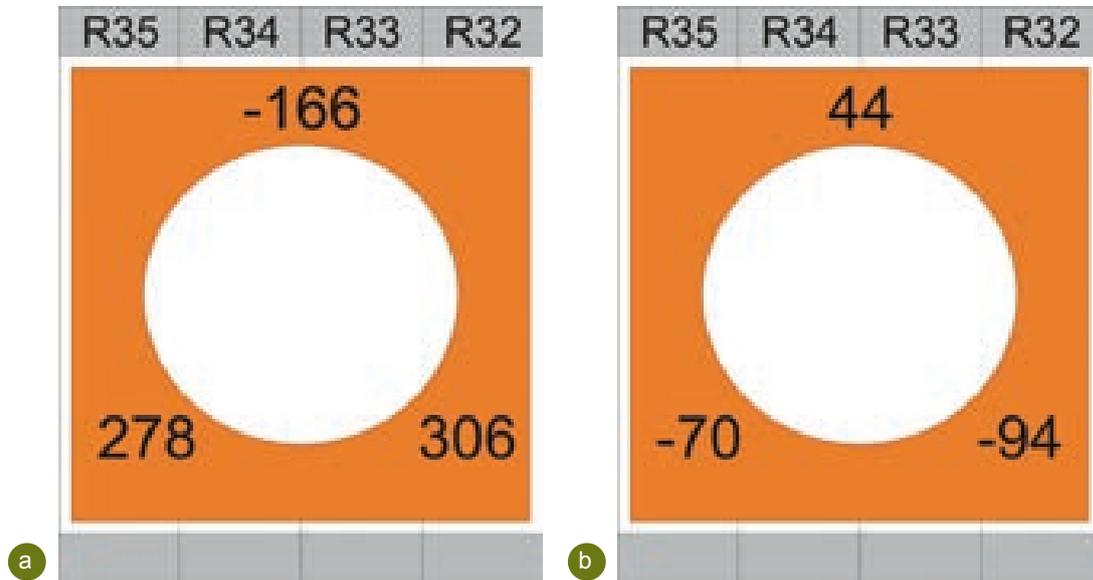
Figure 6-3: Stresses around the reinforcement ring after the excavation of the PRACLAY gallery (positive values indicate compressive stress; negative values indicate tensile stress): (a) tangential; (b) radial.

Based on these measurements, the principal stresses around the reinforcement ring induced by the gallery excavation were calculated. Figure 6-3 shows these stresses at the end of the excavation of the PRACLAY gallery. These measurements are consistent with the stresses around an opening in a plate that is subjected to a compressive stress in one direction. Figure 6-4 shows these stresses around an opening obtained by modelling.

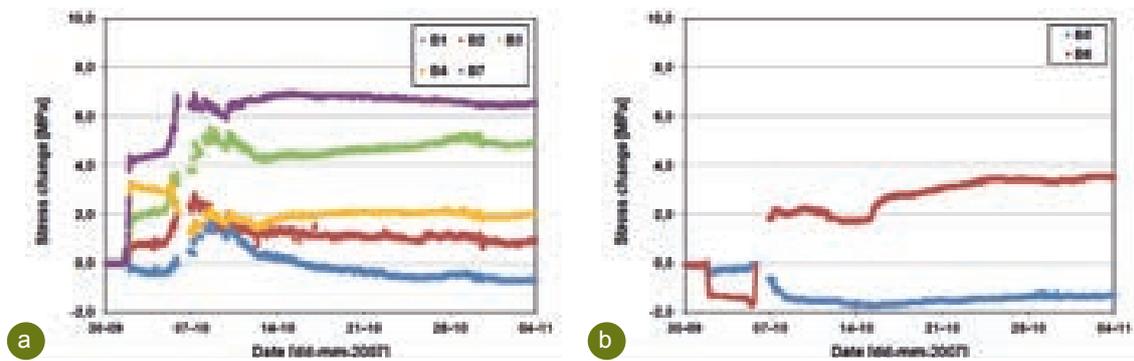
Figure 6-5: Stress variation (a positive sign is an increase in compressive stress) in the lining rings of the Connecting gallery adjacent to the steel reinforcement ring as measured by the strain gauges: (a) strain gauges B1, B2, B3, B4 and B7 at mid height of the Connecting gallery, (b) strain gauges B5 and B6 at the top of the Connecting gallery.

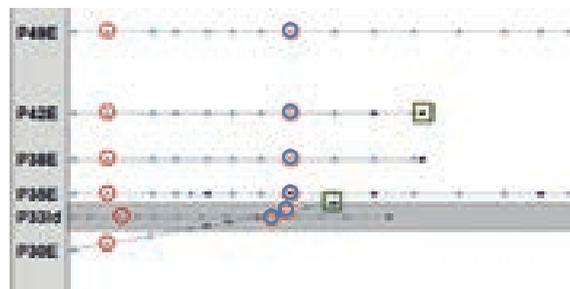
Figure 6-6: Piezometers and flatjacks are installed in boreholes drilled from the Connecting gallery. The piezometers and flatjacks from which the measurements are here presented are marked by red circles and green squares respectively.

The stress and pore water pressure response in the clay to the gallery excavation was measured by flatjacks and piezometers placed in the clay. Some representative stress and pore water pressure measurements are presented here. Figure 6-6 shows the location of these flatjacks and piezometers.

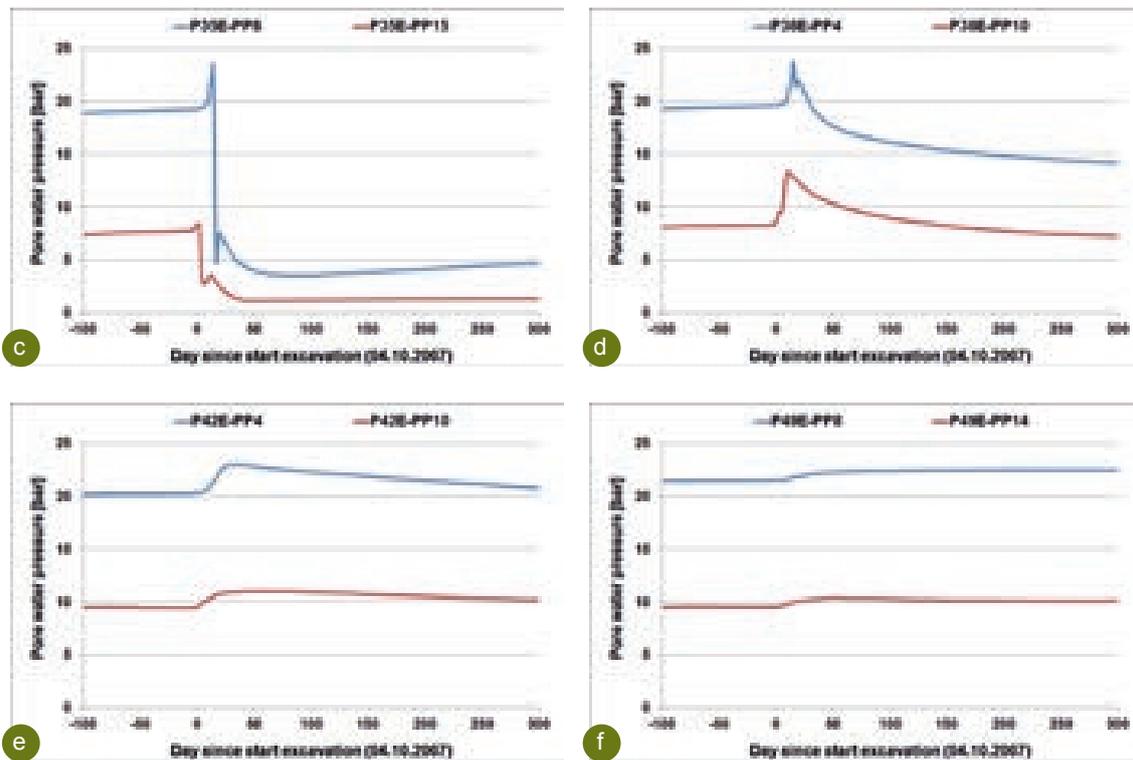
Figure 6-8: Pore water pressure measurements

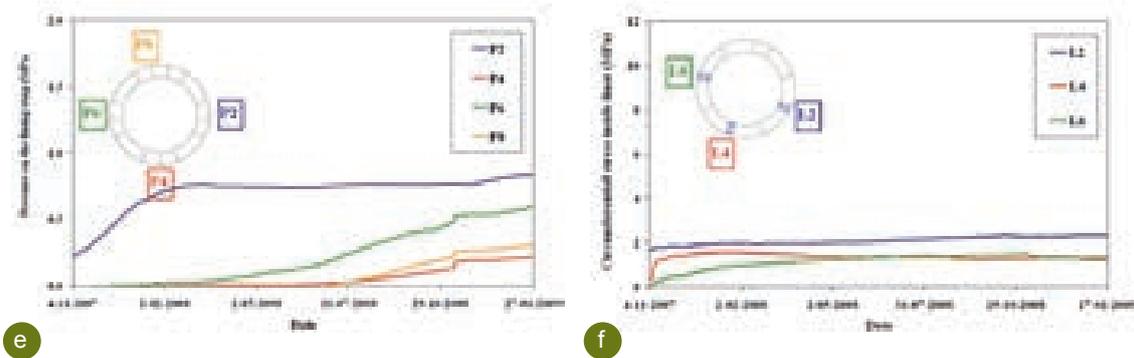
Figure 6-10: Measured stresses in and on lining rings 12, 46 and 78.

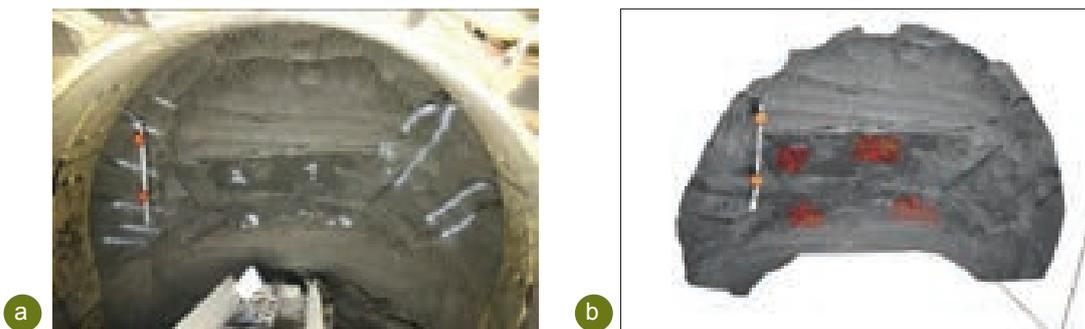
Figure 6-11: (a) The dip and dip direction of the fractures in the front were measured; (b) stereographic pictures were taken to reconstruct a 3D image of the excavation front.
