# **The design and installation of the PRACLAY In-Situ Experiment**

EURIDICE Report, ref. 13-129

1 September 2013

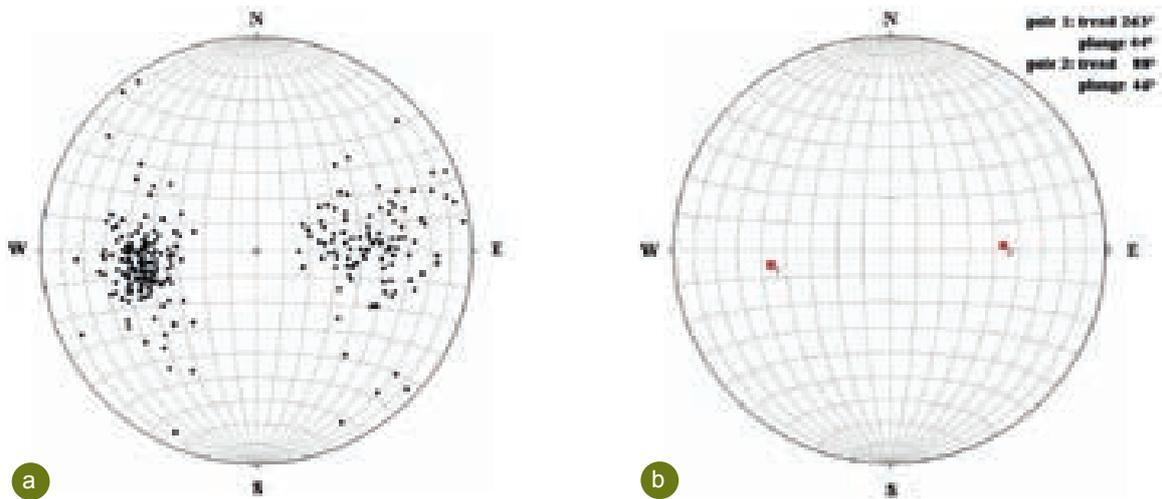
Figure 6-12: (a) Measured and (b) fitted poles to fracture planes plotted on stereographic plot.

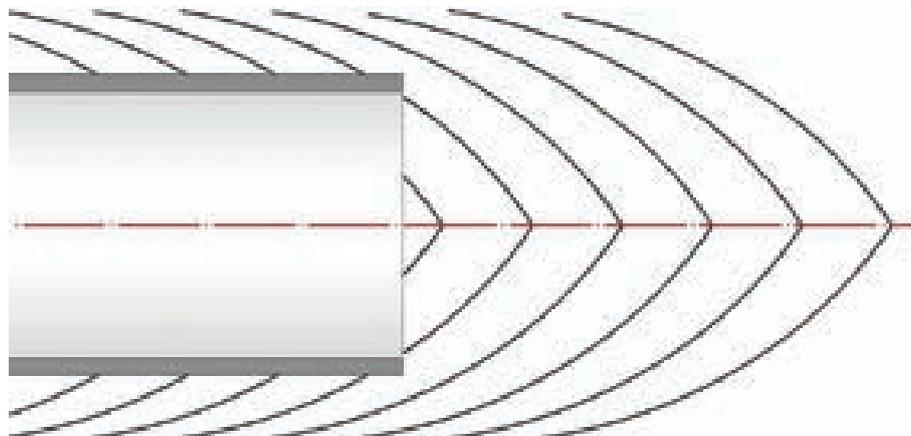
Figure 6-13: Observed fracture pattern (vertical cross section).

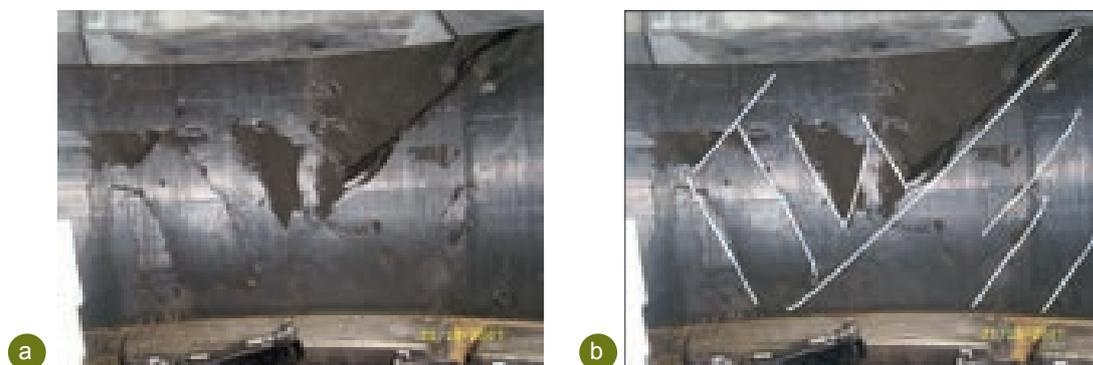
Figure 6-14: (a) Picture of the sidewall and (b) identification of the fractures.

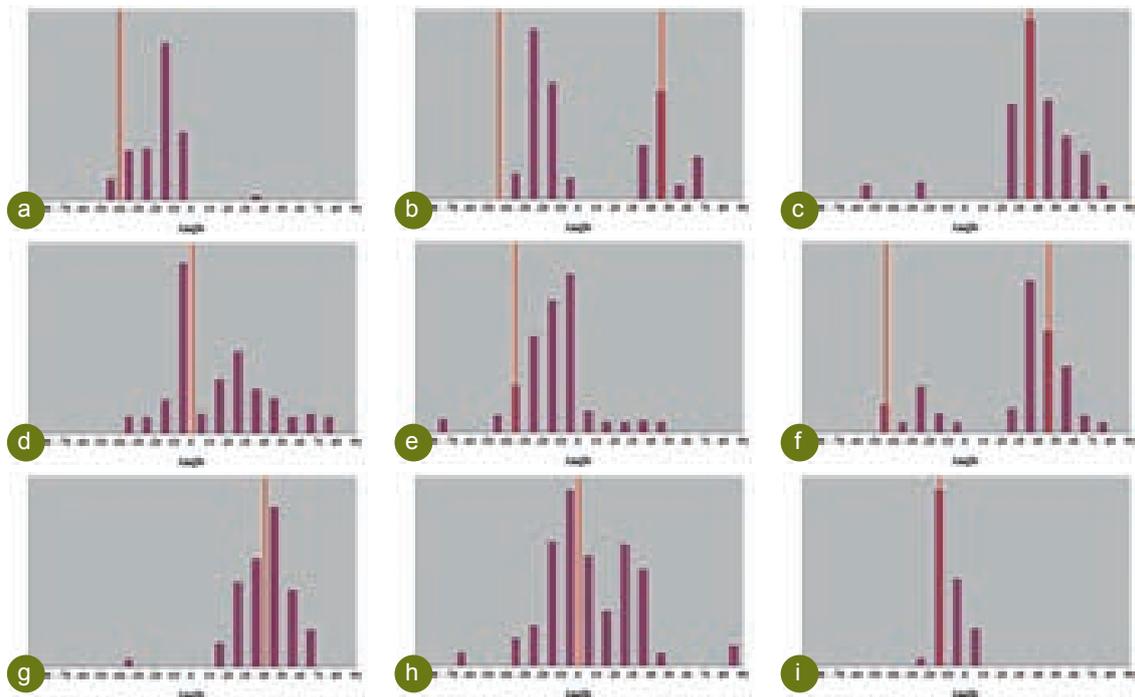
Figure 6-16: Histogram of the cumulative length of the fractures in the different sections with a length greater than 500 mm. A red line indicates the theoretical angle of the intersection between the segment plane and an east-dipping fracture plane of 45° in the upper part and a west-dipping fracture plane of 45° in the lower part: (a) segment 1; (b) segment 2; (c) segment 3; (d) segment 4; (e) segment 5; (f) segment 6; (g) segment 7; (h) segment 8; (i) segment 9.

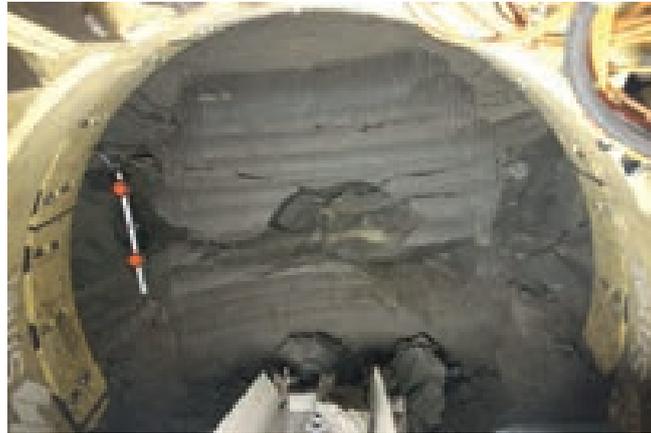
Figure 6-17: Fractures induced by the central borehole.

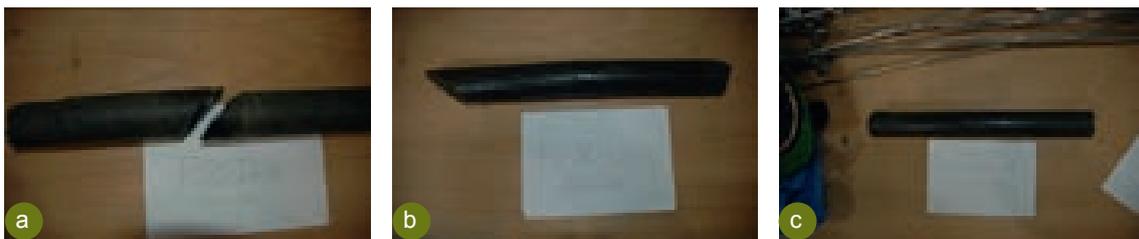
Figure 6-18: Cores from the first 1.5 m of boreholes drilled around the Praclay gallery were taken to examine the radial extent of the fractured zone around the gallery. Fractures were observed in these cores but it was not possible to distinguish between fractures induced by the excavation of the gallery and fractures originating from the drilling itself.

(a) 0 – 0.5 m in PG50Id; (b) 0.5 – 1.0 m in PG50Id; (c) 1.0 – 1.5 m in PG50Id.

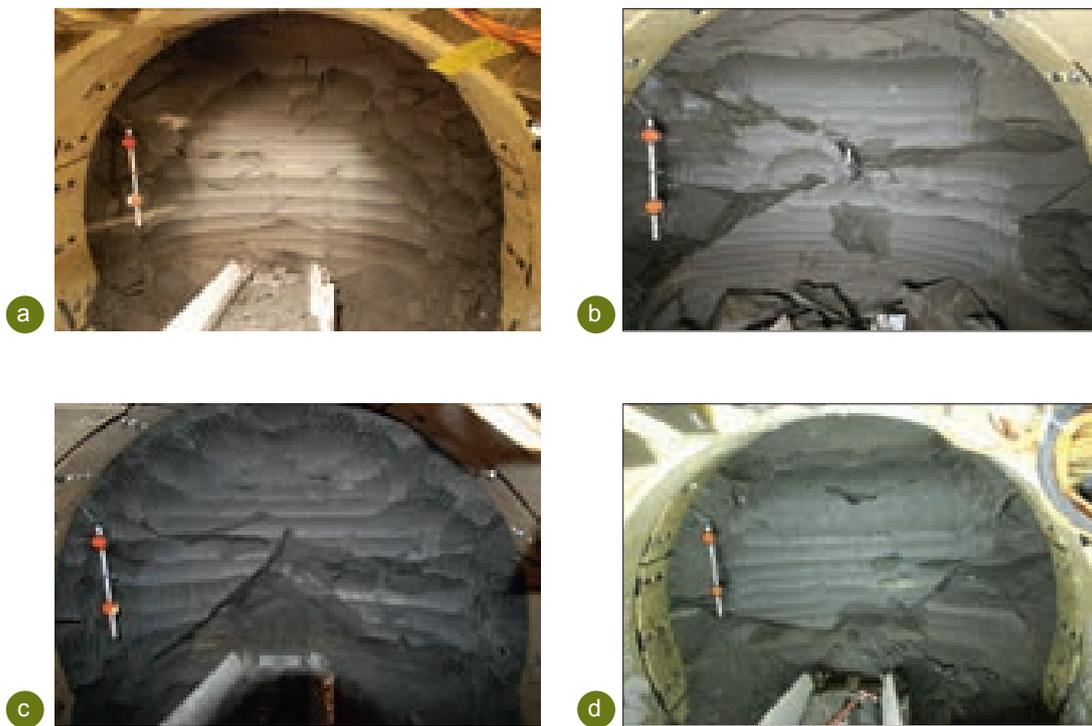
Figure 6-19: Fractures visible in the excavation front of the PRACLAY gallery excavation during the first few metres of the excavation: (a) 1 m from extrados Connecting gallery; (b) 2.5 m from extrados Connecting gallery; (c) 4 m from extrados Connecting gallery; (d) 5.5 m from extrados Connecting gallery.

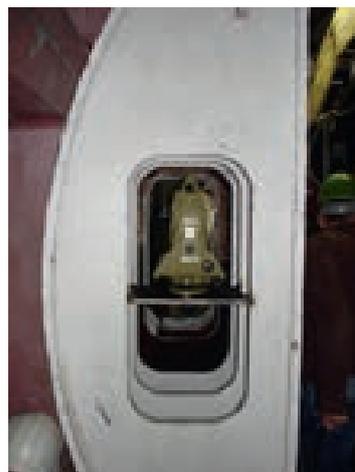
Figure 6-21: Total station to measure the position of the gallery axis during the excavation work.

The position of the gallery axis during the excavation was measured by a total station placed in the Connecting gallery in front of the opening for the PRACLAY gallery (Figure 6-21). A vertical and horizontal deviation

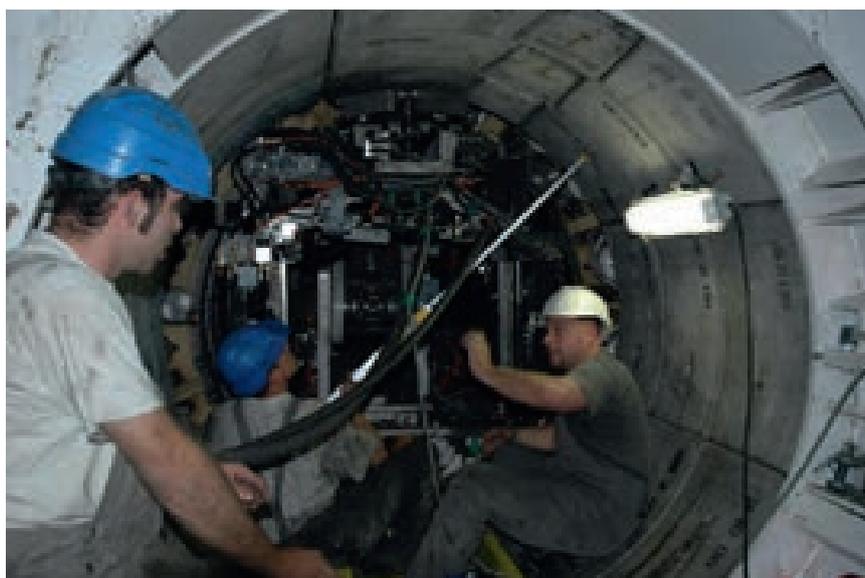
Figure 6-23: Manual measurement of the diameter of the gallery.

The excavated diameter and the internal diameter of the gallery were manually measured for each ring using an extensometer (Figure 6-23). Figure 6-24 and Figure 6-25 show the measured diameters. There is a difference between the vertical and the horizontal diameter. The average horizontal and vertical diameter of the excavated profile is respectively 2506 and 2525 mm. This is in line with the previously discussed convergence measurements and observations (cf. section 6.3). Also the impact of the reduction in the vertical overexcavation after ring 32 can be seen on the vertical diameter of the excavated profile. The average horizontal and vertical internal diameter of the gallery is respectively 1898 and 1906 mm.

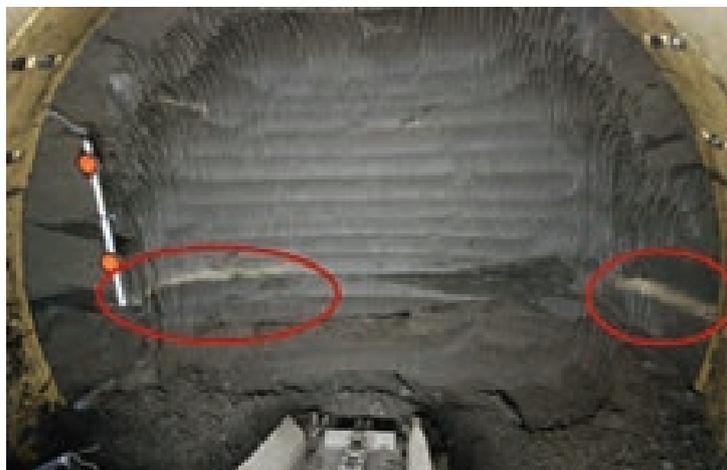
Figure 6-30: Septaria layer mS 140 visible in the excavation front.

The PRACLAY gallery lies along an east-west axis and the excavation offered the possibility to measure the vertical position of the septaria layer mS140 in that direction. The measurements of the vertical position of the septaria layer on the sidewalls of the excavation reveal a dip of  $0.2^\circ$  to the east (Figure 6-30).

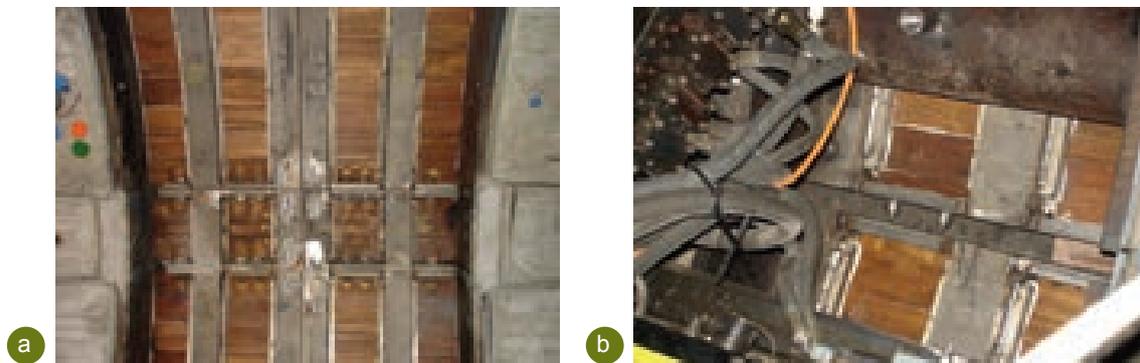
Figure 2-2: Alternative lining where the hydraulic seal will be erected:  
(a) the lining consisted of a permanent part (4 steel rings) and a temporary part (wood placed between the steel rings); (b) the segments of the alternative lining were connected by a pin-hole connection in the steel plates between the rings.

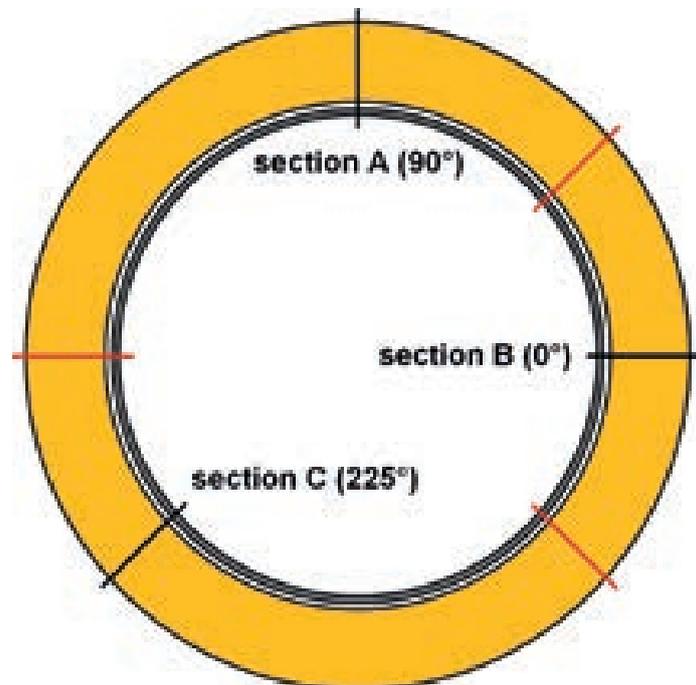
Figure 2-14: Overview from the downstream side of the instrumented sections in the bentonite rings (the red lines indicate the position of the extensometers).

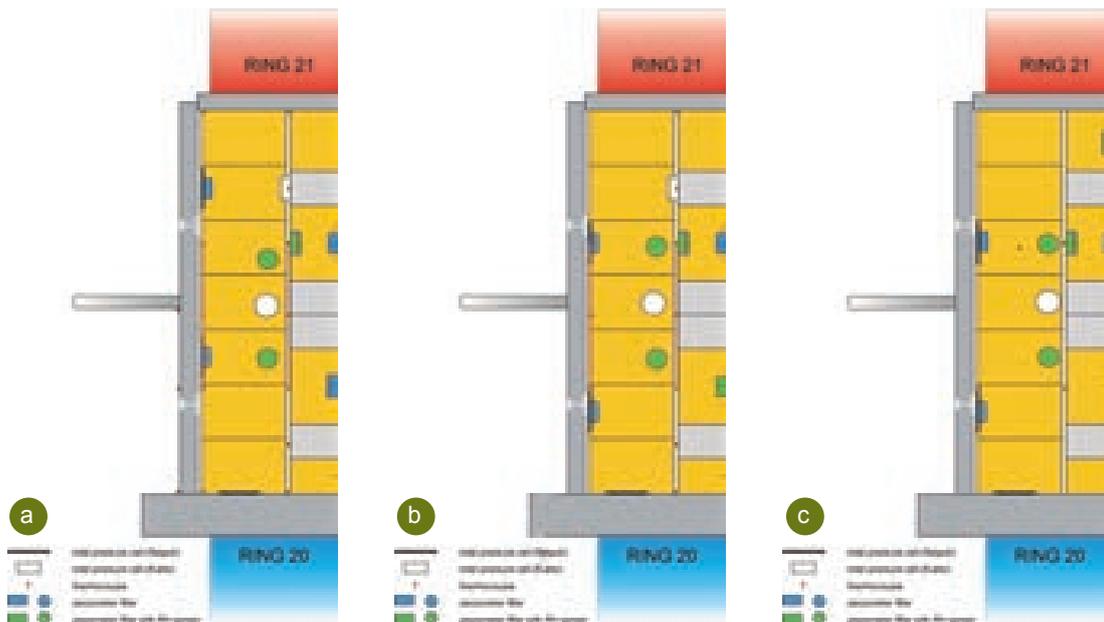
Figure 2-15: Instrumentation in the different sections:  
(a) section A; (b) section B; (c) section C.

Instrumentation was placed in the bentonite blocks to gain information on the bentonite hydration and to be able to test and evaluate the performance of the hydraulic seal. The instrumentation programme (see also section 2.2 – Figure 2-14 and Figure 2-15 – and section 5.2.4) consists of:

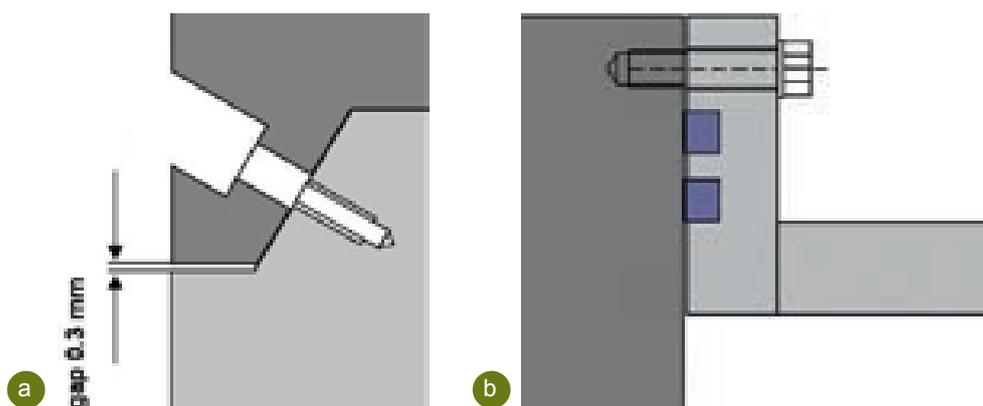
Figure 5-1: Alternative design for: (a) the assembly of the segments of the flange using bolts and a resin applied in a 0.3 mm gap; (b) the assembly of the cylinder (light grey) to the downstream flange (dark grey) is done using two gaskets (blue) and bolts.

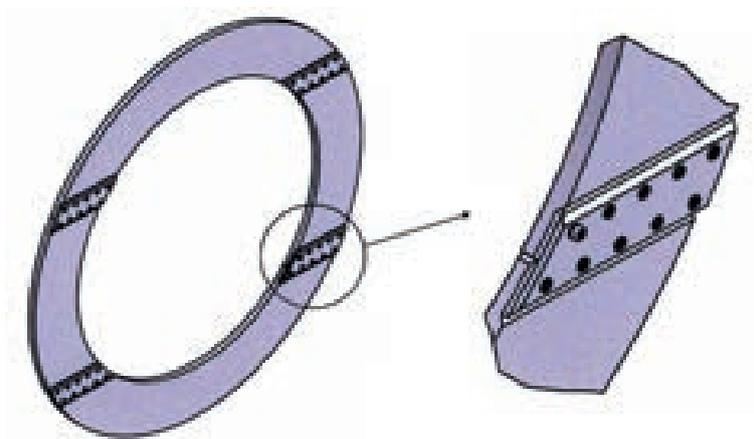
Figure 5-2: The segments of the upstream flange are connected by bolting a plate over the connection.

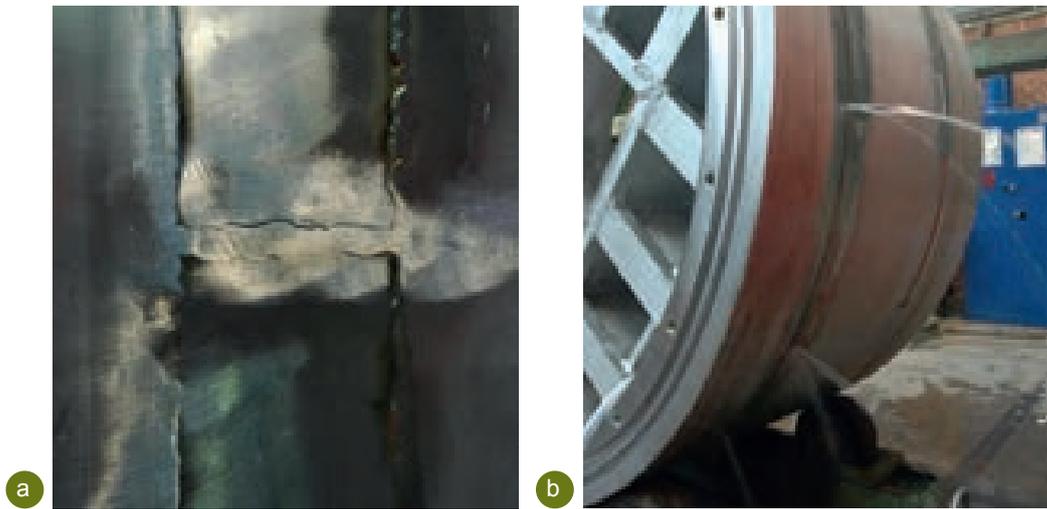
Figure 5-3: (a) Fissure in the filter; (b) Water leakage through fissures in the filters during the testing of the filters.

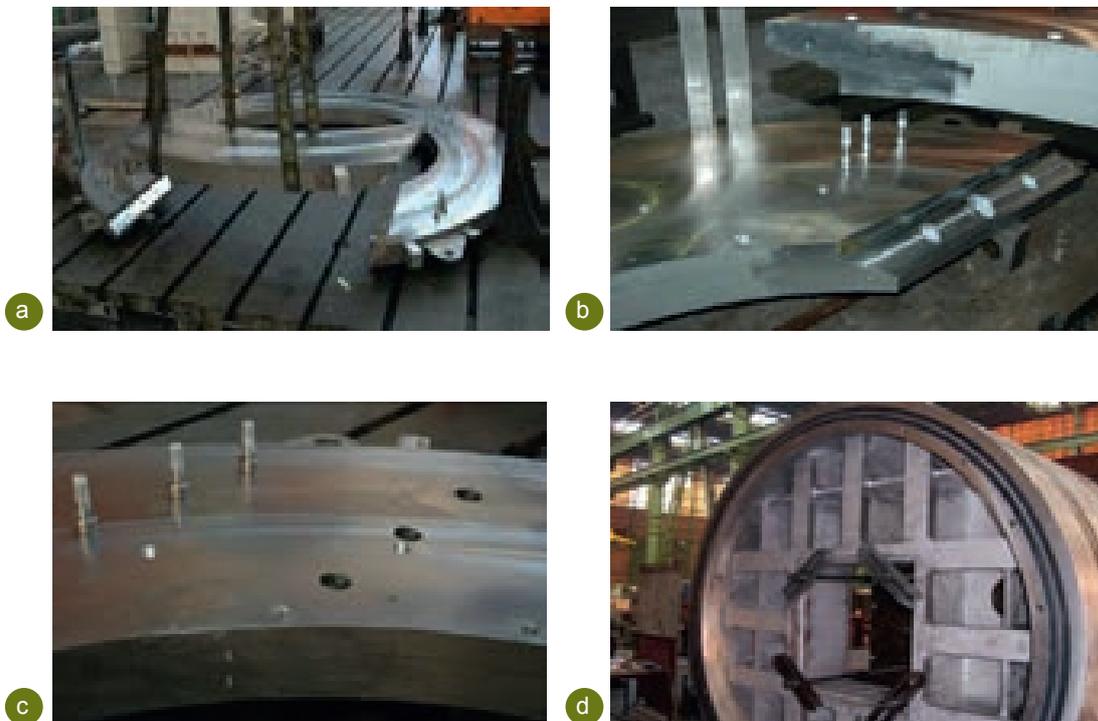
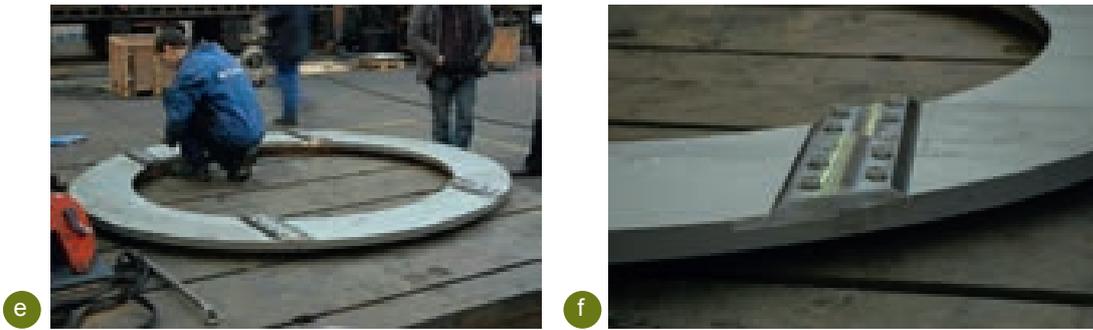
Figure 5-4: Test assembly in the workshop:

- (a) assembly of the four segments of the downstream flange;
- (b) the segments are assembled using a “tooth” connection that is bolted;
- (c) tight connection between the segments;
- (d) placing of the two gaskets in their designated groove in the cylinder flange;
- (e) assembly of the four segments of the upstream flange;
- (f) the segments are assembled by bolting a closing plate over the connection between the segments.

- assembly of segments of the downstream flange (Figure 5-4a-c);
- assembly of the downstream flange to the cylinder with the 2 gaskets placed in their designated groove in the cylinder (Figure 5-4d);
- assembly of the upstream flange (Figure 5-4e-f);
- passage of the upstream flange over the cylinder.

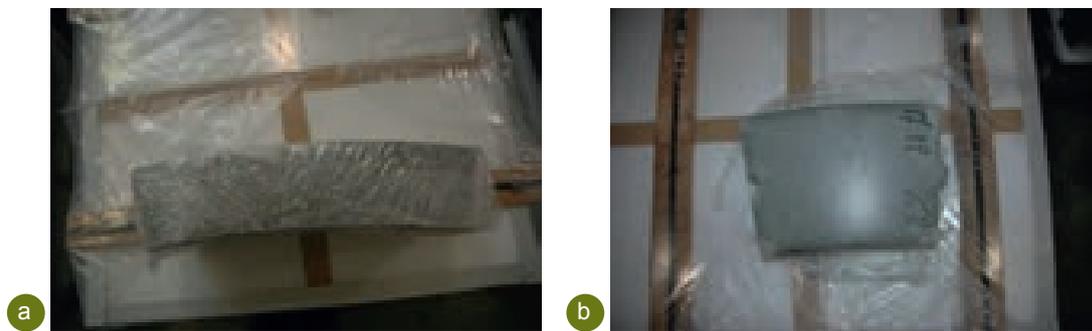
Figure 5-6: (a) Outer layer bentonite block; (b) Inner layer bentonite block.

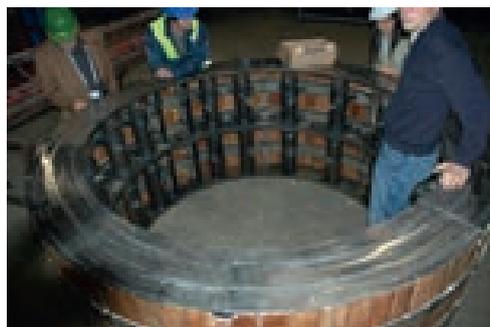
Figure 5-7: The alternative lining at the location of the hydraulic seal during a test assembly on the surface.

After the delivery of the blocks it was realised that the extrados of the wood of the temporary part of the alternative lining at the location of the hydraulic seal was placed 10 mm more to the interior than the extrados of the steel rings (Figure 5-7). The wood was therefore 100 mm thick and had an external diameter of 2480 mm instead of 2500 mm. The diameter of the clay sidewall was therefore 2480 mm instead of 2500 mm. To correct this mismatch, the blocks from the outer layer were scoured over 10 mm at their extrados.

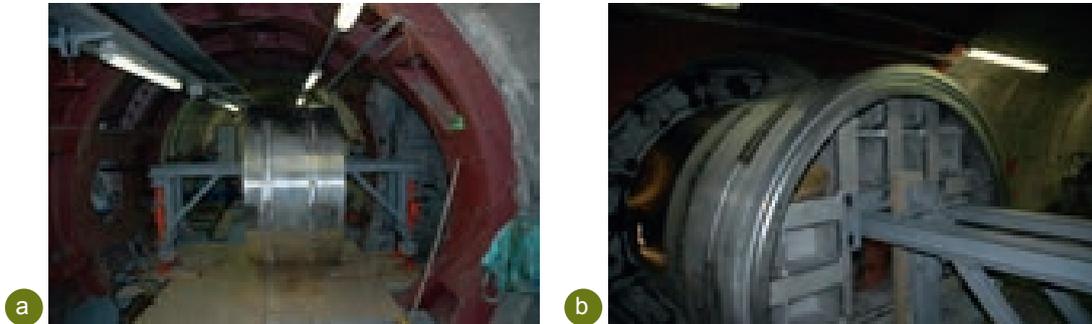
Figure 5-10: (a) Hoisting table on wheels used to transport the cylinder;  
(b) The table consists of two I-profiles that are placed in the central opening of the cylinder. The vertical position of the profiles can be altered.

On 15.01.2010 the cylinder was inserted into the PRACLAY gallery and placed ca. 2 m upstream of the location of the hydraulic seal (Figure 5-11b). This was done using a hoisting table (Figure 5-10). The table

consists of two I-profiles that are placed in the central opening. The vertical position of these I-profiles could be manually altered by the jacks at both ends of the table. The table has wheels and can thus be moved horizontally. The complete table can be assembled and dismantled relatively easily (without the need for large equipment). The table was also used for the erection of the flanges (cf. sections 5.2.2 and 5.2.3) and the assembly of the cylinder to the flanges (cf. section 5.2.5).

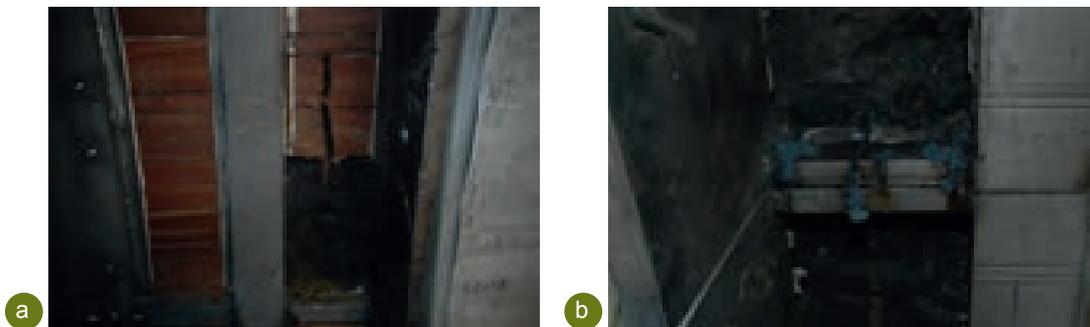
Figure 5-12: Removal of the temporary part of the lining at the location of the hydraulic seal: (a) the steel ribs behind which the wood is placed were removed using a grinding disc and the wood was cut with a drill; (b) the lateral steel plates were removed by plasma burning.

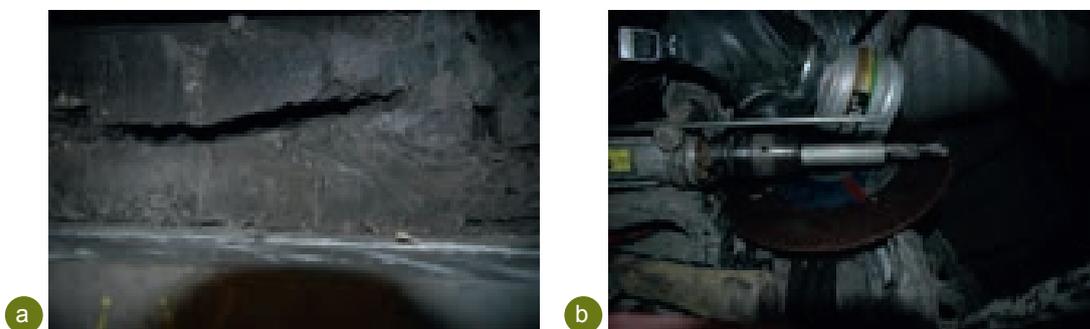
Figure 5-13: (a) Groove in the clay made when drilling the wood of the temporary lining; (b) A small tube was placed over the drill rod, preventing it from cutting into the clay.

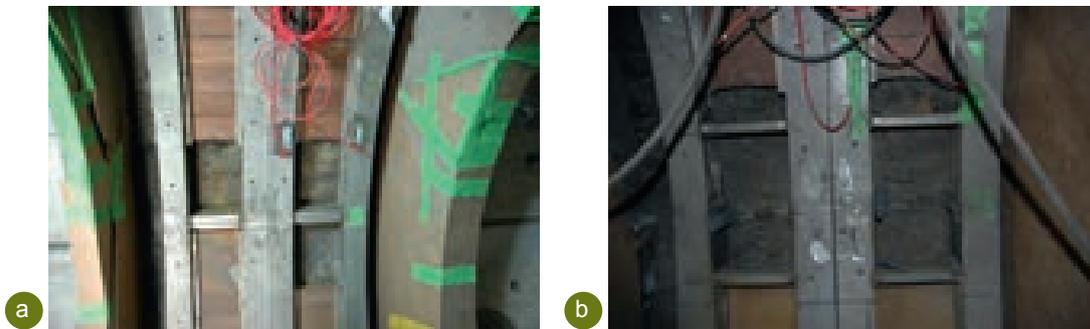
Figure 5-14: (a) The steel lateral plates between the rings;  
(b) New steel plates are placed around the steel plates that were to be removed.

The 4 steel lining rings that remain in place are composed of segments. The neighbouring segments of the first and the second and of the third and fourth ring are connected by two lateral plates placed between them. These plates are fixed by “pin-hole connection” (Figure 2-2b). This connection prevents the segments of the lining ring moving outwards during the swelling of the bentonite and a rather heterogeneous pressure distribution exerted by the bentonite on the clay is obtained (cf. section 2.2). Allowing the rings to move outwards would result in a more homogeneous pressure distribution. Therefore the steel plates are removed at two locations in the ring (Figure 5-14a). When the plates are removed, the maximum free length increases and this might lead to buckling of the ring. Therefore a further two steel plates are welded between the ring to replace the plates to be removed (Figure 5-14b). These steel plates are independent of each other and thus do not prevent the outward movement of the segments.

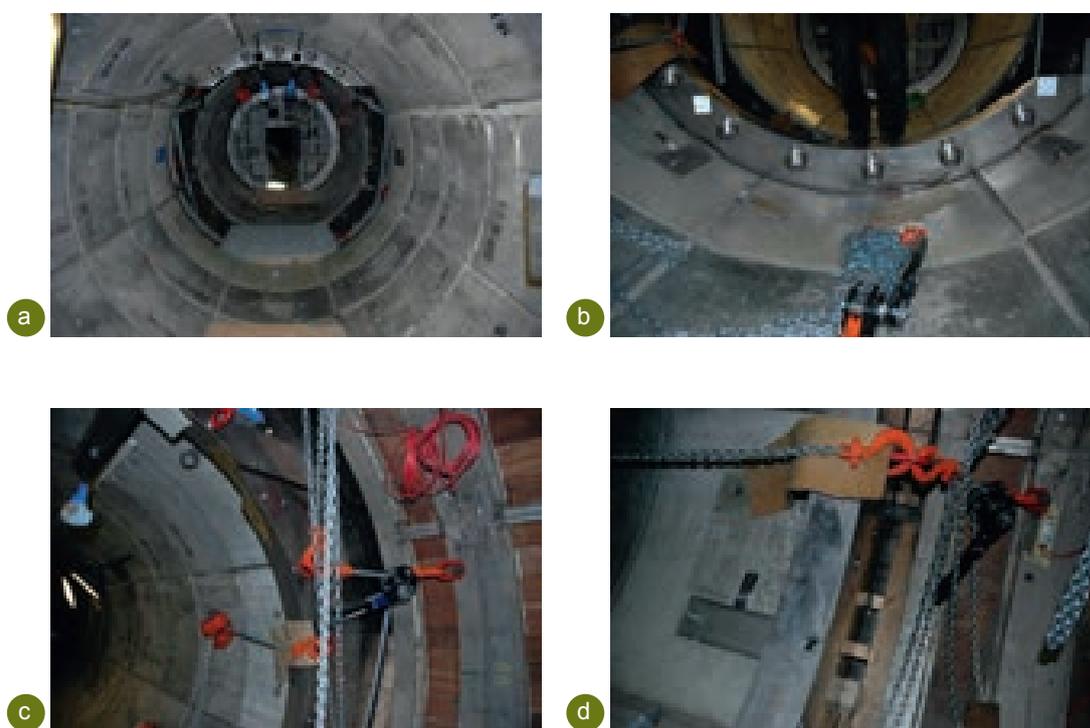
Figure 5-16: (a) The top segment is brought into place and held a little higher than its final position; (b) the bottom segment is already in its correct position and fixed to the gallery floor; (c) the middle segments are positioned; (d) the flanges are bolted together without using resin.

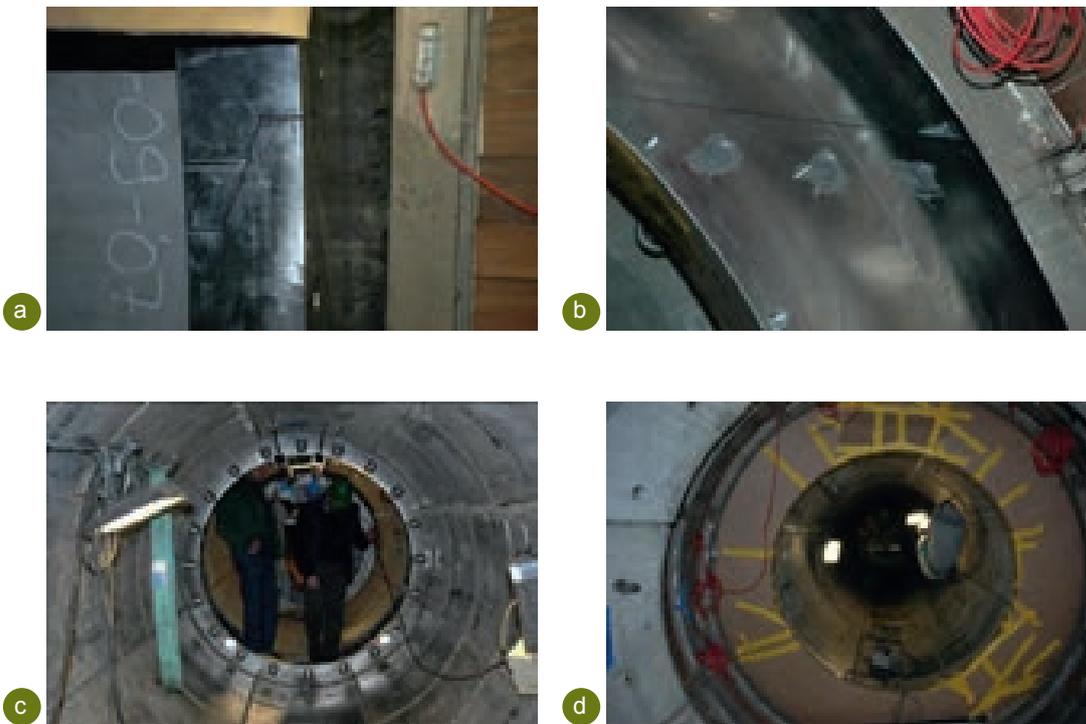
Figure 5-17: (a) The connection between the flange segments is made watertight by applying a resin on their interface; (b) the holes for the bolts assembling the segments are filled with another resin; (c) downstream side of the flange; (d) upstream side of the flange covered in protective wooden sheets.

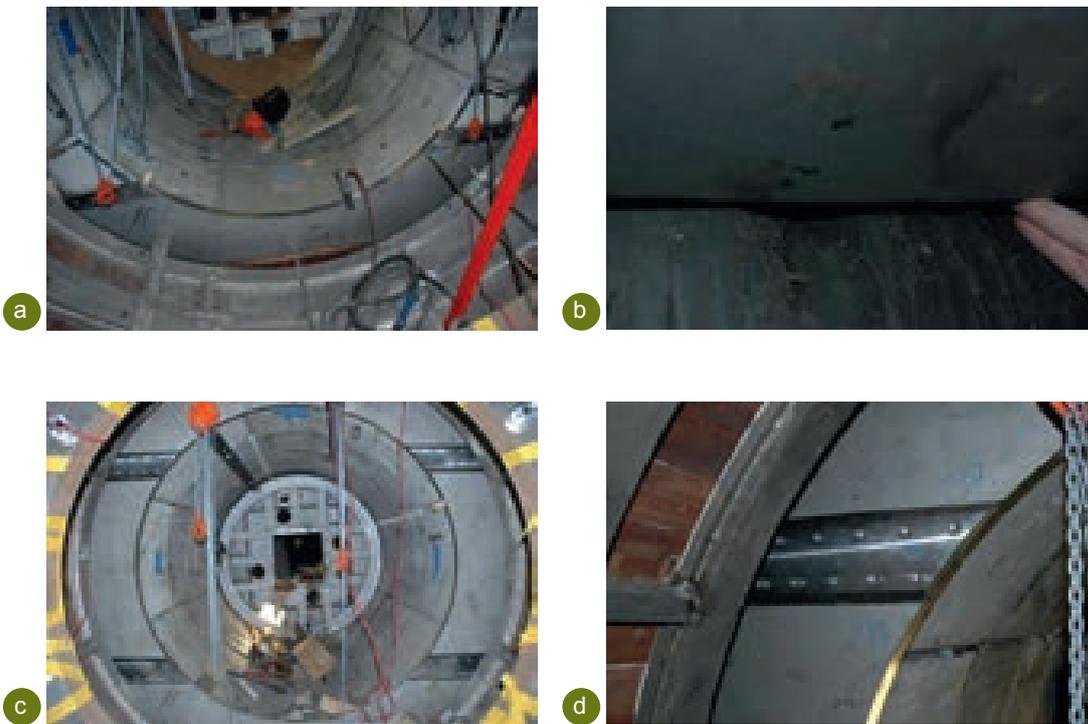
Figure 5-18: (a) The bottom segment is placed in its correct position and fixed to the gallery floor; (b) some clay had to be removed from the gallery sidewall; (c) the top and middle segments are put in place; (d) assembly plates are bolted over the interface between the segments.

Therefore the bottom segment is directly placed in its correct position with the assistance of the surveyor and fixed to the gallery floor (Figure 5-18a). Here, too, some clay at the gallery sidewall had to be scraped off. Efforts were made to keep the amount removed to a minimum, but locally too much clay was removed (Figure 5-18b). This was later filled with a clay slurry (cf. section 5.2.4). The right middle segment, the top segment and the left middle segment were then placed and bolted together using “assembly plates” (Figure 5-18c and Figure 5-18d). After the erection of the upstream flange, its position was again checked by the surveyor.

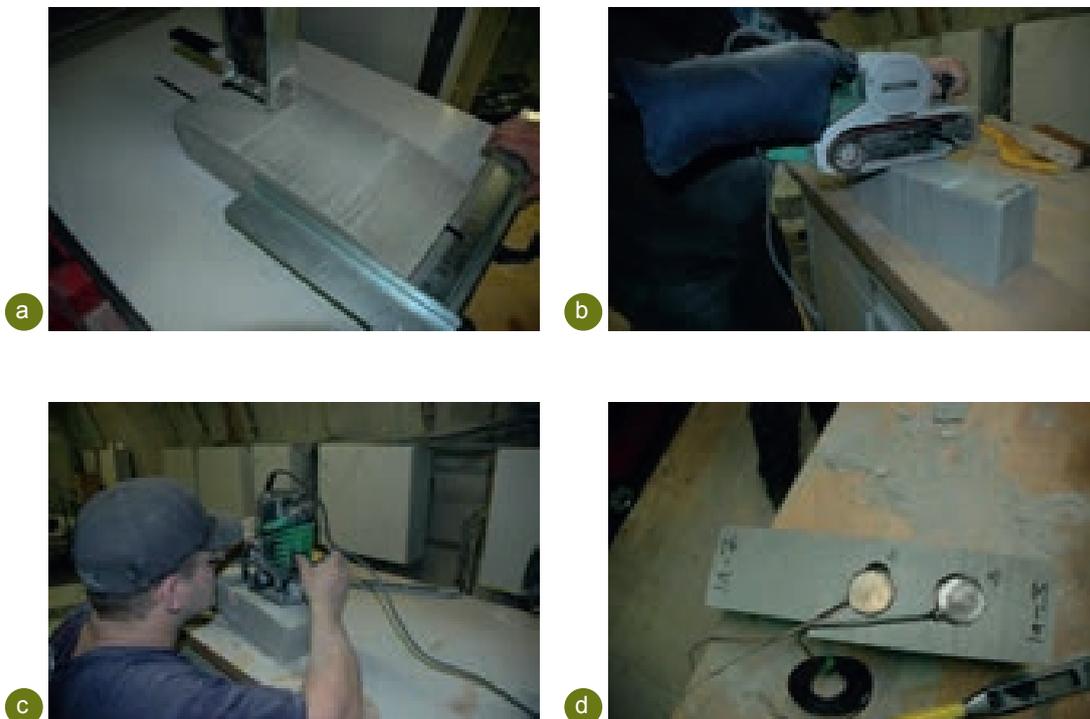
Figure 5-21: The bentonite blocks were shaped in-situ to enable their placement in the annular bentonite ring and to enable the installation of sensors in the blocks.

Two types of bentonite blocks were manufactured: outer layer blocks and inner layer blocks (cf. section 5.1.2). Before their installation most blocks needed some “shaping” to enable their placement in their designated position in the annular bentonite ring (Figure 5-21). Rings 1a, 1d and 2g are smaller than the width of the bentonite blocks of the inner and outer layer and the blocks were sawn to the correct width. Other blocks needed to be shaped because of the steel plates between the steel rings, because of the assembly plates used for the assembly of the upstream flange and because of the sensors and cables in the blocks.

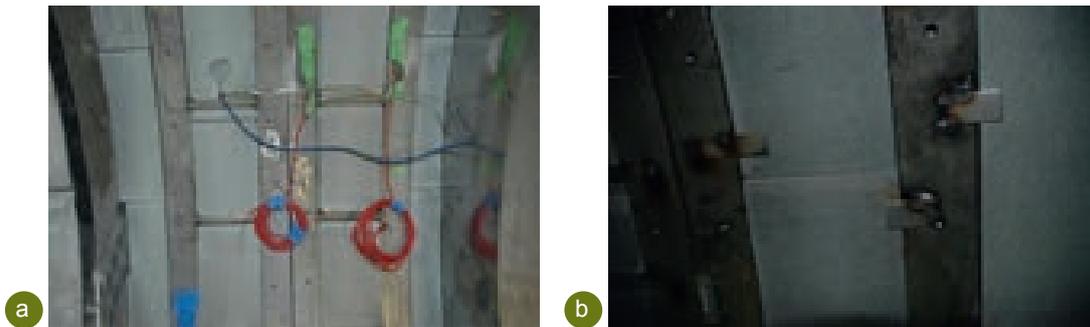
Figure 5-22: (a) The outer bentonite rings are not completely self-supporting, as the rings are interrupted by steel plates; (b) The outer ring blocks in the upper part are kept in place by INOX plates welded to the lining rings.

The outer rings are not self-supporting, as the rings are interrupted by plates between the lining rings (Figure 5-22a). The outer ring blocks placed in the upper part are supported by small INOX plates welded to the lining rings (Figure 5-22b).

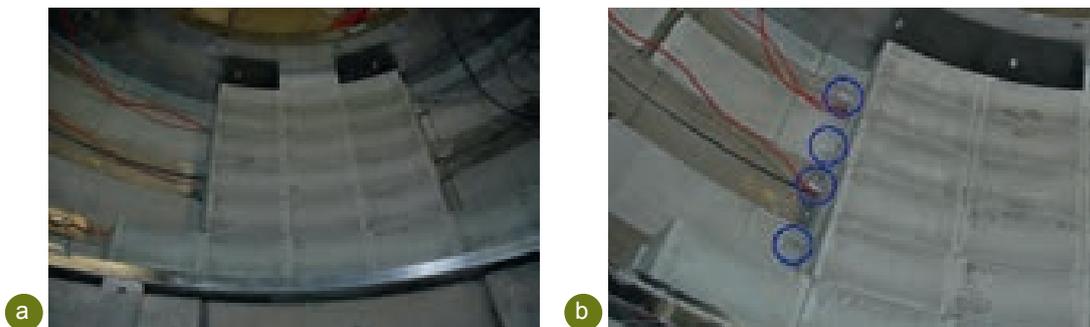
Figure 5-23: (a) Bottom part of the inner bentonite rings; (b) To achieve the technological void between the outer and inner ring, small INOX plates (indicated by blue circles) are placed under the outer blocks.

The inner rings are completely composed of bentonite blocks forming a self-supporting structure (Figure 5-23a). Between the inner and outer ring a void of 10 mm is expected. To achieve this in the lower part, some INOX plates were placed between the inner and outer ring (Figure 5-23b). First the lower blocks of all inner rings were placed.

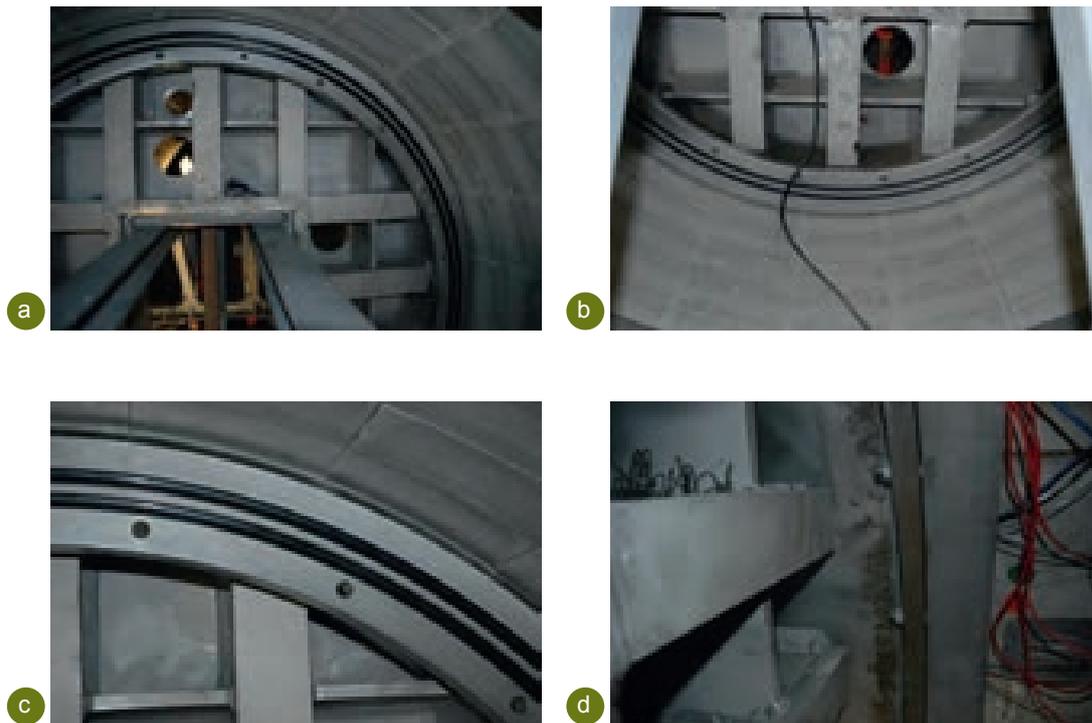
Figure 5-29: (a) The cylinder was introduced into the opening of the flange and the bentonite ring using the hoisting table; (b) The small margin between the upstream flange and the cylinder demanded a very accurate movement of the cylinder; (c) Gaskets were placed in their designated groove; (d) The cylinder was bolted to the downstream flange.

The cylinder was moved through the upstream flange and the ring of bentonite up to its position against the downstream flange using the hoisting table (Figure 5-29a). The margin between the inner diameter of the upstream flange and the extrados of the cylinder was 4 mm on diameter. This required a very precise movement of the cylinder (Figure 5-29d). Two gaskets were placed in their designated groove in the cylinder (Figure 5-29c). They were first lubricated with grease to ensure that each was more or less evenly distributed over the radial length of the groove, thus minimising the tensional friction stresses in the gaskets. The complete movement of the cylinder through the upstream flange took approximately 1 hour. Once the cylinder was placed against the flange, both parts were bolted with a fixed torque (350 kNm), compressing the gaskets and sealing the interface between the cylinder and the downstream flange (Figure 5-29d).

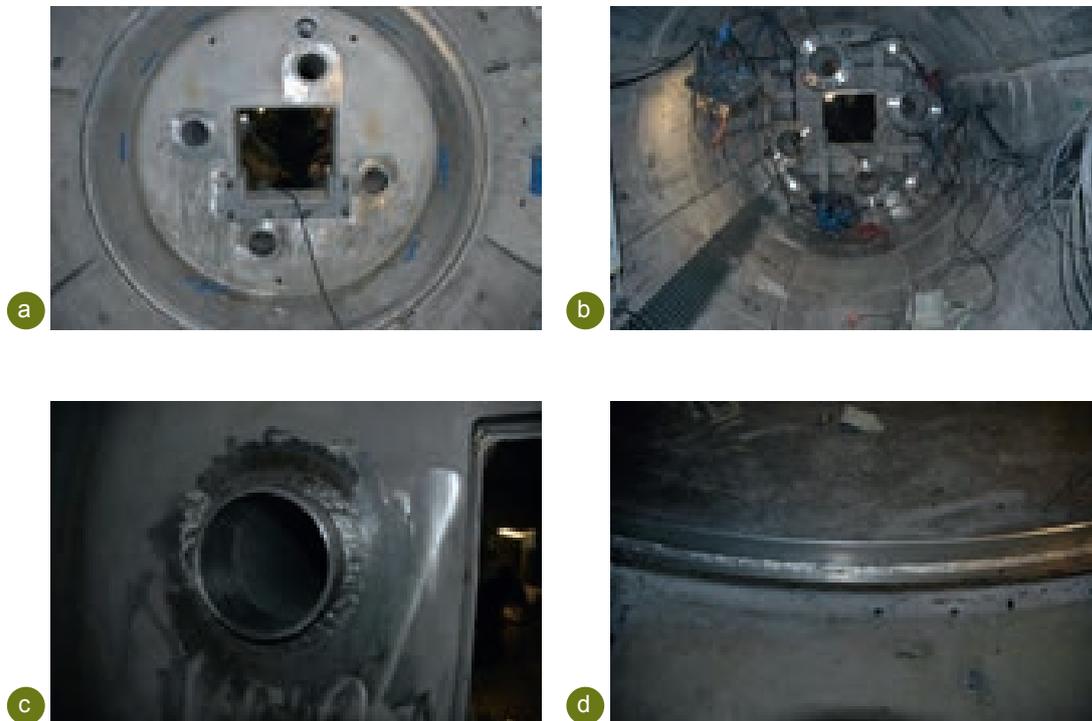
Figure 5-30: (a) Upstream view of the hydraulic seal ; (b) Downstream view of the hydraulic seal; (c) The pipes were welded to the cylinder; (d) The cylinder was welded to the upstream flange and mortar was placed in the gap between the flange and the lining.

The cylinder was then welded to the upstream flange and the 4 pipes were inserted into the openings in the plate of the cylinder and welded to this plate (Figure 5-30a, Figure 5-30b and Figure 5-30c). Finally the opening between the upstream flange and the gallery lining, approximately 17 mm, was filled with mortar (Figure 5-30d).

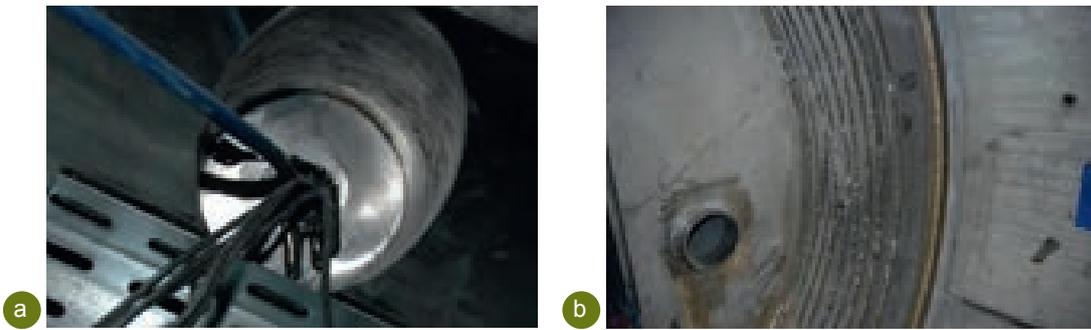
Figure 5-31: (a) Resin (black product) sealing the feed-through openings in the downstream flange; (b) Heating cables placed against the cylinder (cables are placed both on the downstream and on the upstream side).

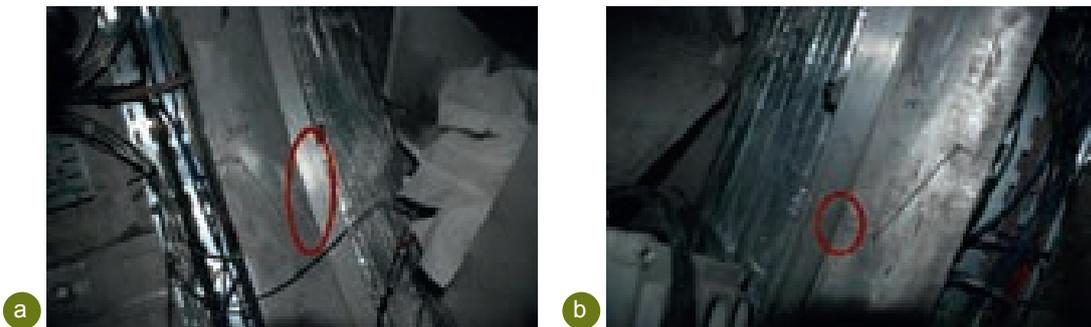
Figure 5-32: Location of the leaks in the hydraulic seal during the artificial hydration: (a) at the junction between the bottom downstream segment, the left middle downstream segment and the cylinder; (b) at the junction between the bottom downstream segment, the right middle downstream segment and the cylinder.

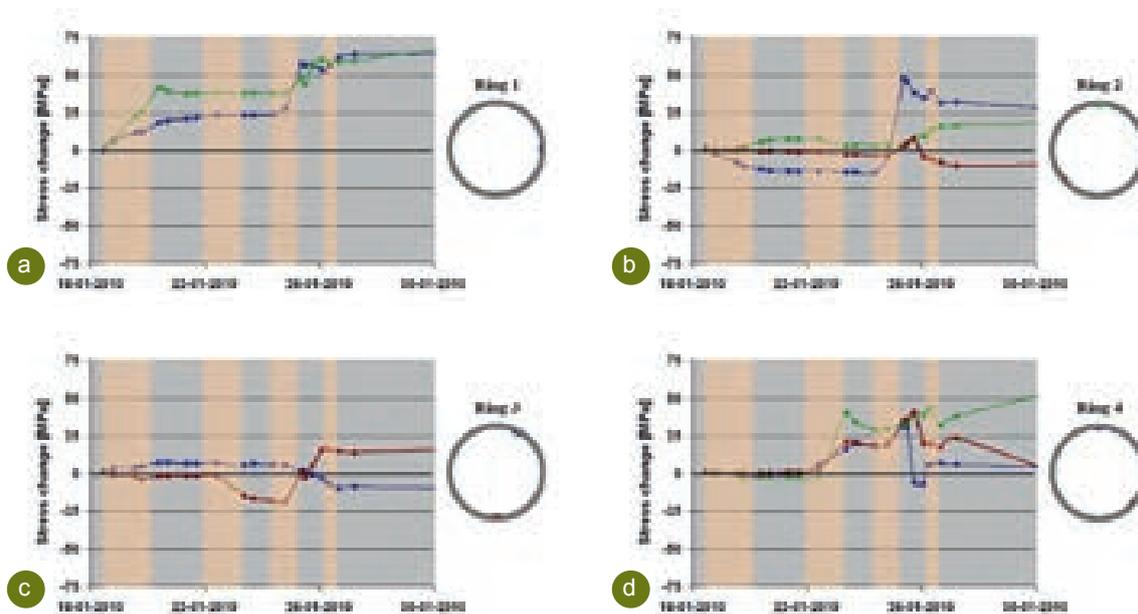
Figure 6-2: Measured stresses (a positive change is a reduction in compressive stress, a negative change is an increase in compressive stress) in the lining rings: (a) ring 1; (b) ring 2; (c) ring 3; (d) ring 4.

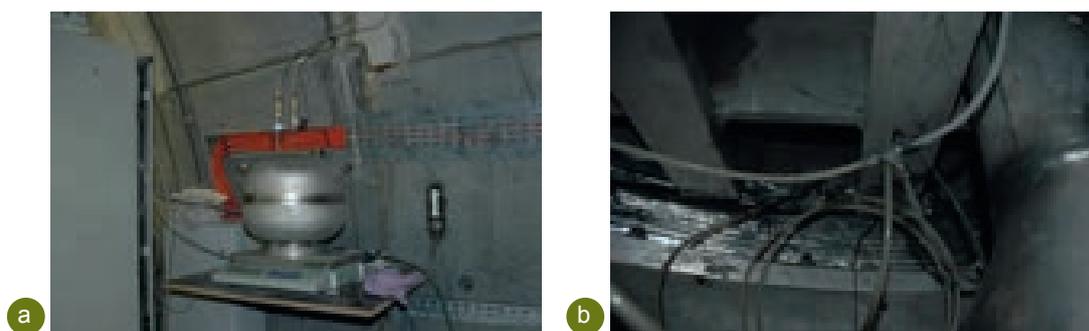
Figure 6-4: (a) Pressure vessel filled with synthetic water and placed on weighing scales to monitor the injected amount of water; (b) Connection between the filters on the seal extrados and the injection hoses.

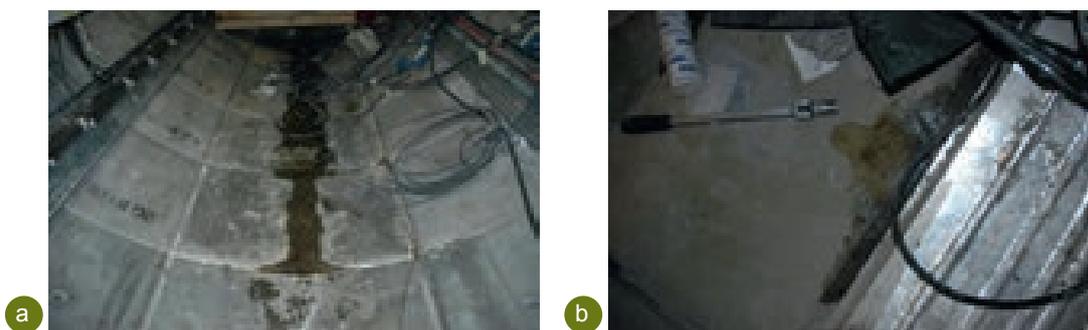
Figure 6-5: Water leakage in the gallery on the 2nd day of the artificial hydration:  
(a) downstream; (b) upstream.

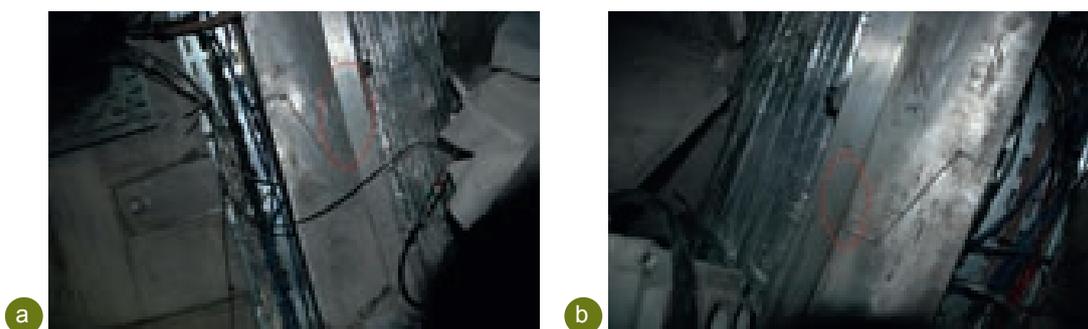
Figure 6-6: The location of the leakage of water from the seal on 12.04.2010 at  
(a) the interface between the cylinder and the bottom and left segments of the downstream flange and  
(b) the interface between the cylinder and the bottom and right segments of the downstream flange.
