# **The design and installation of the PRACLAY In-Situ Experiment**

EURIDICE Report, ref. 13-129

1 September 2013

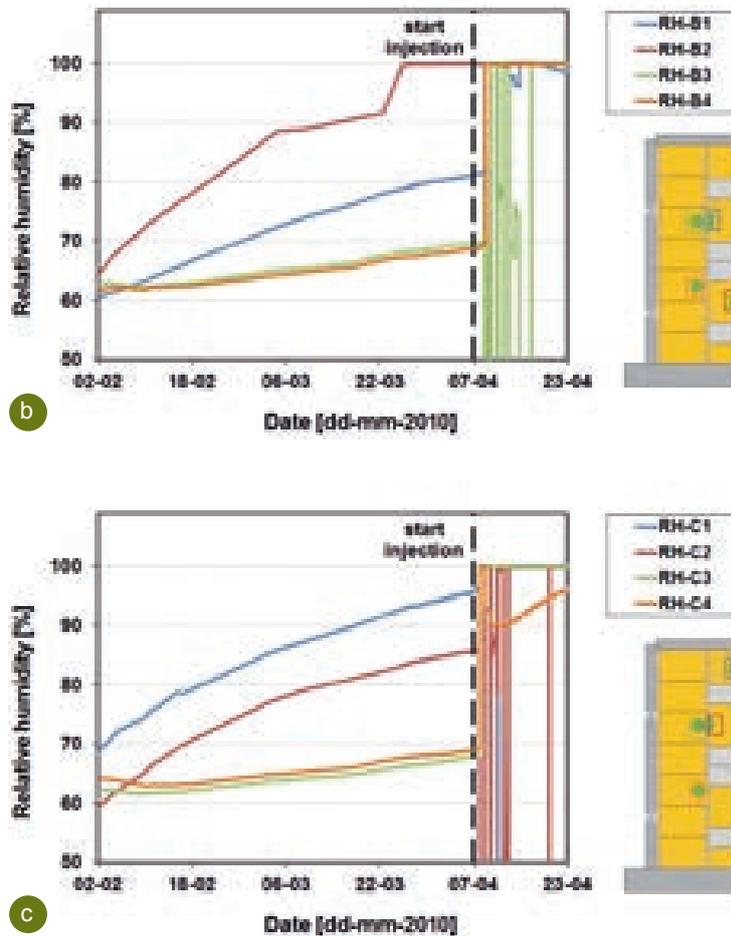
Figure 6-8: Measured relative humidity: (a) section A-A (top section); (b) section B-B (middle section); (c) section C-C (bottom section).

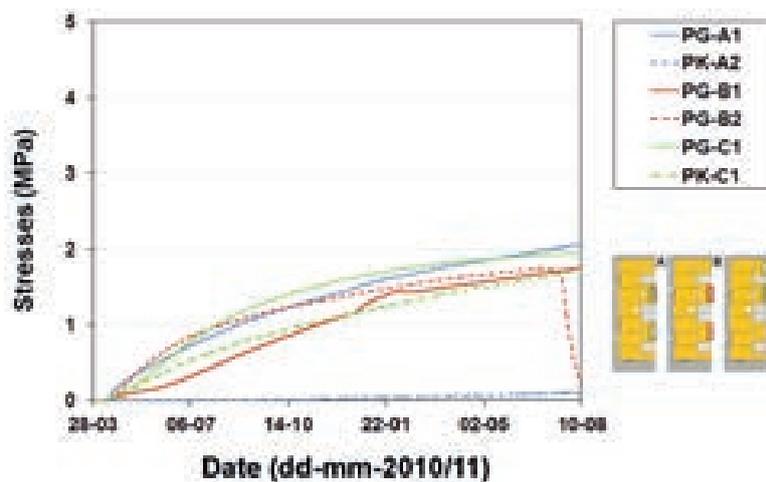
Figure 6-9: Radial stresses measured at the interface between the bentonite and the Boom Clay sidewall.

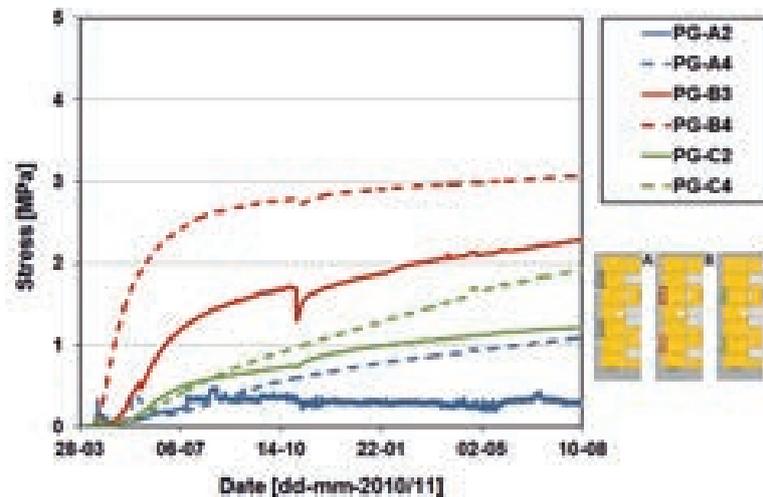
Figure 6-13: Radial stresses measured at the interface between the bentonite and the steel cylinder.

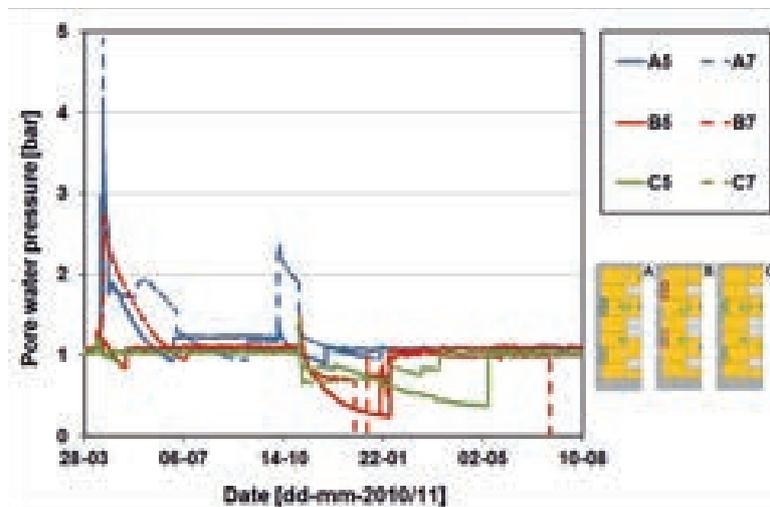
Figure 6-17: Measured pore water pressures at the interface between the bentonite and the steel cylinder.

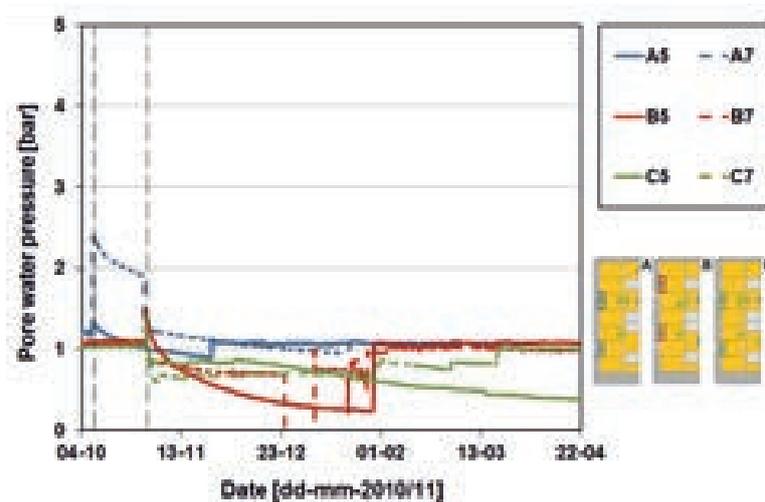
Figure 6-20: Measured pore water pressures at the interface between the bentonite and the steel cylinder after the manipulation of filters in this interface (the dashed line indicates the start of manipulation of filters A5-A7 and B5-B7-C5-C7 respectively).

Figure 6-18, Figure 6-19 and Figure 6-20 show the evolution in the pore water pressures on the filters that were artificially subjected to overpressure.

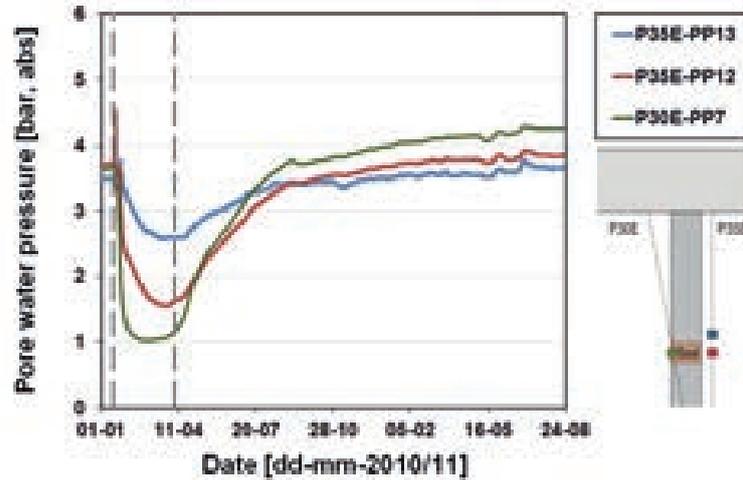
Figure 6-21: Measured pore water pressures in the Boom Clay close to the hydraulic seal (the dashed grey lines indicate the start of the seal installation and the start of the artificial hydration respectively).

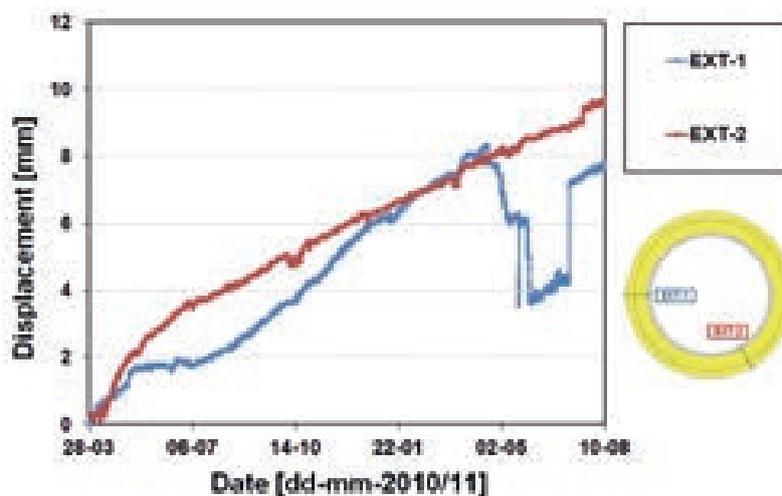
Figure 6-22: Measured radial displacement (an outward displacement is positive) of the bentonite ring.

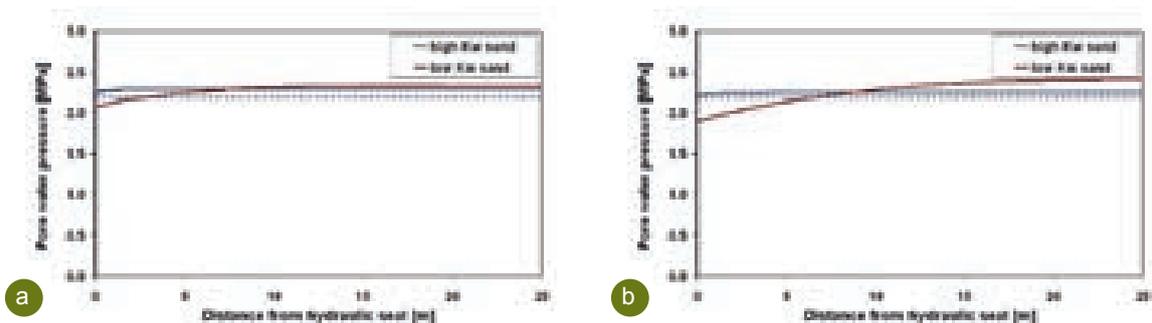
Figure 2-3: Water pressure in the backfill material along the heated section of the gallery for a backfill material with high conductivity (10<sup>-6</sup> m/s) and low conductivity (10<sup>-10</sup> m/s): (a) after 1 year of heating; (b) after 10 years of heating.

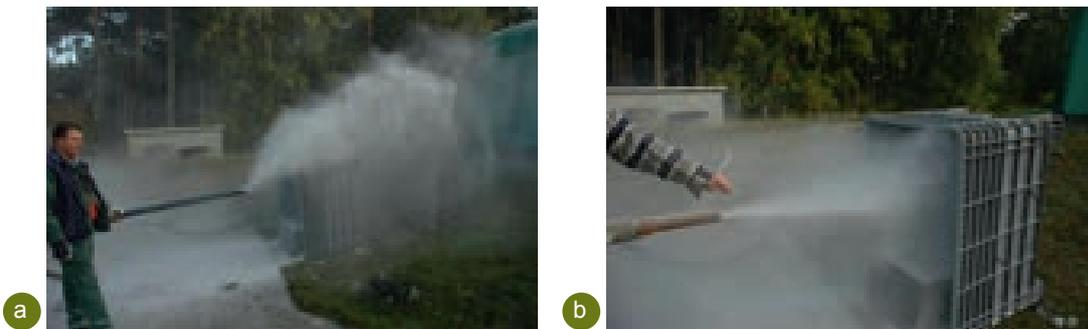
Figure 4-3: (a) Sand blown out of the injection tube;  
(b) Testing the abrasiveness of the blown sand.

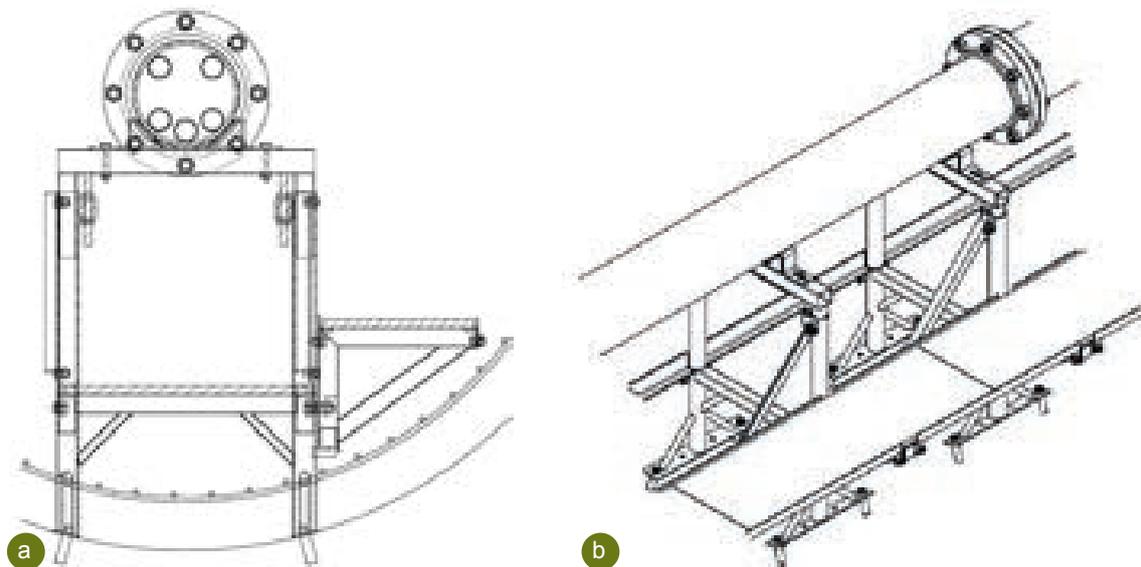
Figure 4-5: Central tube and support structure.

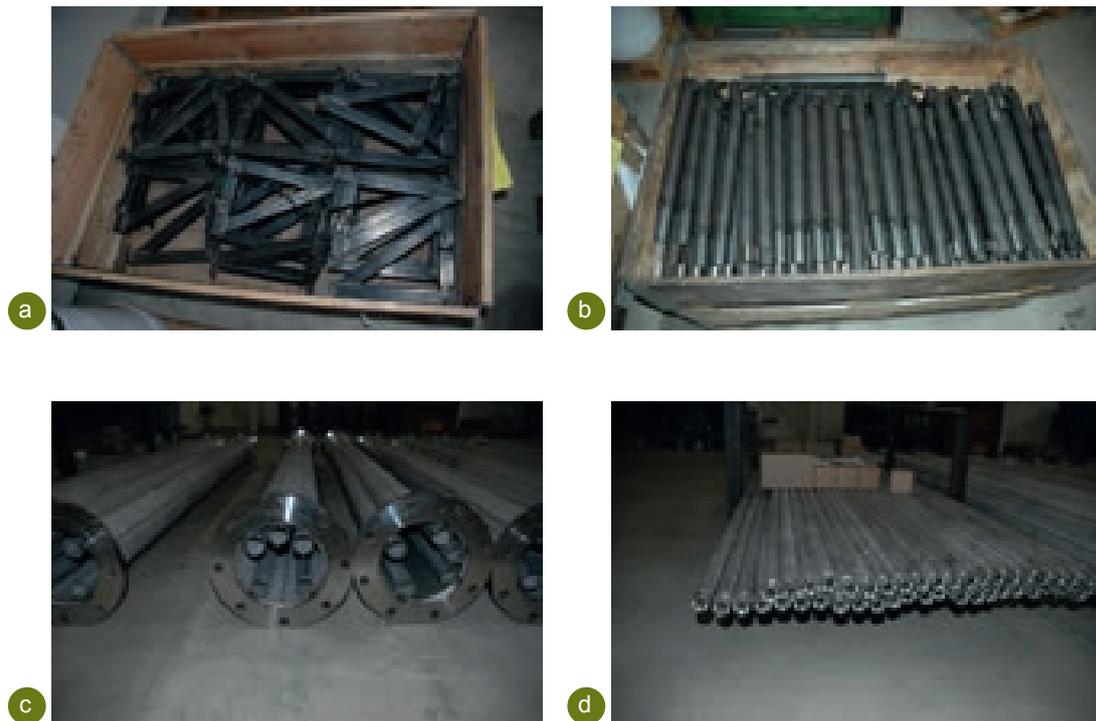
Figure 4-6: (a) and (b) Components of the support structure for the central tube;  
(c) 3 m long section of the central tube in which 5 smaller tubes are placed;  
(d) stainless steel casing for the secondary heater cables.

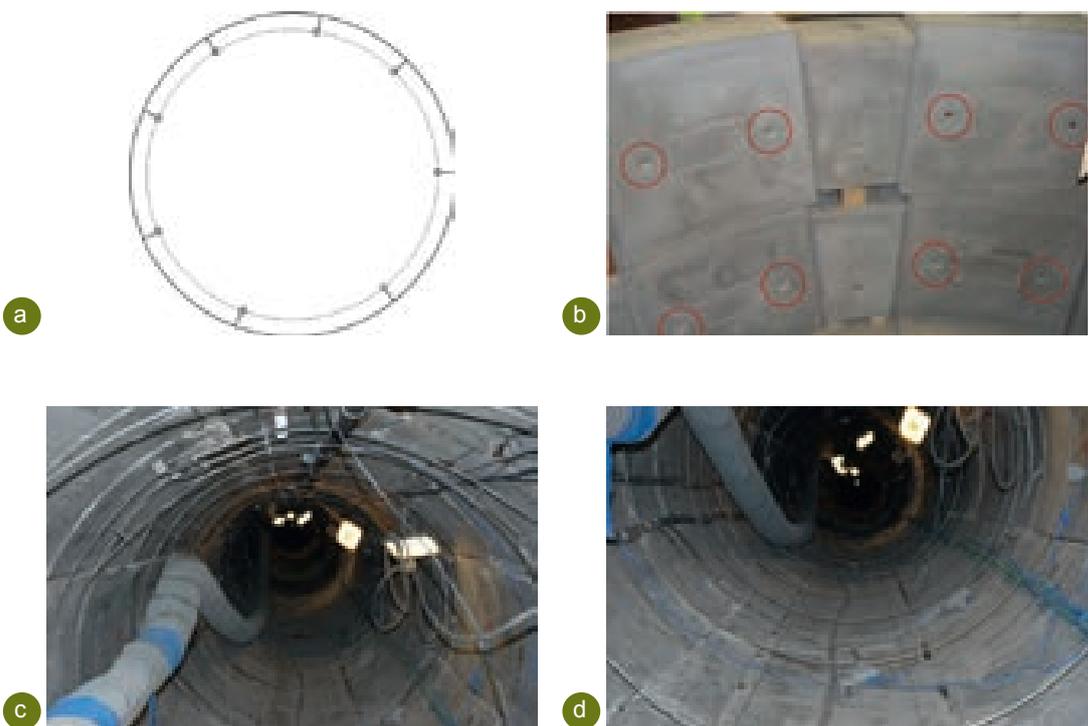
Figure 5-3: Installation of the circular rods to support the primary heater cables: (a) the rods are placed at a distance of 100 mm from the gallery intrados through rings attached to the lining; (b) the rings are attached to the gallery in the M20 openings in the lining segments (marked in red); (c) and (d) view into the PRACLAY gallery after installation of the support rods.

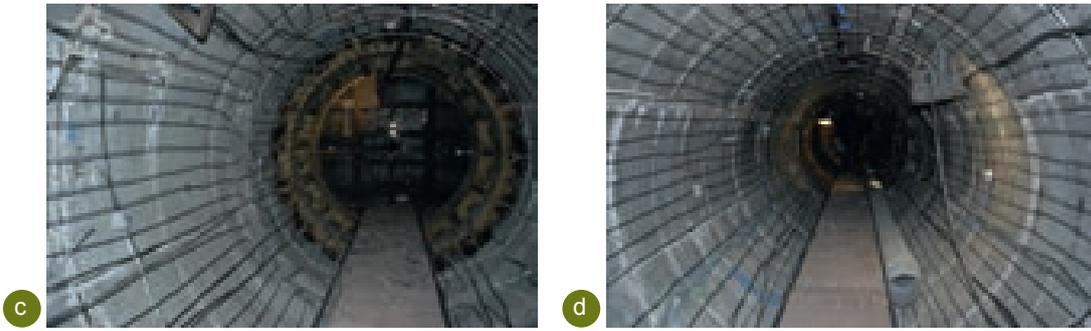
Figure 5-5: Installation of the heater cables in the middle and top sections.

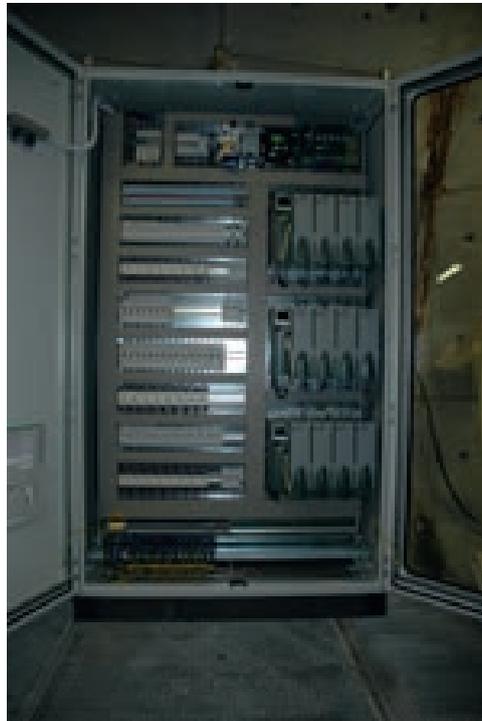
Figure 5-6: Control system of the PRACLAY heating system.

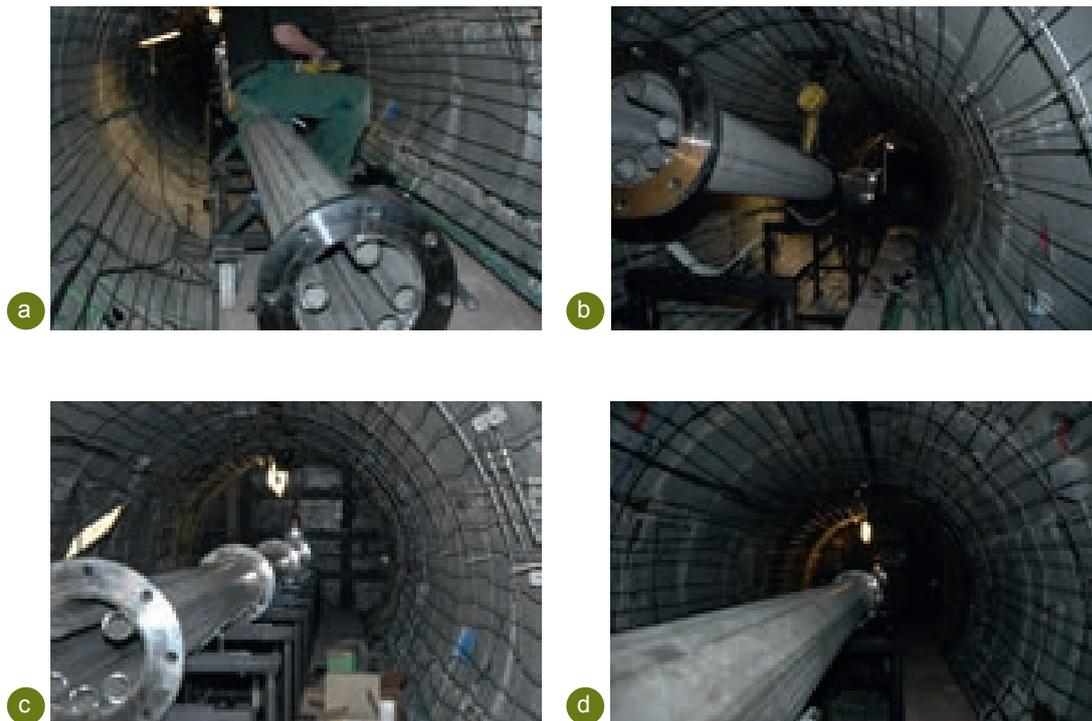
Figure 5-7: Assembly of the central tube sections (a) the tube section is transported through the gallery on a wagon to its assembly position; (b) the tube section is hoisted and a support structure is built below the hoisted tube section; (c) the tube section is lowered onto the support structure and its upstream end is bolted to the previously installed tube section; (d) the downstream end of the tube section is positioned using a laser.

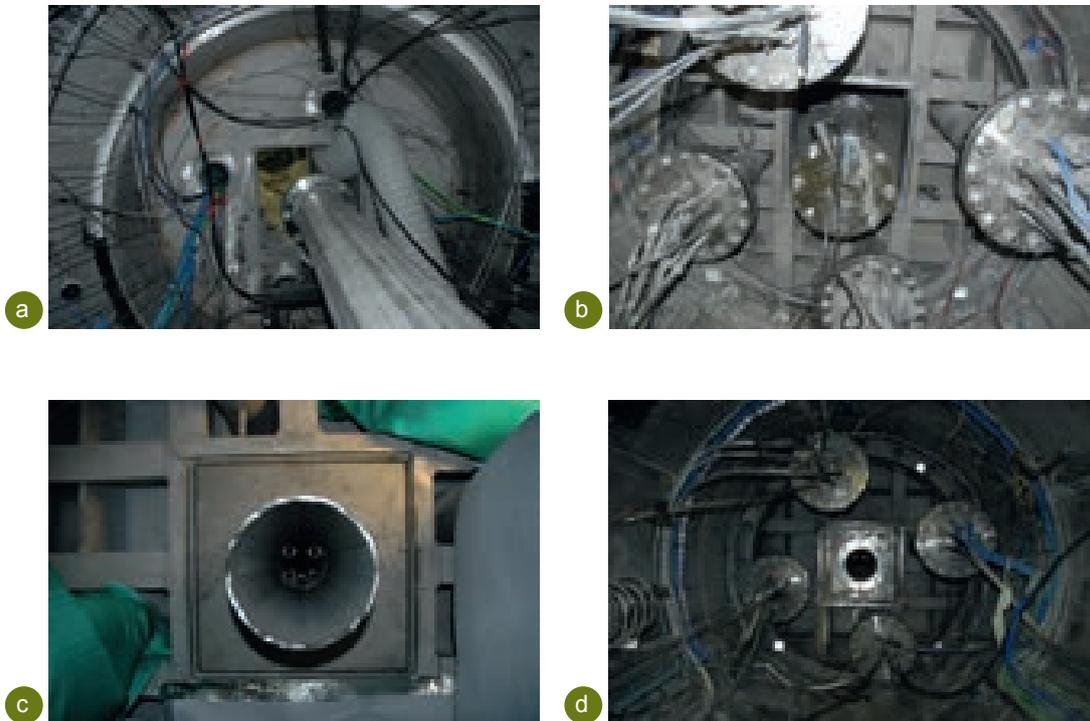
Figure 5-8: (a) Before backfilling, the central tube could only come to just before the hydraulic seal; (b) once backfilling was complete, the last tube section was assembled; (c) the flange on the last section of the central tube was cut to allow the assembly of the central plate onto the hydraulic seal; (d) after assembly of the central plate, this flange was again welded onto the end of the central tube.

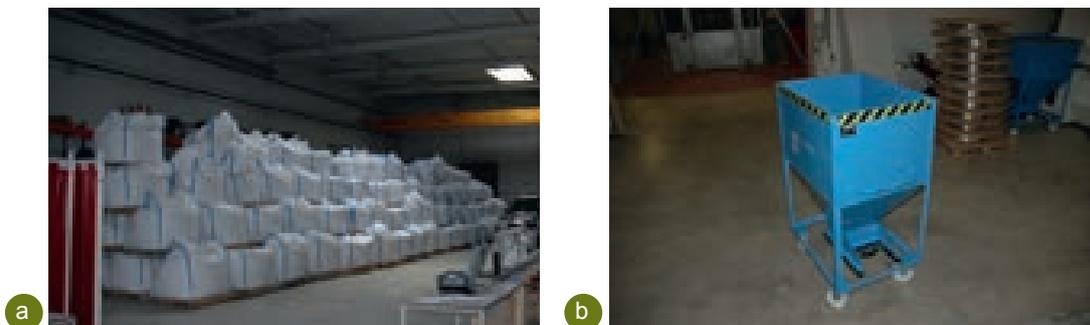
Figure 5-9: (a) Storage of 170 tonnes of Mol M34 sand; (b) the sand was loaded into containers and transported to the underground laboratory; (c) and (d) the sand was blown into the gallery using a shotcreting machine, which blew the sand through a tube placed at the top of the gallery; (e) and (f) sand front in the gallery.

Finally the heated part of the PRACLAY gallery was filled with Mol M34 sand (Figure 5-9). The sand was delivered by SIBELCO in big bags of 0.9 t (0.6 m<sup>3</sup>). Three containers were used to transport the sand

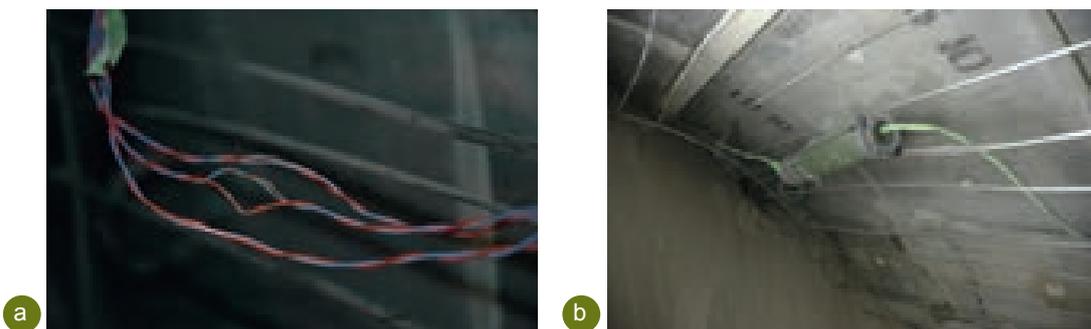
Figure 5-10: (a) Cable of thermocouple damaged by the sand backfilling; (b) damaged cable repaired by placing a tube over the damaged cable section.

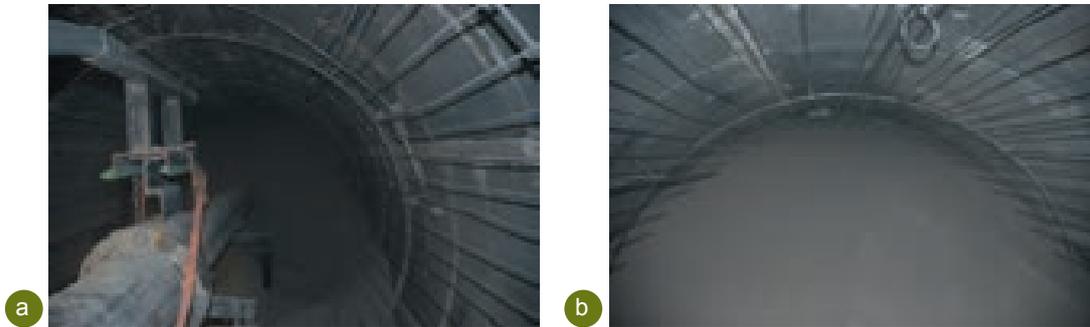
Figure 5-11: (a) The injection tube was placed on top of the central tube to avoid damaging the cables along the gallery lining; (b) the gallery backfilling was still going well in the adjusted configuration.

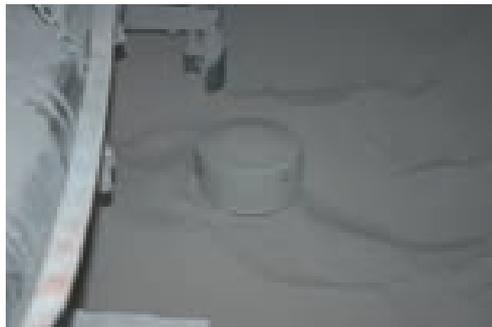
Figure 5-12: Box capturing the backfill sand to determine its density.

During backfilling a box was placed in the gallery to determine the density of the backfill sand (Figure 5-12). The measured density was  $1.6 \text{ t/m}^3$ . The hydraulic conductivity of the sand for this dry density was again calculated and was  $5.2 \cdot 10^{-4} \text{ m/s}$ , which is sufficiently high (cf. section 2.2).

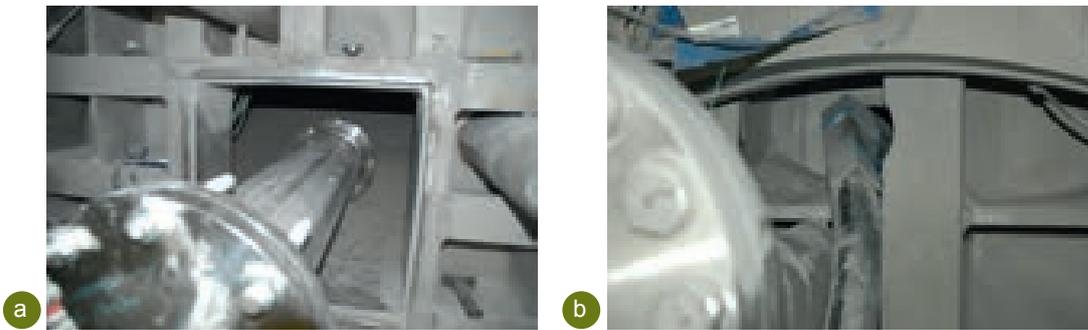
Figure 5-13: The top section just behind the hydraulic seal could only be backfilled after closing the hydraulic seal: (a) before closure of the hydraulic seal; (b) backfilling of the top section after closure of the hydraulic seal.

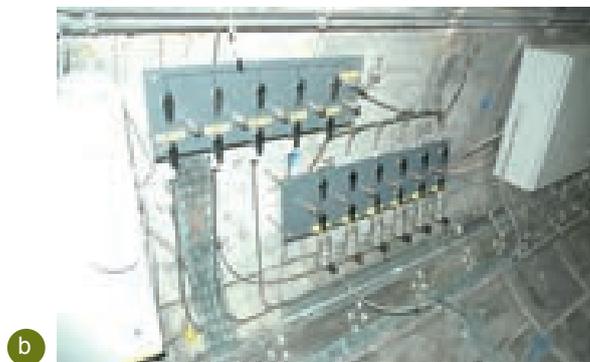
Figure 5-14: (a) Saturation system consisting of 6 saturation filters S1 to S6 and 5 vent filters V1 to V5; (b) injected volume indicator.

(Figure 5-14a). The water injection was performed 24h/day and ca. 2.5 m<sup>3</sup> water was injected per day. Flow indicators were used to ensure that an equal water volume was injected through each filter (Figure 5-14b). After 12 days, on 9.12.2011, 29 m<sup>3</sup> water had been injected and the injection was stopped for the weekend, as it was considered possible that the backfill sand would become completely saturated during the weekend and the purpose of the water injection was to completely saturate the backfill sand without pressurizing the backfilled gallery. The injection was restarted on Monday 12.12.2011. On 15.12.2011 water came out of the venting filters indicating that the backfill sand was completely saturated. 38 m<sup>3</sup> water had been injected. The water injection was then stopped.
