The extension of the HADES underground research facility at Mol, Belgium

The construction of the connecting gallery

**W. Bastiaens, F. Bernier, M. Buyens, M. Demarche,
X.L. Li, J.-M. Linotte, J. Verstricht**

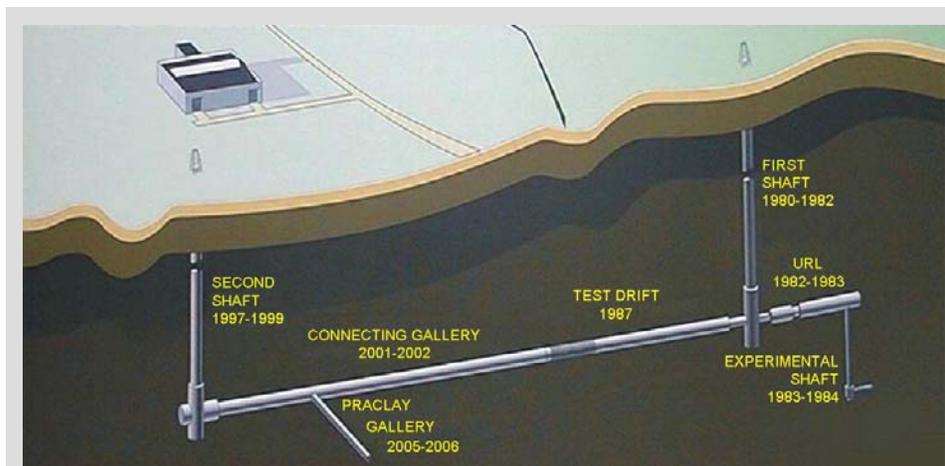
Figure 1: Construction history of the underground research facility HADES. The 80-metre-long connecting gallery connects the recently built second shaft to the already existing facility. The construction of the PRACLAY gallery is foreseen for 2005–2006.

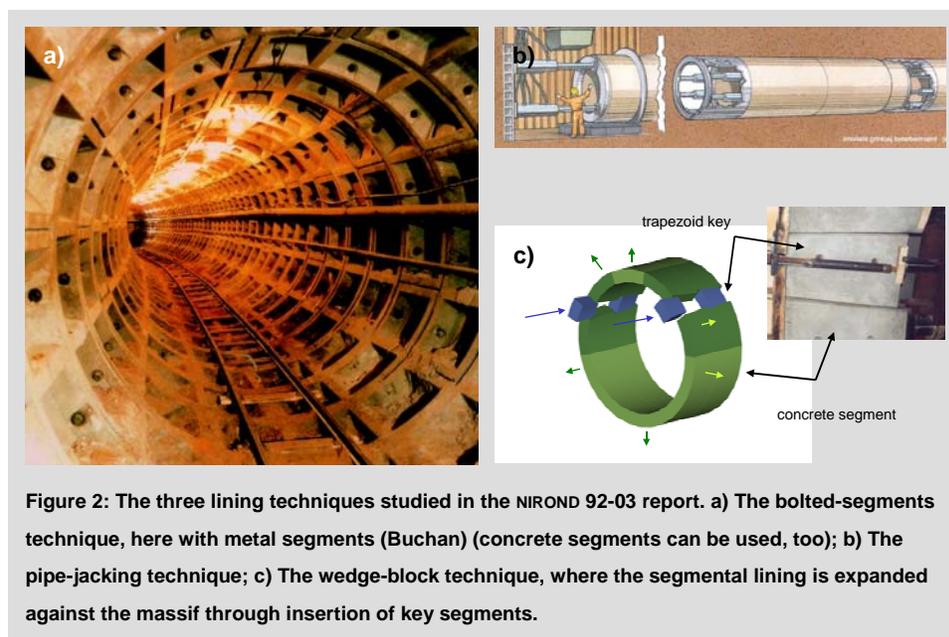
Figure 2: The three lining techniques studied in the NIROND 92-03 report. a) The bolted-segments technique, here with metal segments (Buchan) (concrete segments can be used, too); b) The pipe-jacking technique; c) The wedge-block technique, where the segmental lining is expanded against the massif through insertion of key segments.

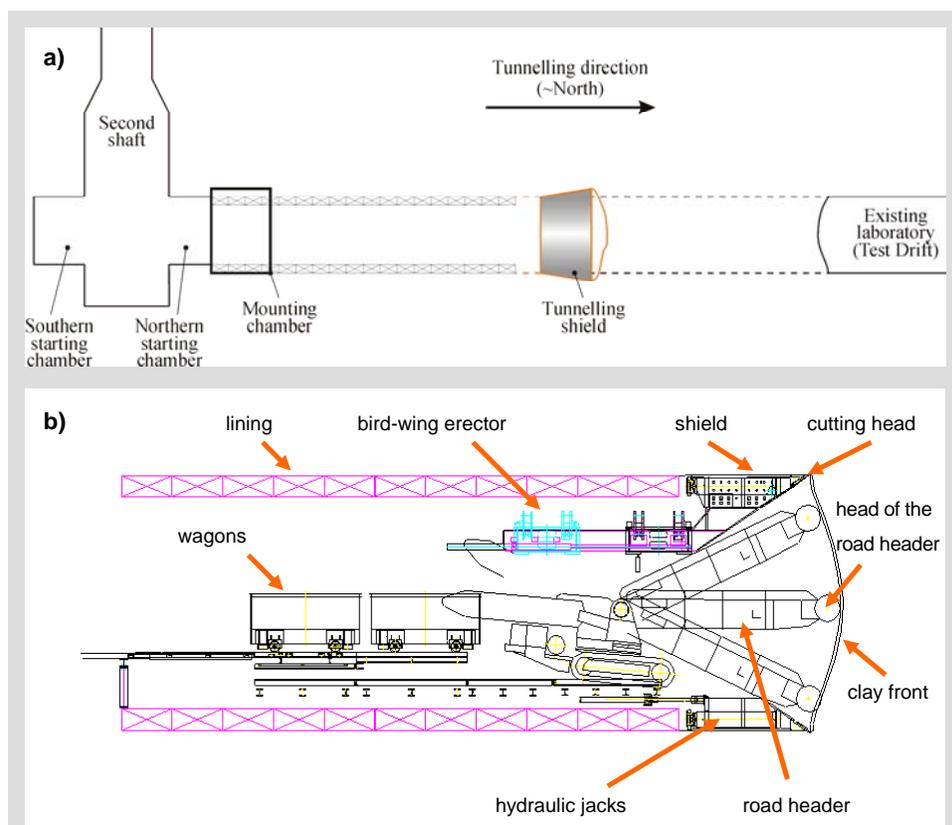
Figure 4: Construction of the connecting gallery. a) Cross-section showing the underground infrastructure; b) Cross-section showing the tunnelling machine in the connecting gallery (see also Figure 22).

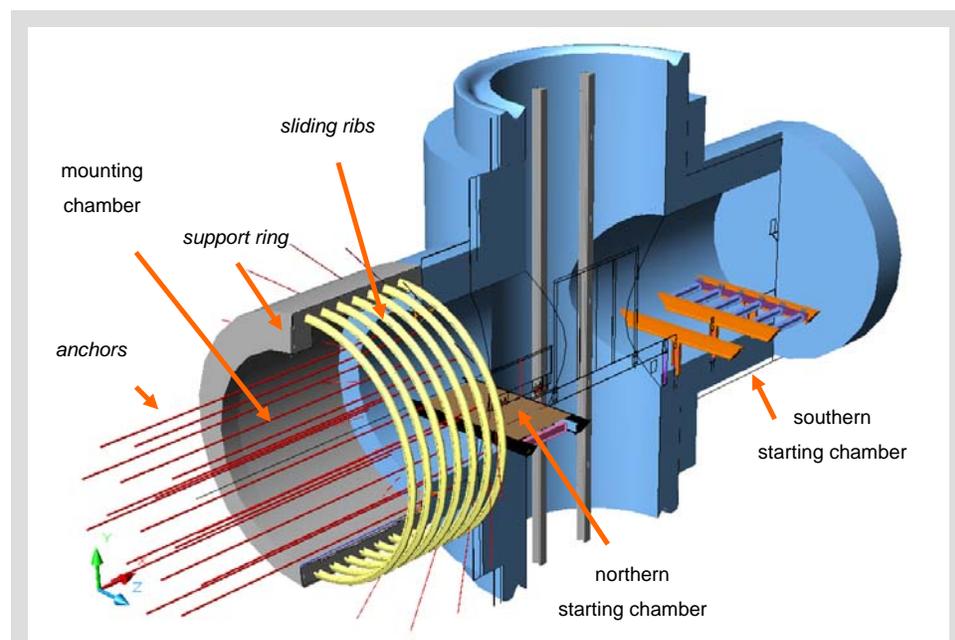
Figure 7: The mounting chamber and the two starting chambers (SCM Tunnel).

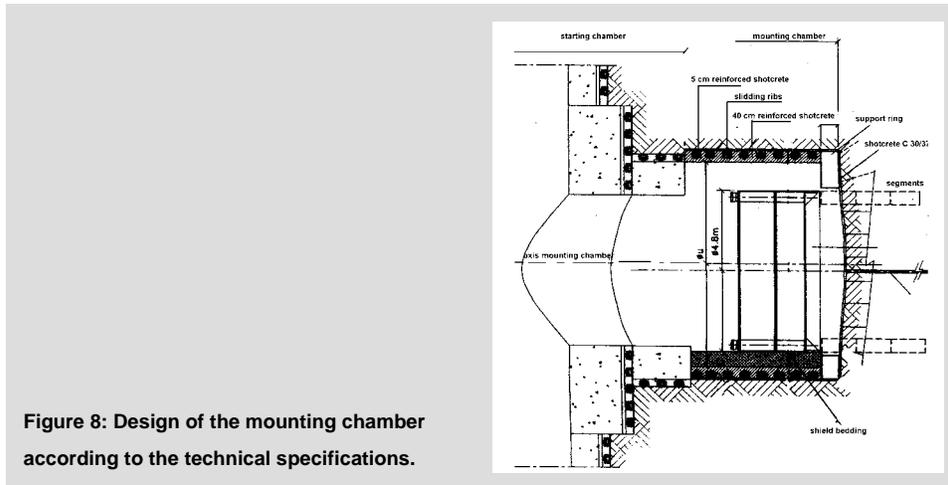
Figure 8: Design of the mounting chamber according to the technical specifications.

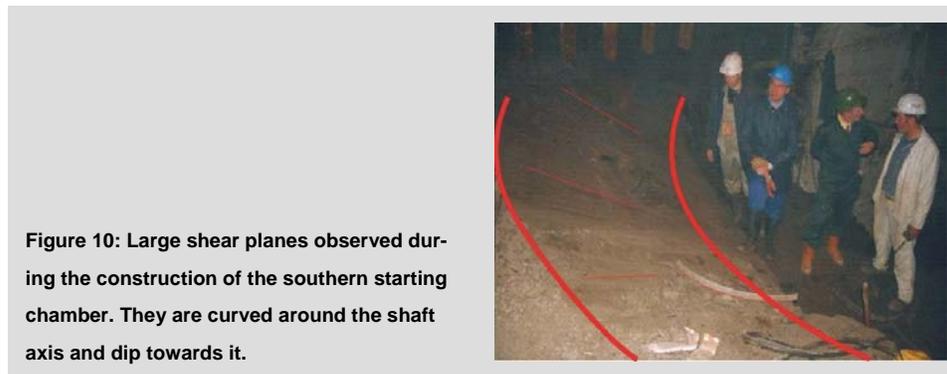
Figure 10: Large shear planes observed during the construction of the southern starting chamber. They are curved around the shaft axis and dip towards it.

The unexpected large shear planes observed during the construction of the northern and southern starting chambers at the bottom of the second shaft (Figure 10) led to carrying out an *auscultation programme* prior to starting the excavation of the mounting chamber. This programme aimed to collect as many data and as much knowledge as possible concerning the origin and the extent of the damaged zone around the shaft and, in particular, to confirm the hypothesis that the fractures were associated with the construction of the shaft. (The lack of active support during excavation of the starting chambers and the low excavation rate have certainly favoured the opening of the fractures and the detachment of clay blocks.) The shear planes that were observed consisted indeed of an interconnected network of fracture planes inclining at 35° towards the shaft axis, with circular shapes suggesting that they were symmetric around its axis and with slickensides clearly showing a movement towards it.

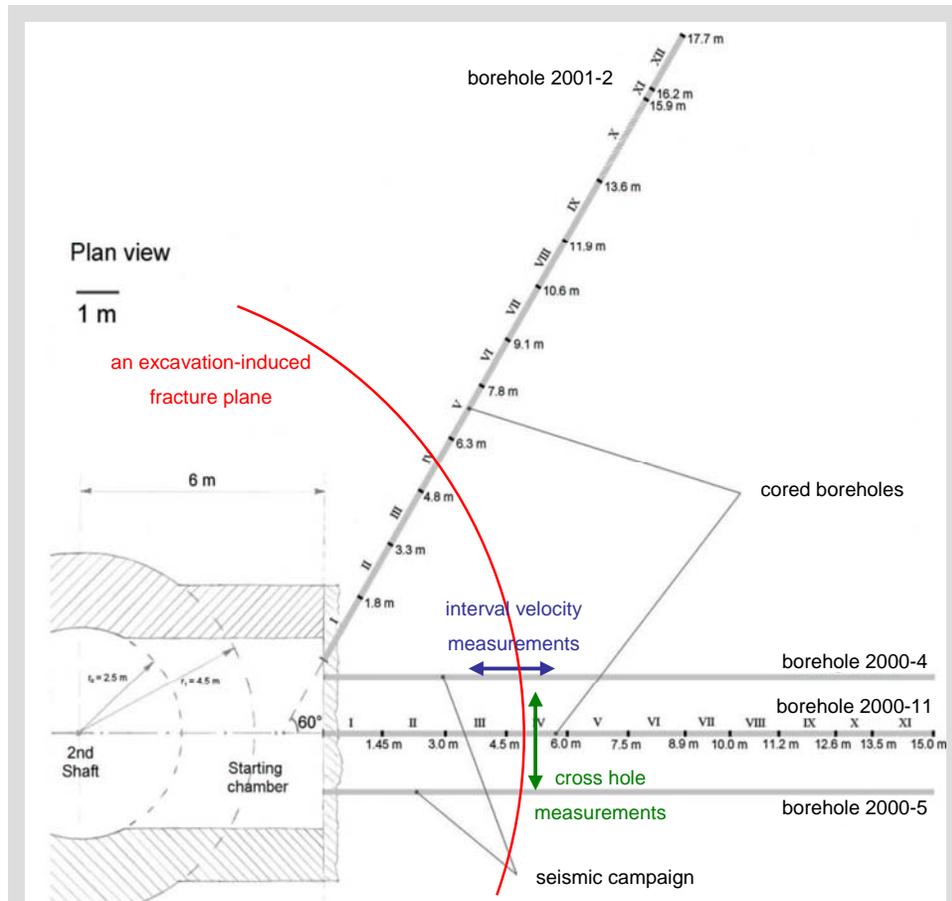
Figure 11: Plan view of the four horizontal boreholes of the auscultation programme, with schematic indication of an excavation-induced fracture plane and of the propagation direction of the seismic waves in both interval velocity measurements and cross hole measurements.

The auscultation programme consisted of seismic measurements, carried out by the German Federal Institute for Geosciences and Natural Resources (BGR), and two cored boreholes (Figure 11). It confirmed the hypothesis that the fractures did not have a natural origin (in other words, that they were not pre-existing), but had been induced by the construction of the second shaft instead. (Later, the construction works revealed that the zone between 0 and 2 metres was a zone with open fractures and that the zone in the next metres was a zone with closed fractures (Section 6.2).)

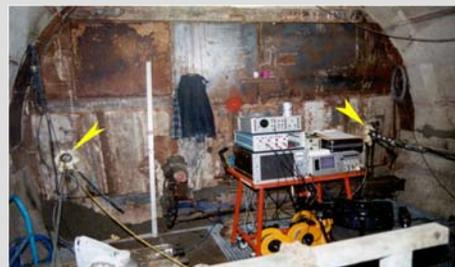
Figure 12: The two boreholes used for the seismic measurements (indicated by the yellow arrows) were located at mid-height of the starting chamber (BGR).

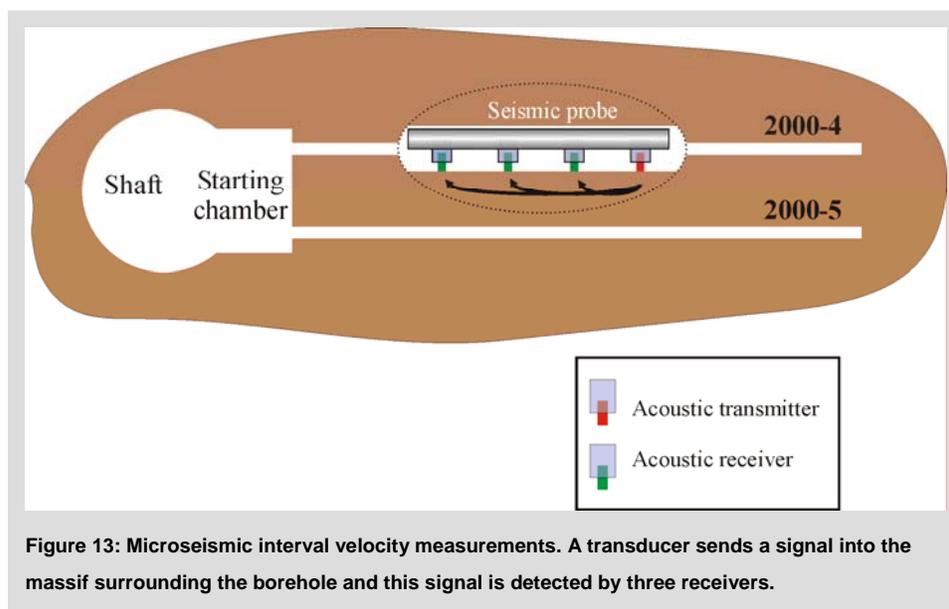
Figure 13: Microseismic interval velocity measurements. A transducer sends a signal into the massif surrounding the borehole and this signal is detected by three receivers.

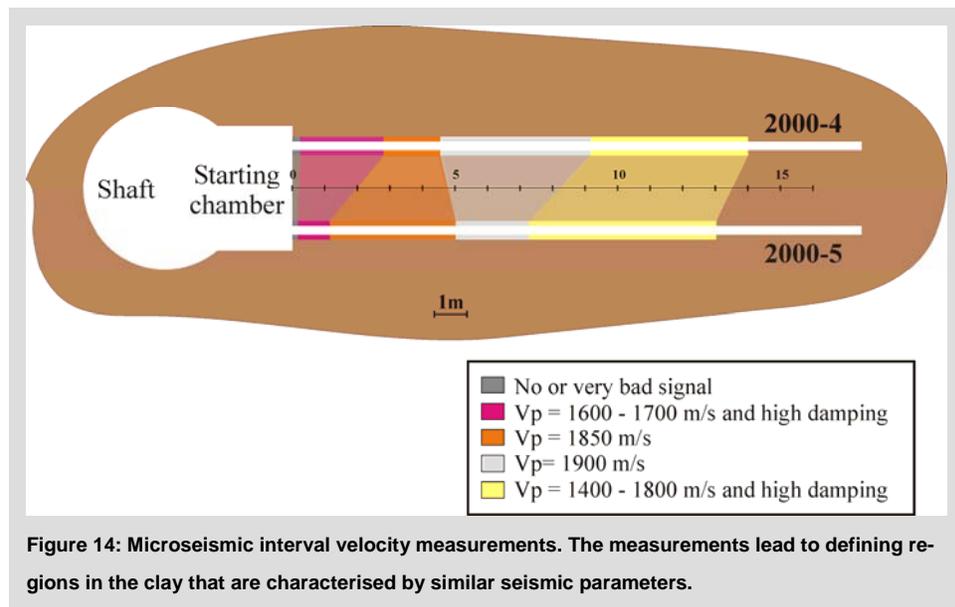
Figure 14: Microseismic interval velocity measurements. The measurements lead to defining regions in the clay that are characterised by similar seismic parameters.

PVC tubes to prevent further damage before the cross hole seismic measurements. The measurements revealed the following features (Figure 14):

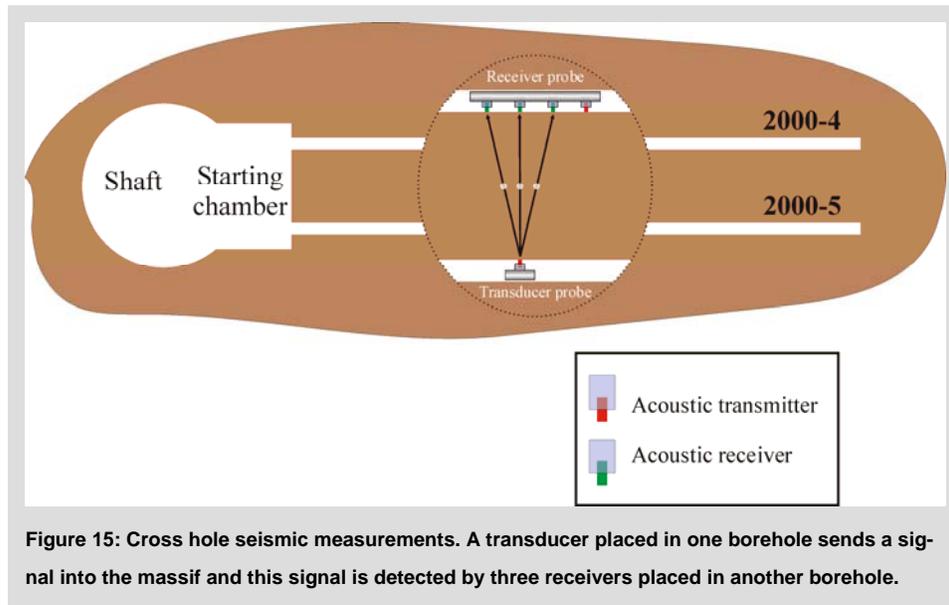
Figure 15: Cross hole seismic measurements. A transducer placed in one borehole sends a signal into the massif and this signal is detected by three receivers placed in another borehole.

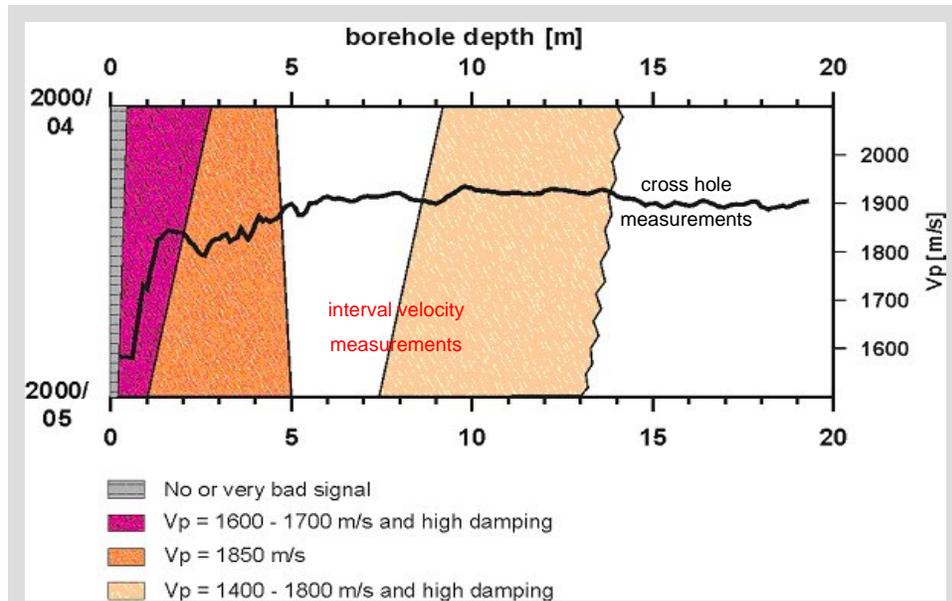
Figure 16: Compilation of the main results of the seismic measurements (based upon a BGR figure). The interval velocity measurements in boreholes 2000-4 and 2000-5 led to defining several regions in the clay, each one of them being characterised by similar seismic parameters, whereas the cross hole measurements (from borehole 2000-4 to borehole 2000-5) led to determining the evolution of the P-wave velocity.

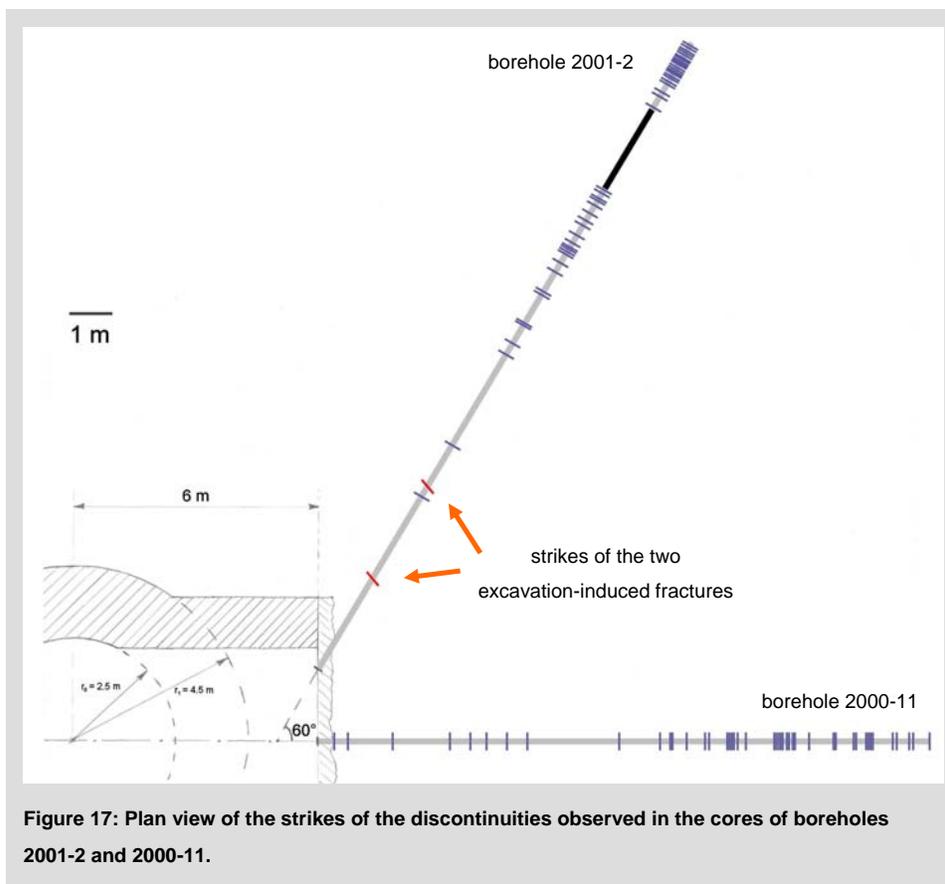
Figure 17: Plan view of the strikes of the discontinuities observed in the cores of boreholes 2001-2 and 2000-11.

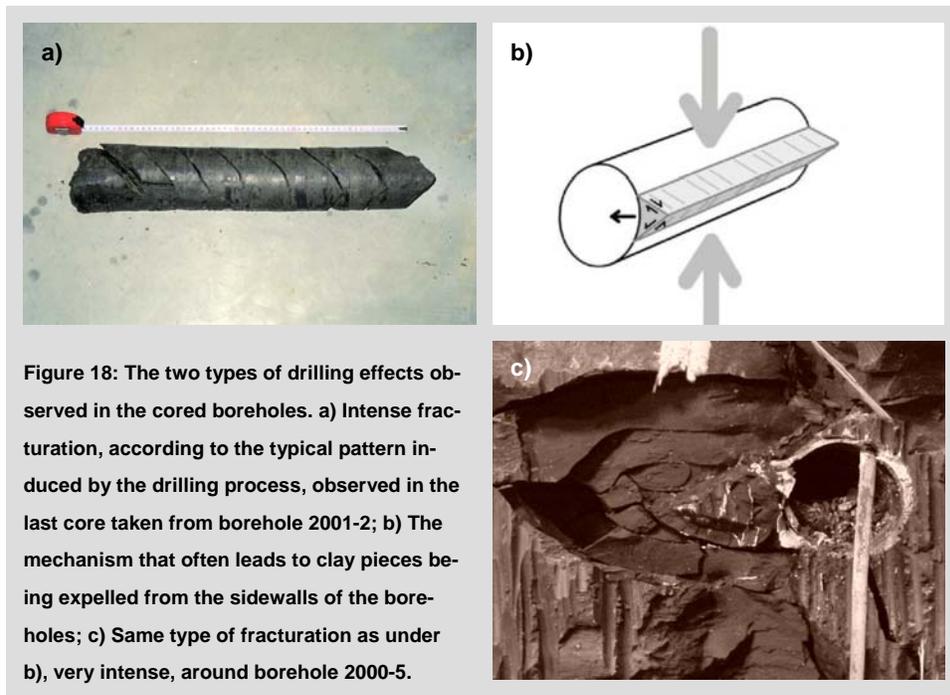
Figure 18: The two types of drilling effects observed in the cored boreholes. a) Intense fracturation, according to the typical pattern induced by the drilling process, observed in the last core taken from borehole 2001-2; b) The mechanism that often leads to clay pieces being expelled from the sidewalls of the boreholes; c) Same type of fracturation as under b), very intense, around borehole 2000-5.

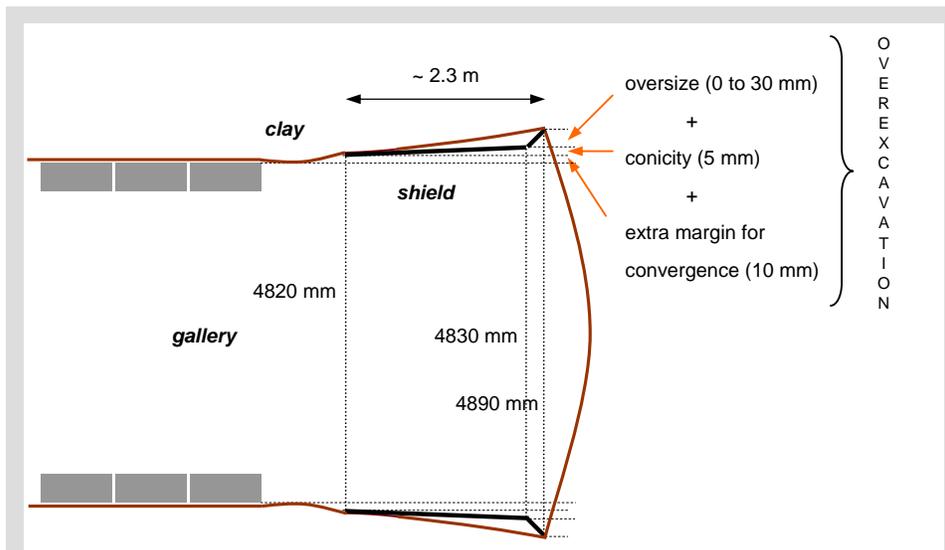
Figure 19: Cross section of the tunnelling shield, showing its conical shape, the adjustable knives providing the oversize, and the total overexcavation (not on scale).

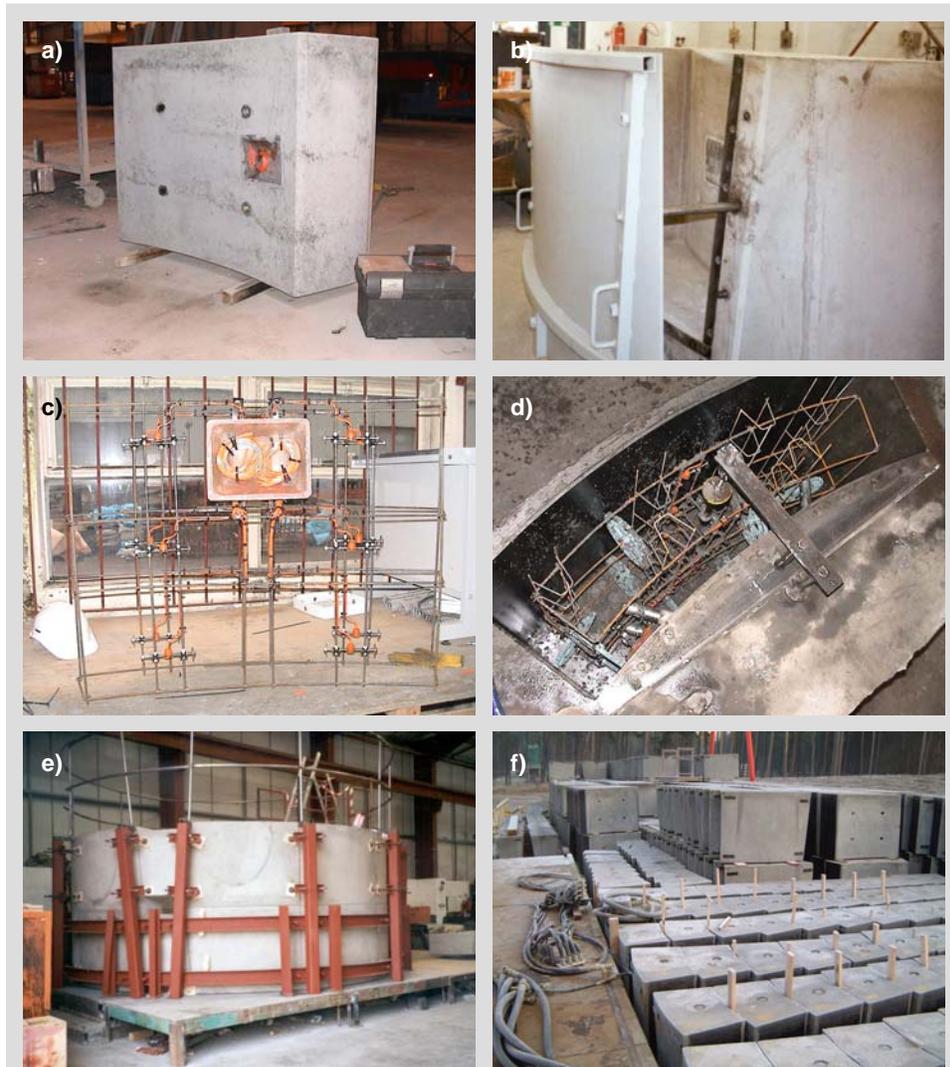
Figure 20: Manufacturing of the lining segments. a) General view of an instrumented segment, also showing its four manipulation holes; b) A mould with its removable steel framework; c) Support frame with instrumentation ready to be installed in a mould; d) Casting of an instrumented segment; e) Trial assembly of two rings; f) Segments stored on site.

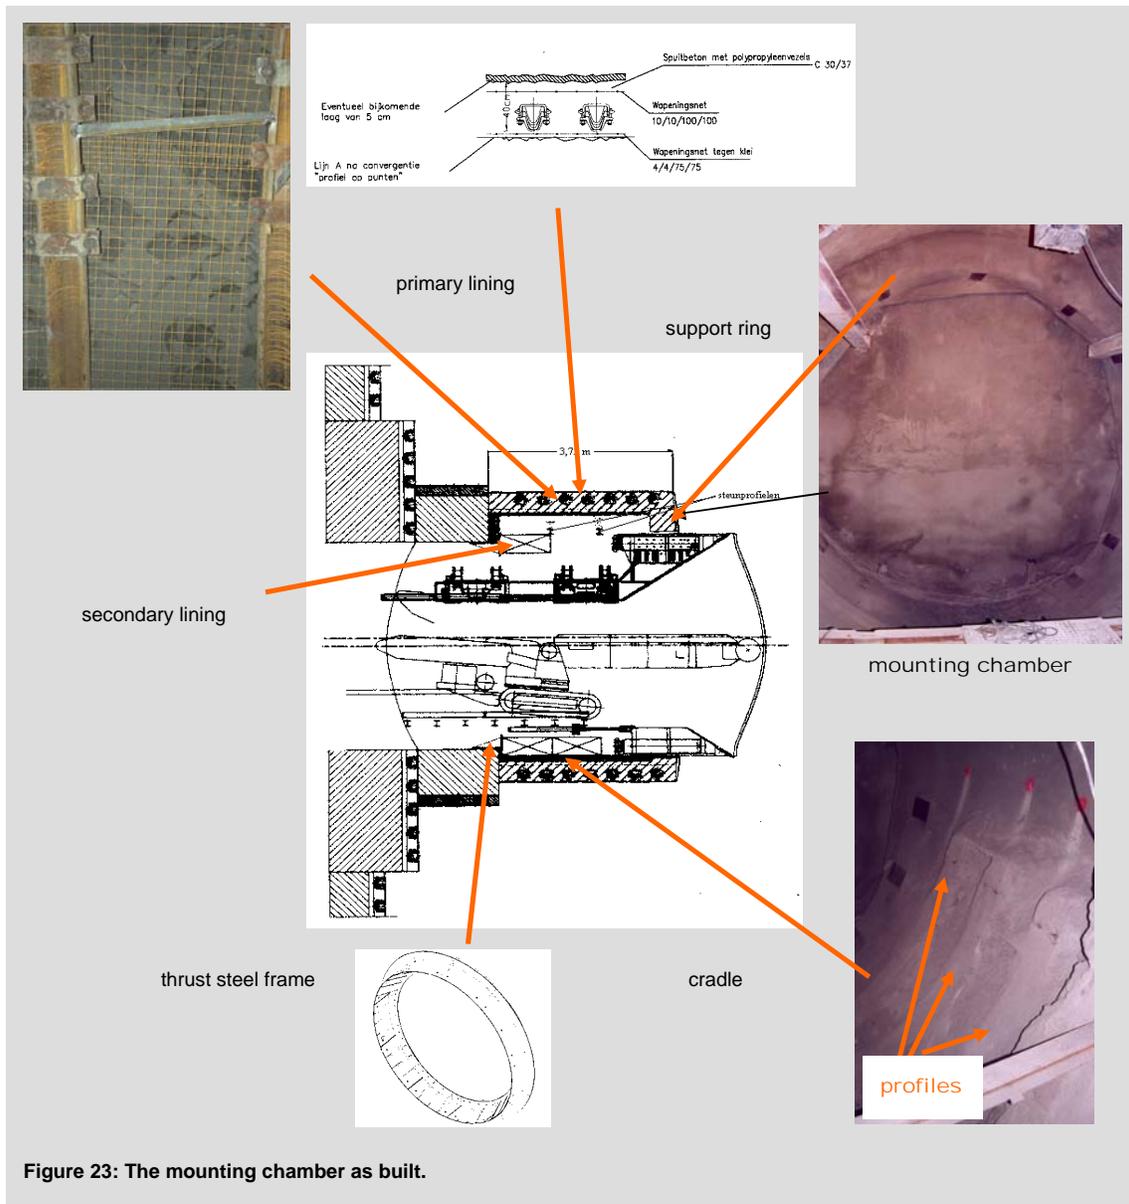
Figure 23: The mounting chamber as built.

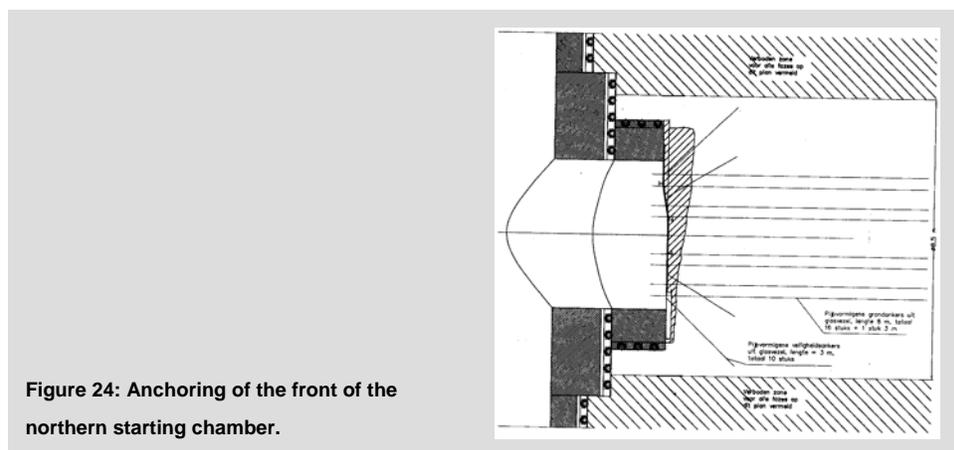
Figure 24: Anchoring of the front of the northern starting chamber.

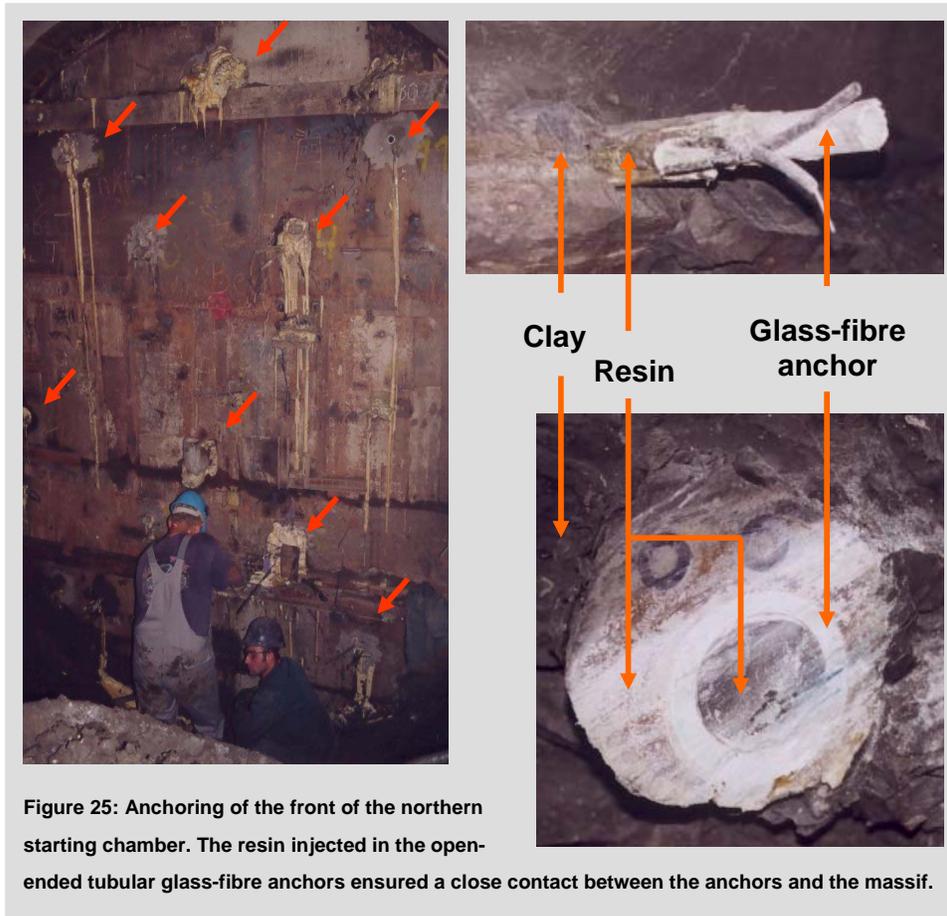
Figure 25: Anchoring of the front of the northern starting chamber. The resin injected in the open-ended tubular glass-fibre anchors ensured a close contact between the anchors and the massif.

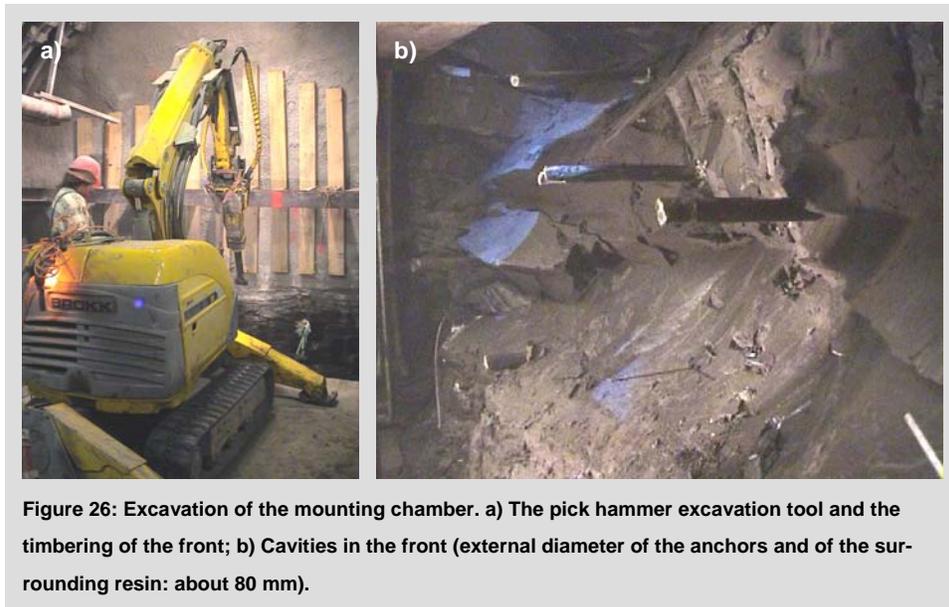
Figure 26: Excavation of the mounting chamber. a) The pick hammer excavation tool and the timbering of the front; b) Cavities in the front (external diameter of the anchors and of the surrounding resin: about 80 mm).

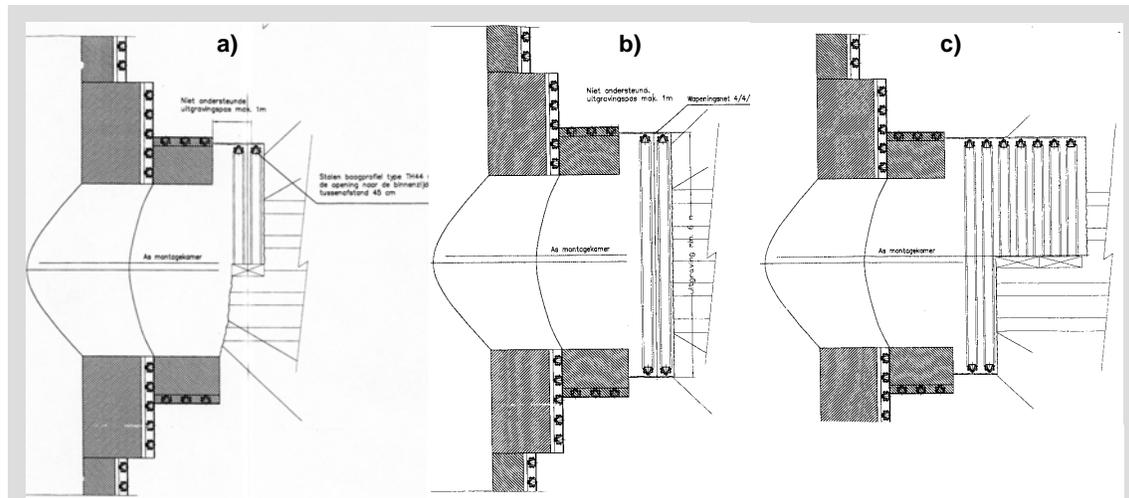
Figure 27: Excavation of the mounting chamber. a) Excavation of the top half over a distance of 1 metre and installation of the top half of the first two sliding ribs; b) Excavation of the bottom half over a distance of 1 metre and closing of the first two sliding ribs; c) Excavation of the complete top half and installation of the sliding ribs. (The excavation of the complete bottom half is not depicted.)

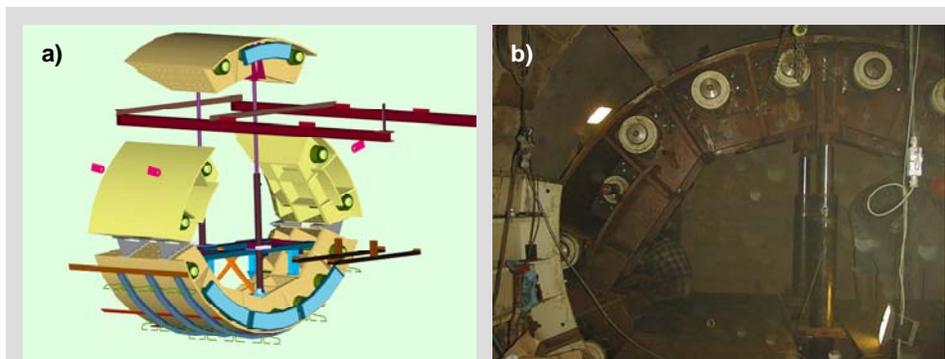
Figure 28: Assembly of the tunnelling machine. a) One of the many illustrations of the storyboard of the shield assembly (SCM Tunnel); b) Assembly in the mounting chamber.

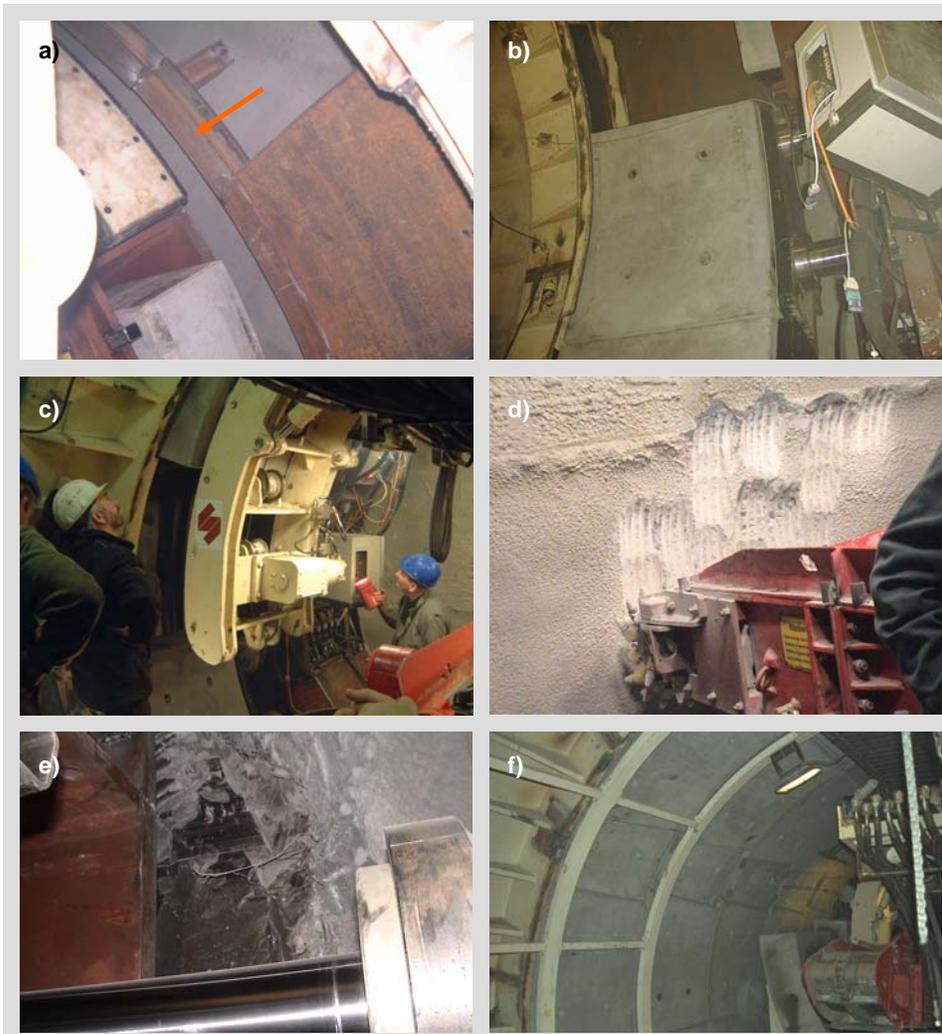
Figure 29: Construction of the secondary lining of the mounting chamber. a) The first steel ring after the thrust steel frame; b) Construction of the first lining ring, against the thrust steel frame; c) Placement of a lining segment of the first ring with the bird-wing erector; d) Start of the excavation of the concrete front of the mounting chamber with the road header; e) Transition between the primary lining of the mounting chamber and the clay; f) The first four lining rings; g) Cross section of the first four lining rings, the fourth ring being partly in the mounting chamber and partly in the connecting gallery.

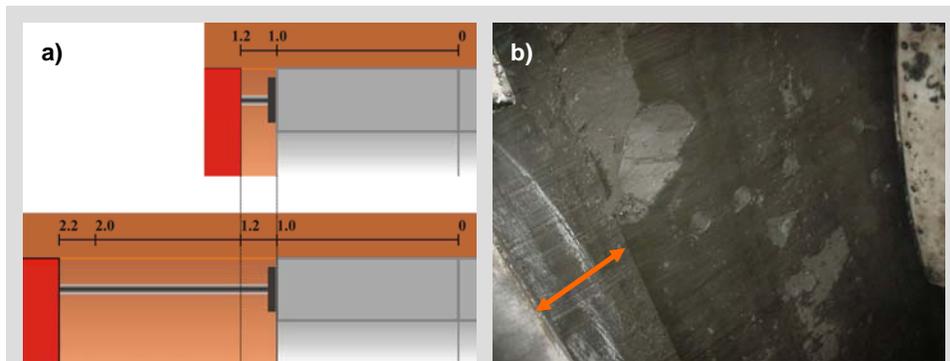
Figure 30: The unsupported zone at the back of the shield. a) A 20-cm-long section of clay was always left unsupported for twice as long as the rest of the unsupported zone; b) Close-up of the sidewall, showing differential convergence of such a 20-cm-long section.

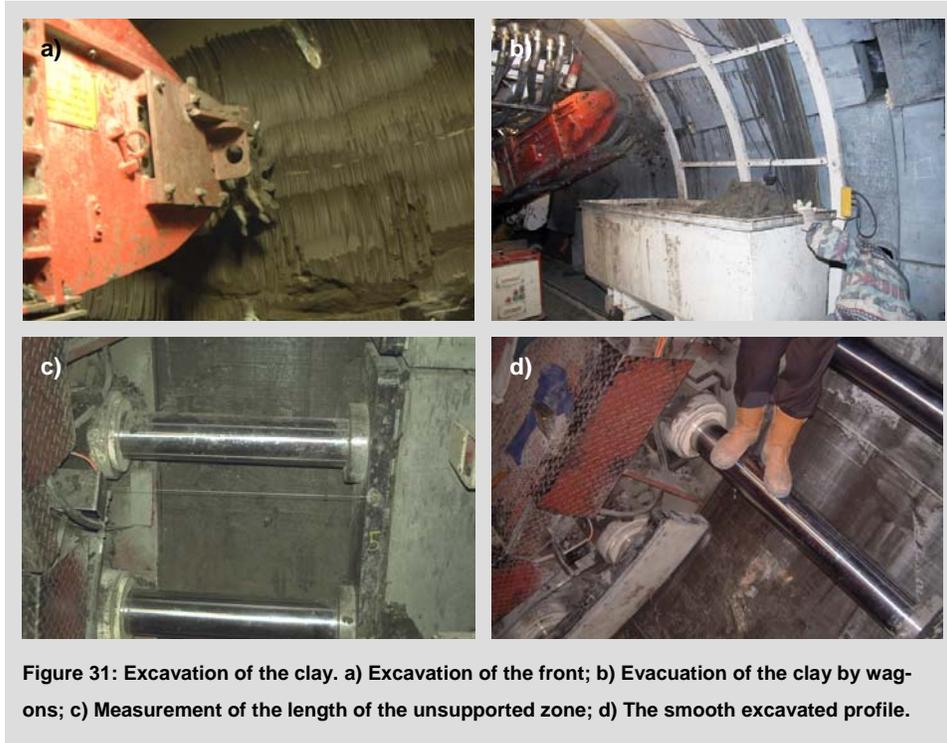
Figure 31: Excavation of the clay. a) Excavation of the front; b) Evacuation of the clay by wagons; c) Measurement of the length of the unsupported zone; d) The smooth excavated profile.

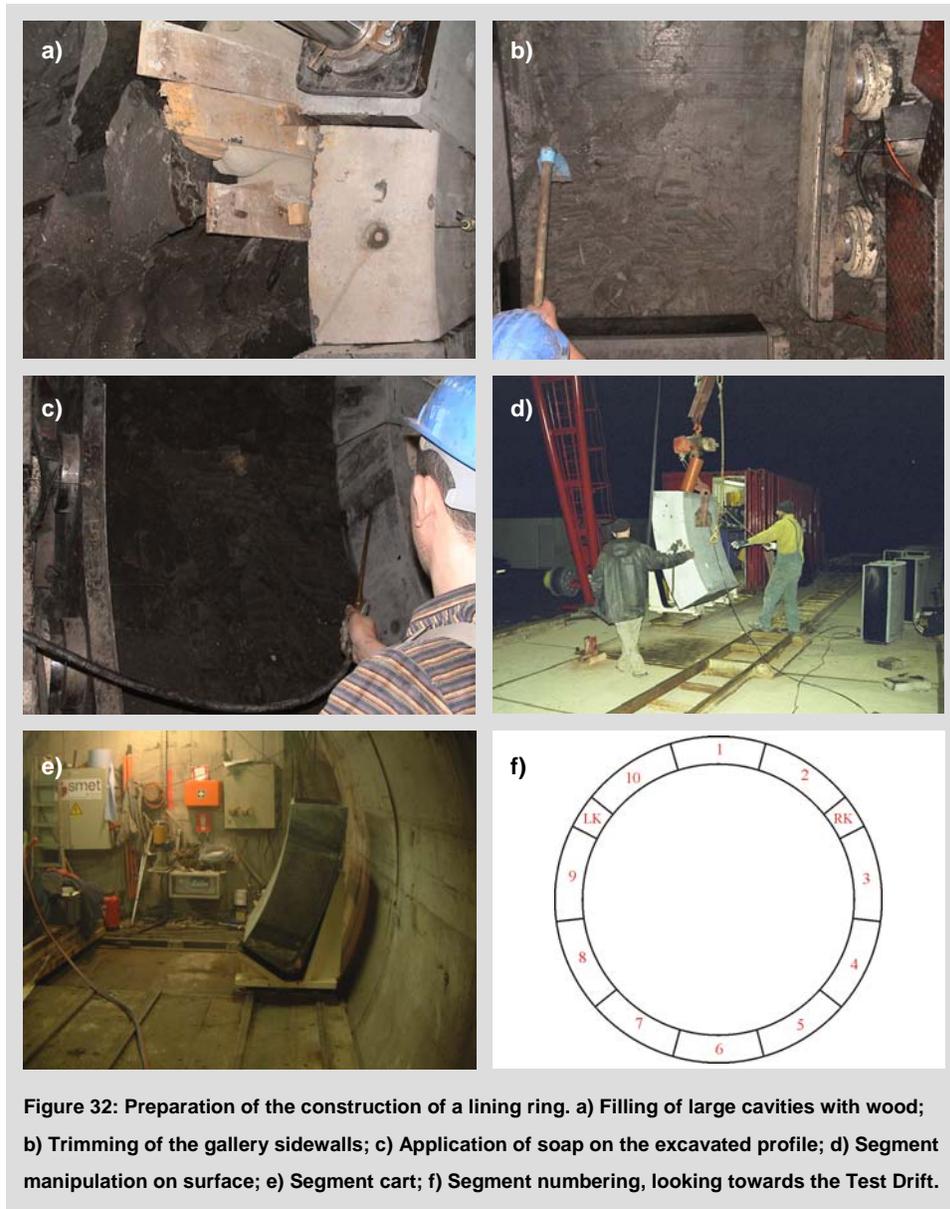
Figure 32: Preparation of the construction of a lining ring. a) Filling of large cavities with wood; b) Trimming of the gallery sidewalls; c) Application of soap on the excavated profile; d) Segment manipulation on surface; e) Segment cart; f) Segment numbering, looking towards the Test Drift.

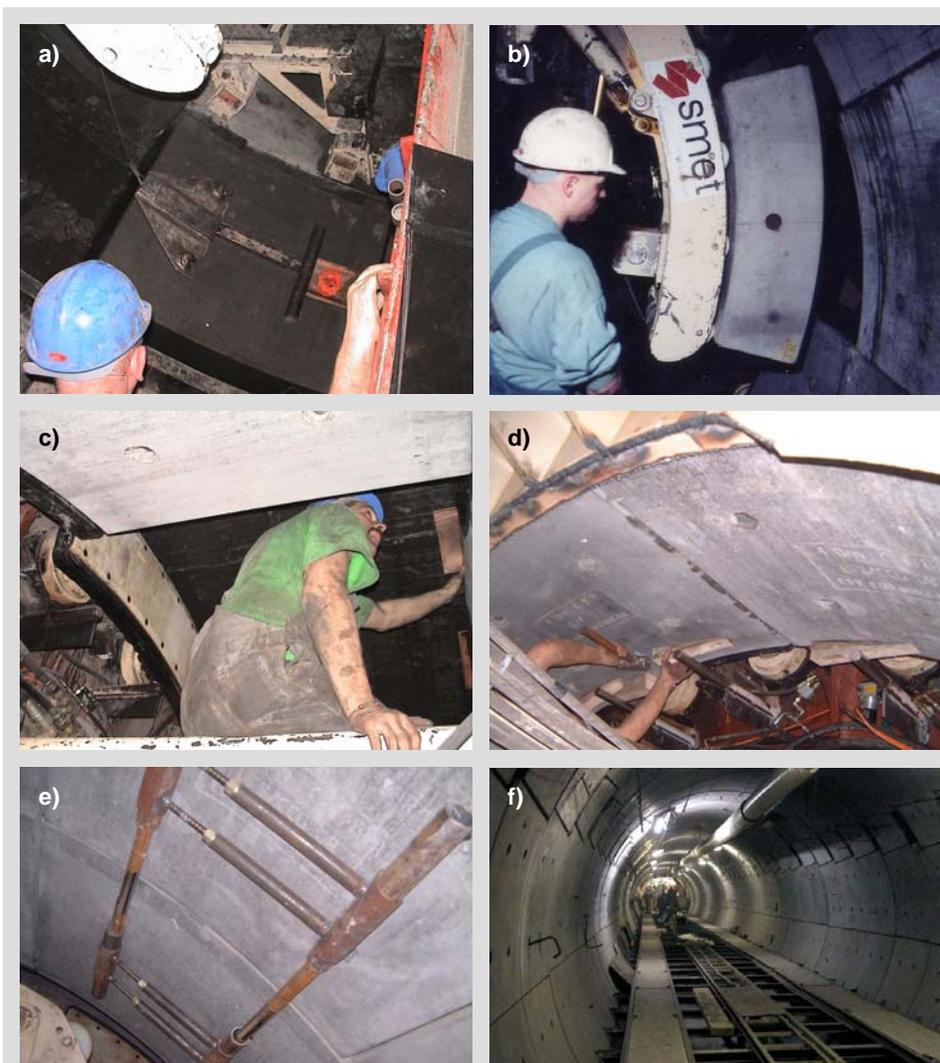
Figure 33: Placement of the lining segments. a) Placement of segment 6 with the help of the triangular steel plate; b) Placement of segment 3; c) Segment held in place by the corresponding jacks; d) and e) The two parts of the anti-fall system, one being attached to the shield, the other to the previous ring; f) General view of the connecting gallery.

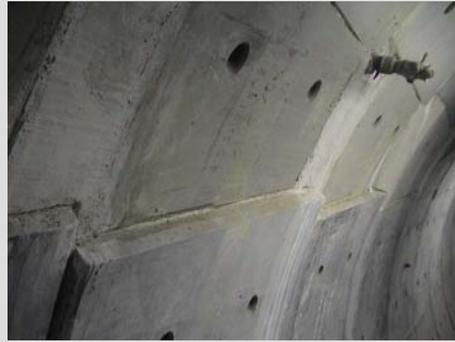
Figure 34: Misalignments between segments.
An injection point for filling the cavities between the lining and the massif is also visible (see hereafter “Problems linked to the clay massif”).

Ideally, the intrados of each lining ring should have been perfectly smooth. However, misalignments of up to 5 cm were reported, mainly due to the many cavities in the excavated profile (Figure 34) (see hereafter “Problems encountered and their solutions” and Section 6.2.2). These cavities, which have been described qualitatively for each ring, made it very difficult to build smooth rings and were likely to have an influence on the external pressures on the lining in the short and long terms. After completion of the gallery, the steps between the upper segments of all the rings of the gallery were measured. (The working floor did not allow easy measurements in the lower half.) A topographic survey was then performed in December 2002 and January 2003 to measure the exact position of each segment (namely, the Lambert coordinates of six points per segment, determined with an accuracy of about 1 mm).

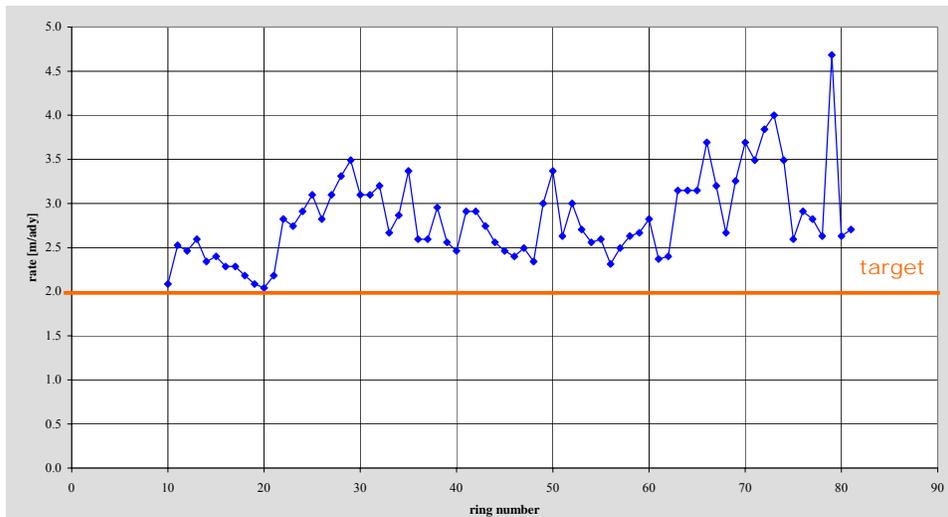
Figure 35: The construction rate (based on SCM Tunnel data) was consistently above the target construction rate of 2 metres per 24 hours.

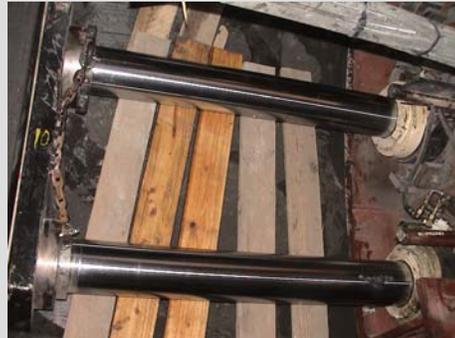
Figure 36: Timber placed between the jacks and the sidewall to prevent clay blocks from coming off.

Remedy (i) To excavate the upper part of the front (over 0.5 to 1 metre) before its lower part, which reduced the number of blocks coming off and, subsequently, the number of cavities, (ii) to remove loose blocks and, (iii) whenever necessary, to place timber in the upper part of the gallery, between the hydraulic jacks and the roof or the sidewalls (Figure 36). (Risks to workers near the front were limited to when they had to repair the road header.)

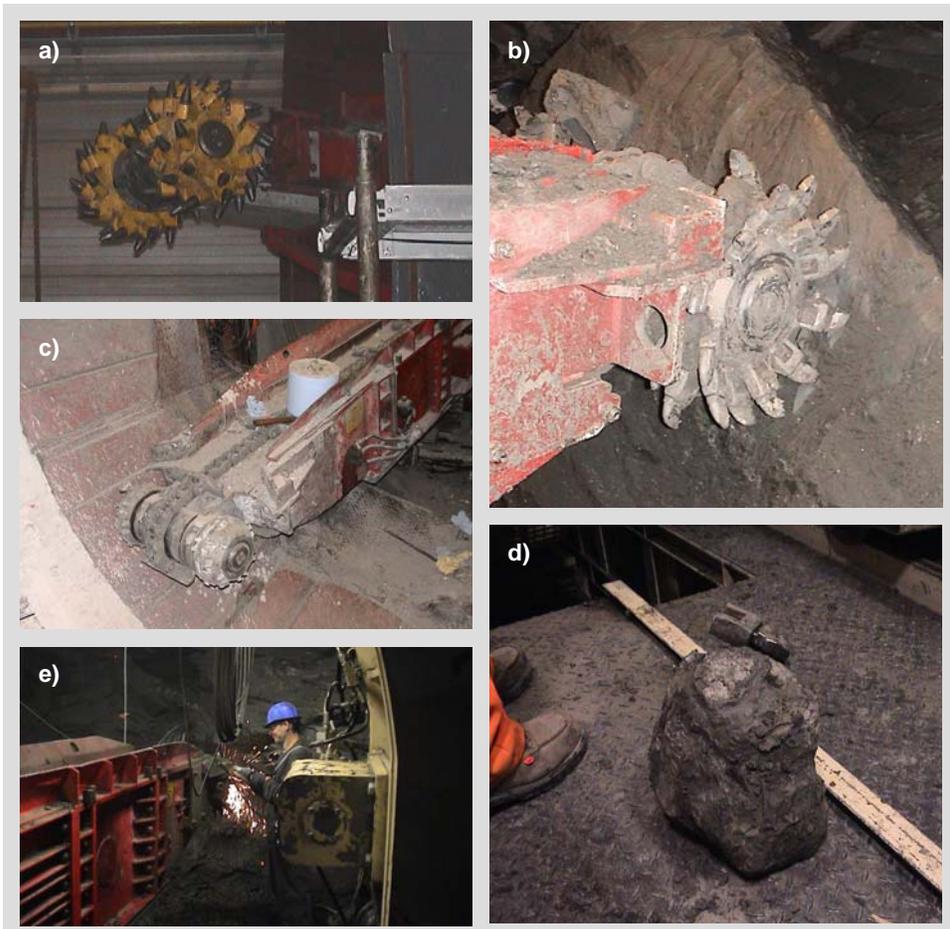
Figure 37: Head of the road header. a) Original head, used to excavate the concrete front of the mounting chamber (see also Figure 29d); b) Head for clay; c) Same head with almost no teeth anymore; d) Pyrite concretion with a tooth-holder (and a tooth) that broke on it; e) Welding work on the head.

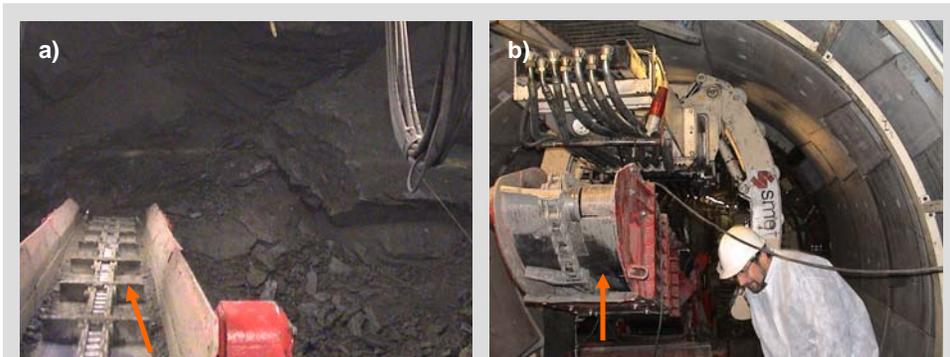
Figure 38: The conveyor transporting the clay from the excavation front to the back of the tunnelling machine. a) Intact metal scrapers; b) Two partly broken metal scrapers at the rear end of the conveyor.

Remedy To replace the scrapers.
