The extension of the HADES underground research facility at Mol, Belgium

The construction of the connecting gallery

**W. Bastiaens, F. Bernier, M. Buyens, M. Demarche,
X.L. Li, J.-M. Linotte, J. Verstricht**

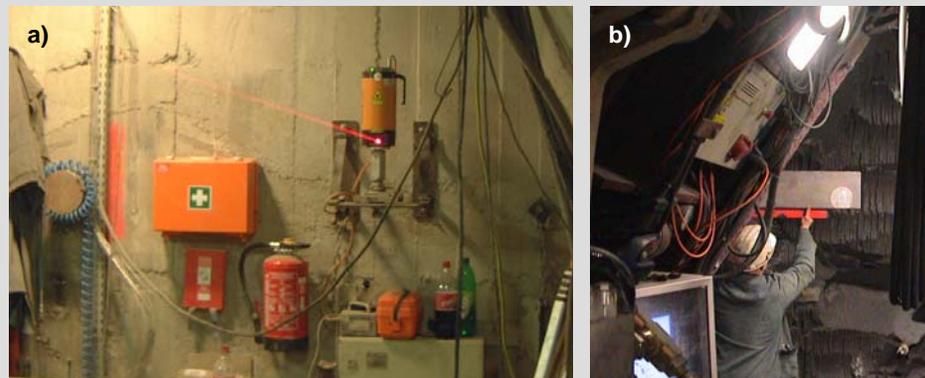
Figure 39: Laser source in the southern starting chamber (a) and target manually placed near the front of the shield (b), used to check the shield direction.

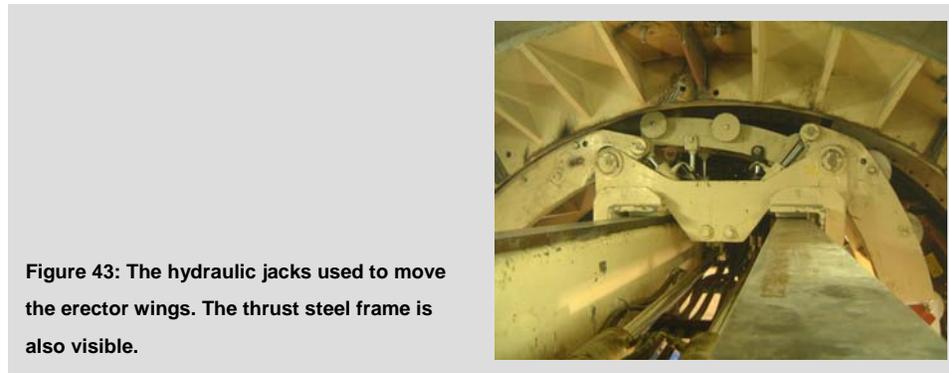
Figure 43: The hydraulic jacks used to move the erector wings. The thrust steel frame is also visible.

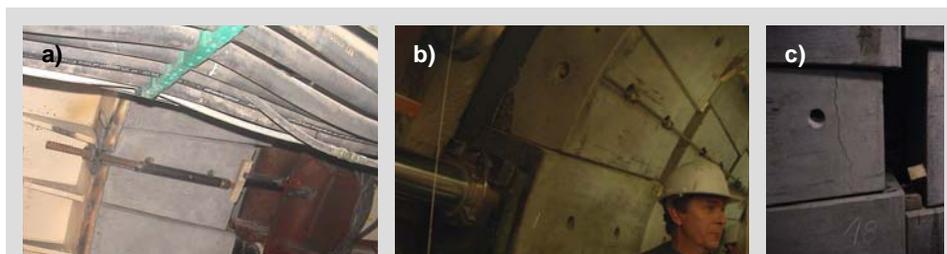
Figure 44: Methods used to prevent the keys from being squeezed out of the rings. a) Key of ring 1, fixed to the thrust steel frame; b) Subsequent keys, always secured to the previous one; c) Key of the previous ring held in place by wooden wedges.

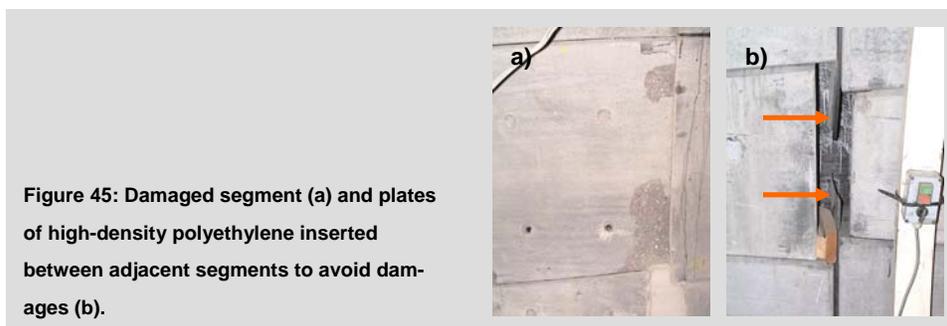
Figure 45: Damaged segment (a) and plates of high-density polyethylene inserted between adjacent segments to avoid damages (b).

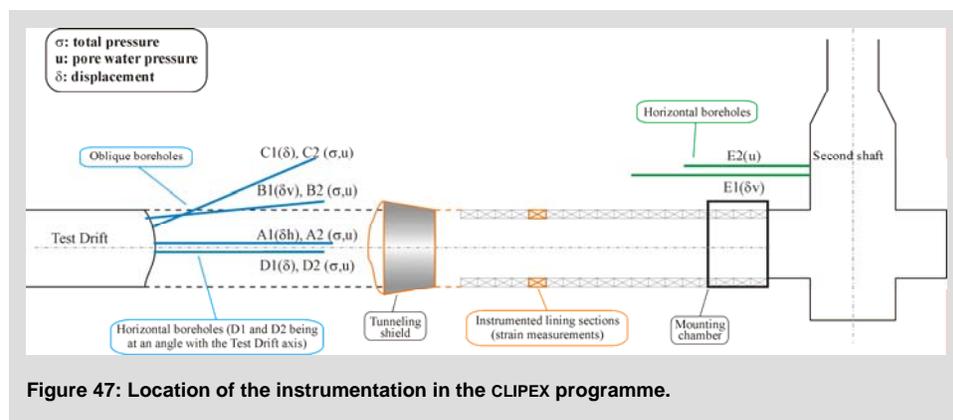
Figure 47: Location of the instrumentation in the CLIPLEX programme.

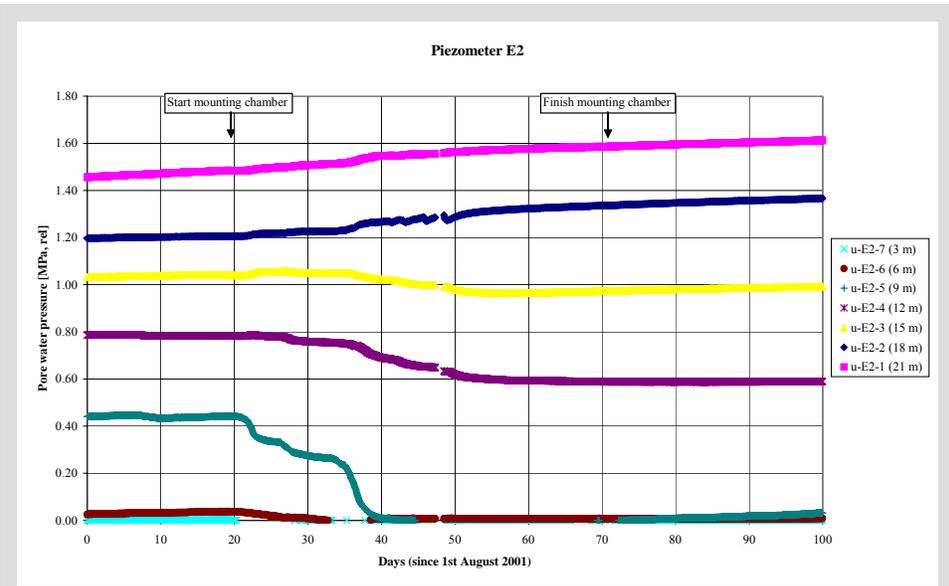
Figure 48: Evolution of the pore water pressure before, during, and after the construction of the mounting chamber (piezometer E2, at about 6.5 metres above the axis of the future connecting gallery). The positions of the filters are measured from the intrados of the second shaft. The 3.75-metre-long mounting chamber is located between about 3.5 and 7.25 metres from the intrados.

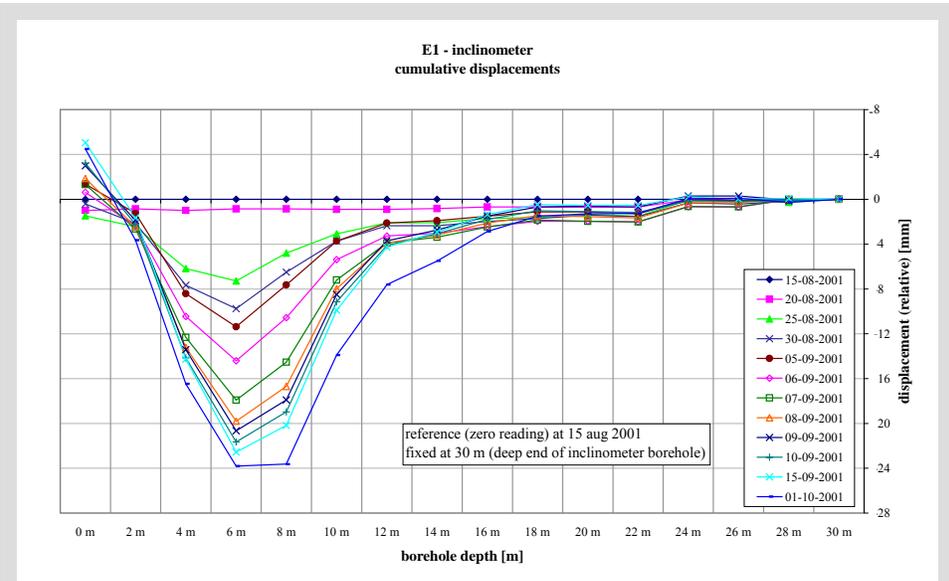
Figure 49: Vertical displacements at the beginning of the excavation of the mounting chamber, located between about 3.5 and 7.25 metres from the intrados of the second shaft (inclinometer E1, at about 5 metres above the axis of the future connecting gallery). The positions of the sensors are measured from the intrados of the second shaft.

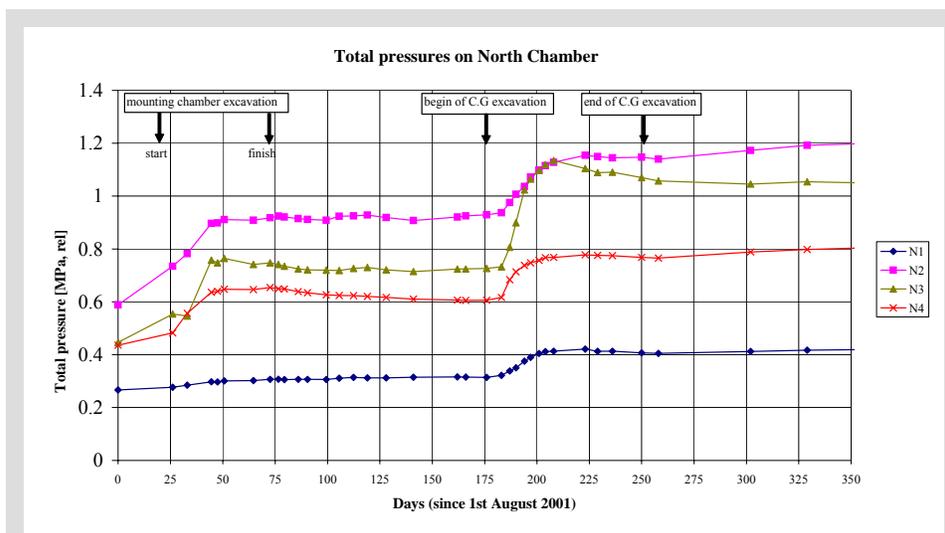
Figure 50: Readings of the total pressure sensors that were installed behind the lining of the northern starting chamber (N1: eastern sidewall, half height; N2: roof; N3: western sidewall, half height; N4: bottom).

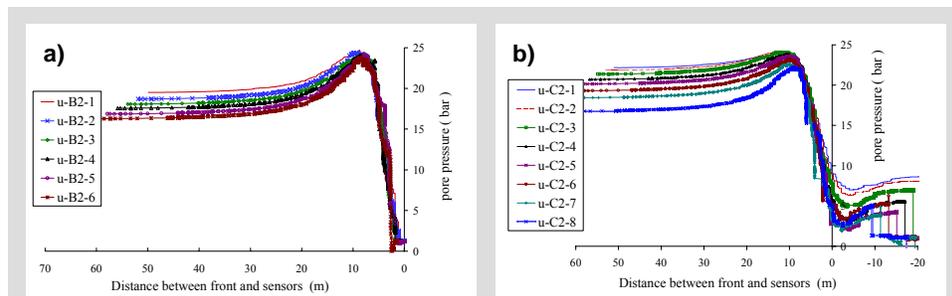
Figure 51: Evolution of the pore water pressure with the distance to the excavation front.
a) Piezometer B2, just above the gallery; b) Piezometer C2, at a larger angle above the gallery.

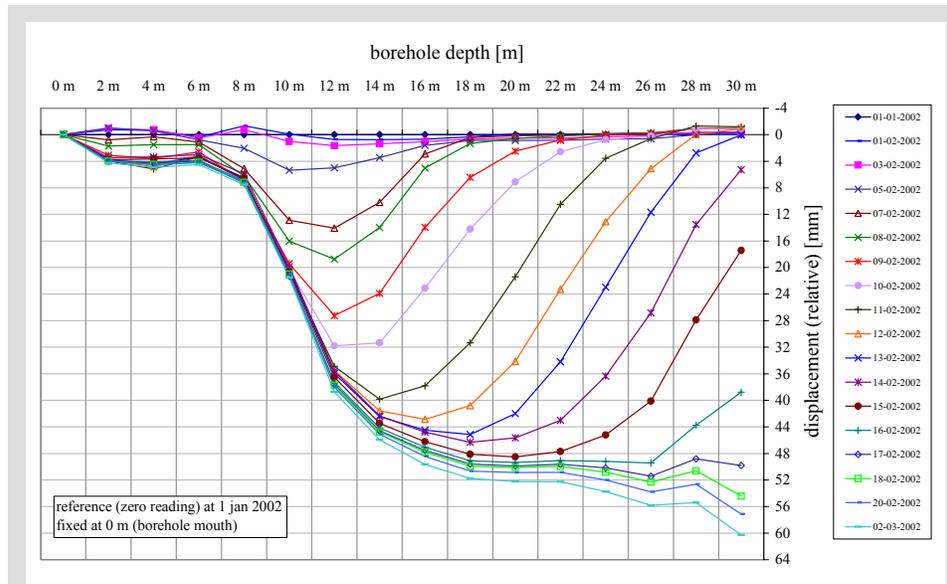
Figure 53: Evolutions of the vertical displacements above the connecting gallery both during and after excavation (inclinometer E1). The shape of the plots reflects the evolution of the deformation of the inclinometer with time.

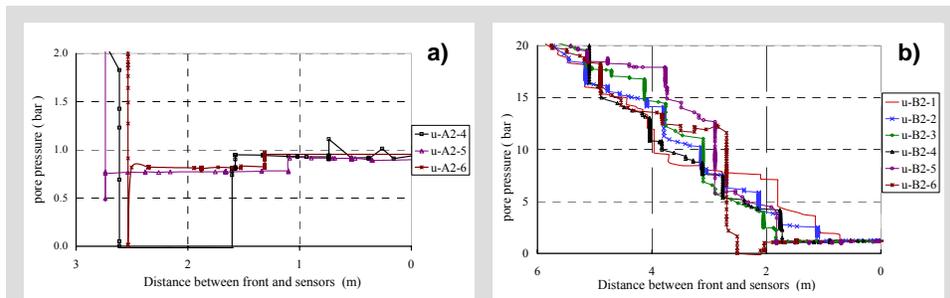
Figure 54: Evidences of the presence of fractures. a) Sudden re-equilibrium of the pore water pressure with the atmospheric pressure as fractures connect with the gallery (axial piezometer A2); b) Decrease of the pore water pressure during the installation of the lining (when the excavation front is close to the sensors) (piezometer B2, just above the gallery).

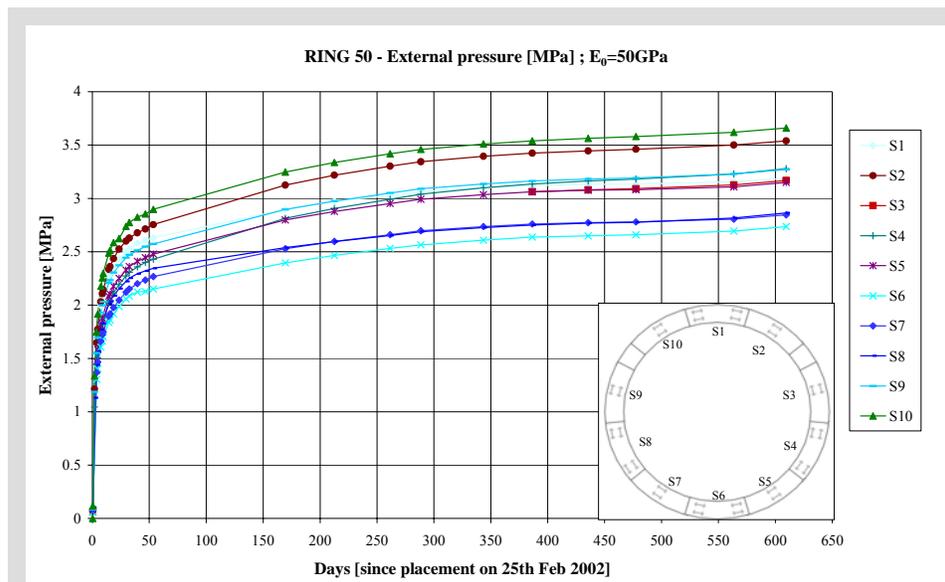
Figure 55: Time-dependent behaviour. Calculated external pressures on the segments of ring 50, located about in the middle of the connecting gallery, since their installation on February 25, 2002 (in days). The in-depth analysis of the data up to 06.05.2003 (day 436 since installation) led to concluding that the ground pressure on the lining is between 2.1 and 3.1 MPa.

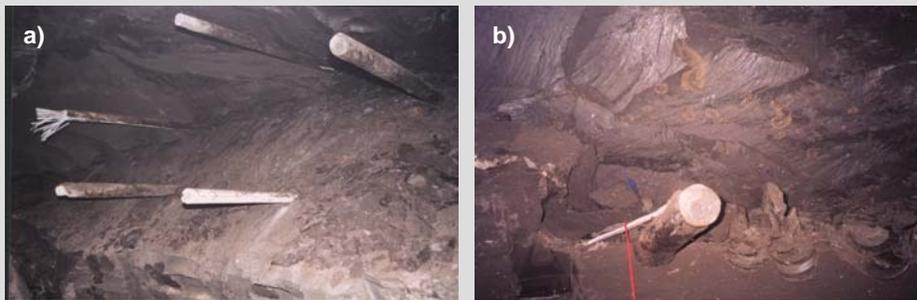
Figure 57: The two main types of discontinuities in and around the mounting chamber. a) A large shear plane covering the width of the excavation front, with the anchors sticking out of the clay (about 80 mm in diameter, including the resin); b) Oxidation spots on the surface of a tension fissure in the upper right corner of the excavation, at a depth of about 2 metres; c) Vertical cross section through the middle of the chamber. In red, all the measurements of shear planes, both before the excavation of the mounting chamber (cored borehole 2000-11, auscultation programme—Section 4.1.2) and during its excavation. In yellow, all the observations of shear planes. In green, tension fissures. Dotted lines are extrapolations.

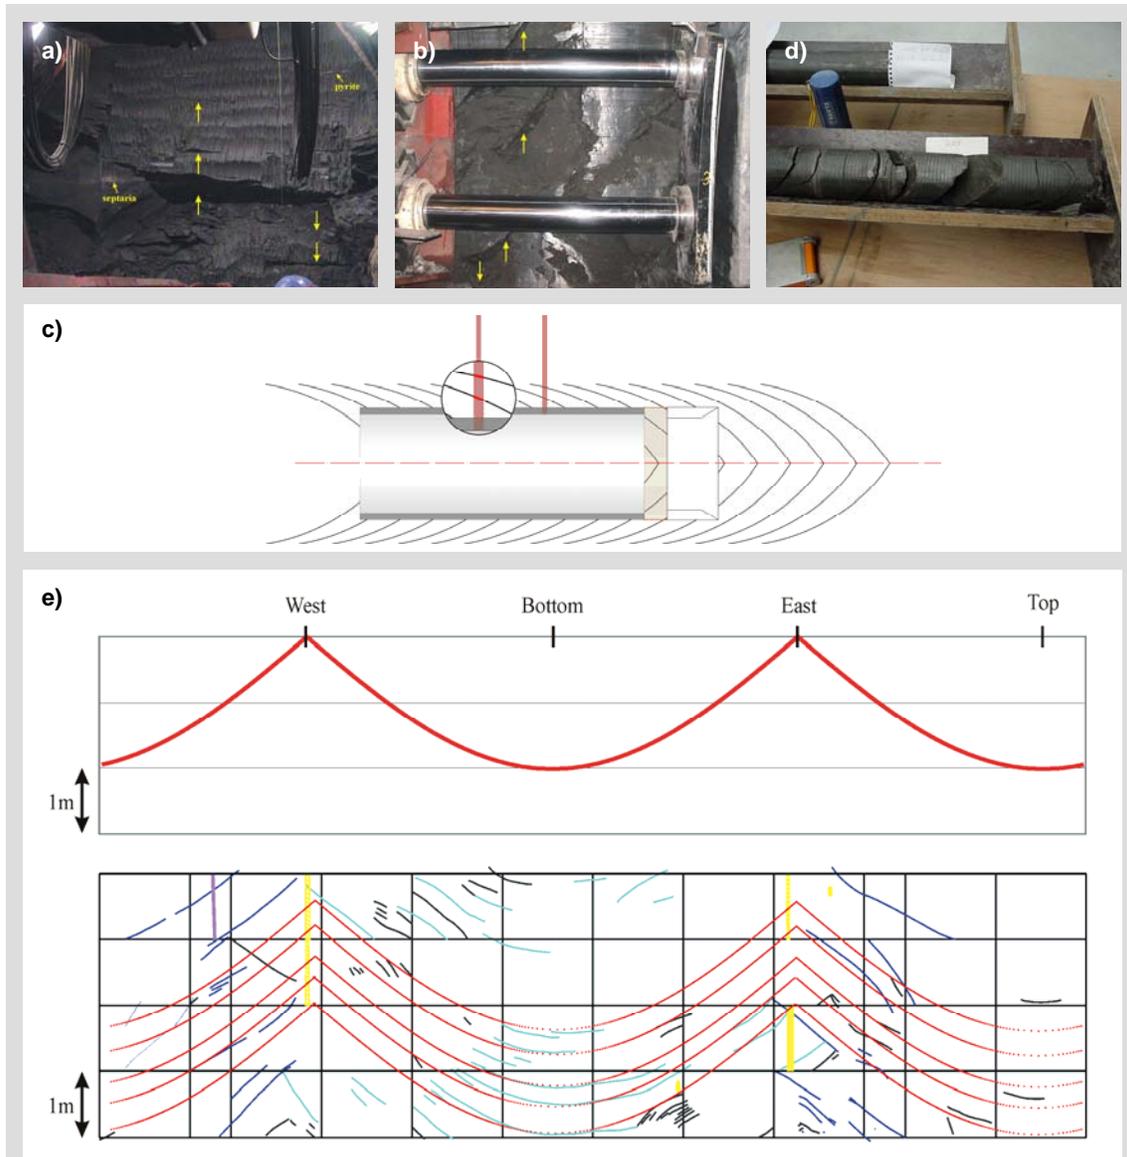
Figure 59: Fractures observed during the construction of the connecting gallery. a) Excavation front; b) Eastern sidewall, unsupported zone; c) Vertical cross section through the gallery showing the fracturation pattern around it, as deduced from the observations; d) Detail of a clay core obtained from a borehole drilled from the gallery (as shown on c); e) Theoretical traces on the excavated profile (represented as an unfolded cylinder) of a (slightly simplified) fracturation pattern and part of the fracture map (one band corresponds to 1 metre). The theoretical and observed traces are similar. Pyrite (purple) and septaria (yellow) layers are shown, too.

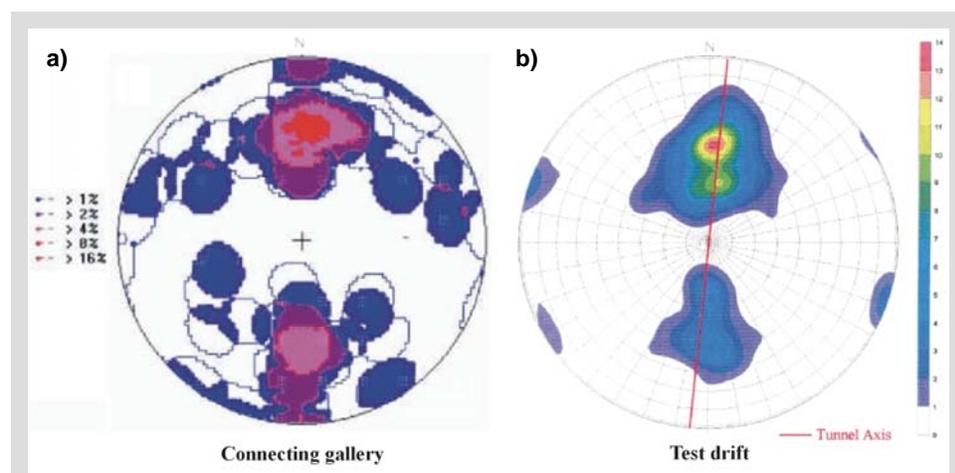
Figure 60: Stereographic plots of the fractures encountered during the construction of (a) the connecting gallery and of (b) the Test Drift, showing strong similarities in the patterns.

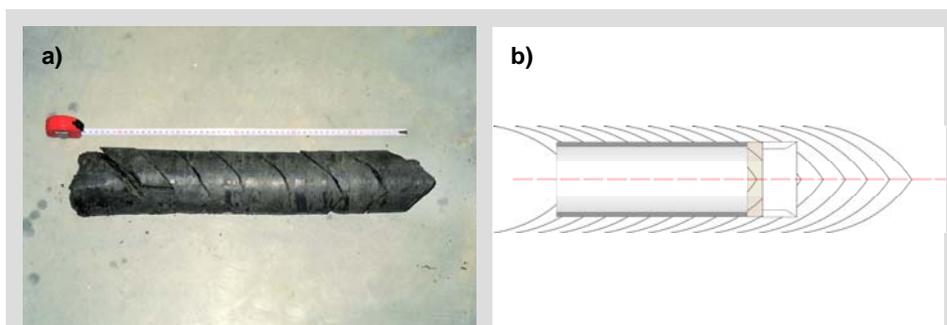
Figure 61: Similarities between the fracturation patterns observed (a) in the cores taken in the framework of the auscultation programme and (b) during excavation of the connecting gallery.

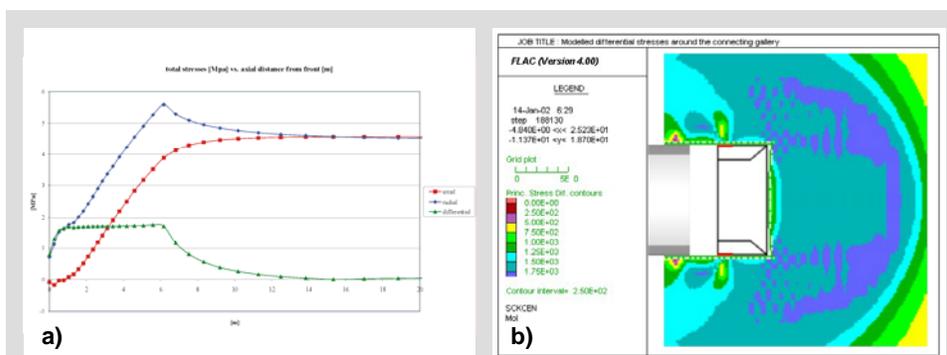
Figure 62: Modelled stresses along the gallery axis ahead of the excavation front. a) Axial, radial, and differential stresses, the plastic zone extending up to 6 metres ahead of the front; b) Differential stresses.

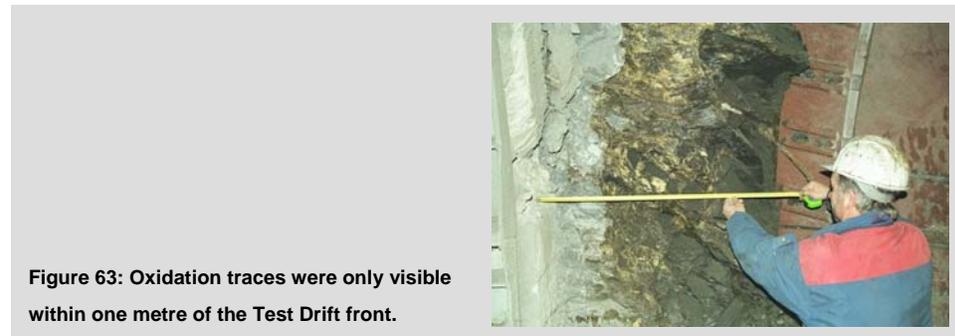
Figure 63: Oxidation traces were only visible within one metre of the Test Drift front.

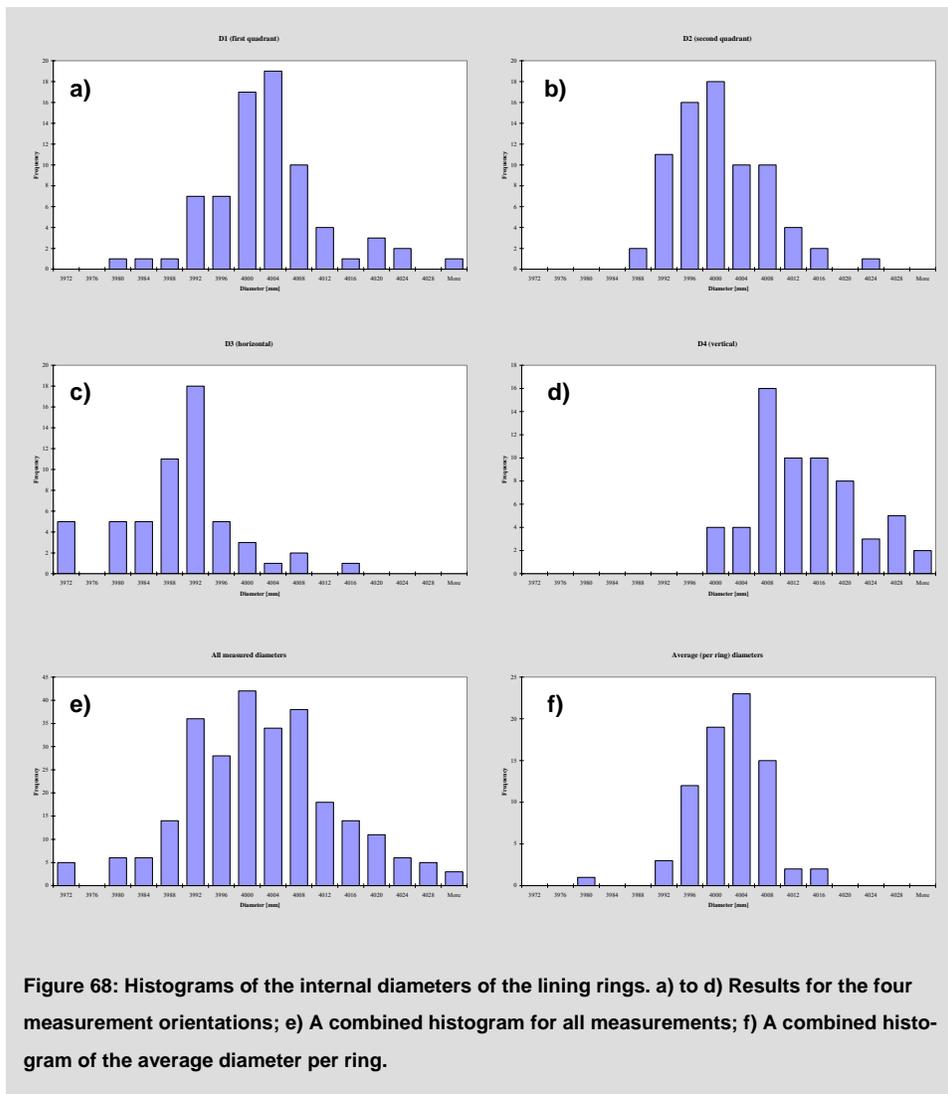
Figure 68: Histograms of the internal diameters of the lining rings. a) to d) Results for the four measurement orientations; e) A combined histogram for all measurements; f) A combined histogram of the average diameter per ring.

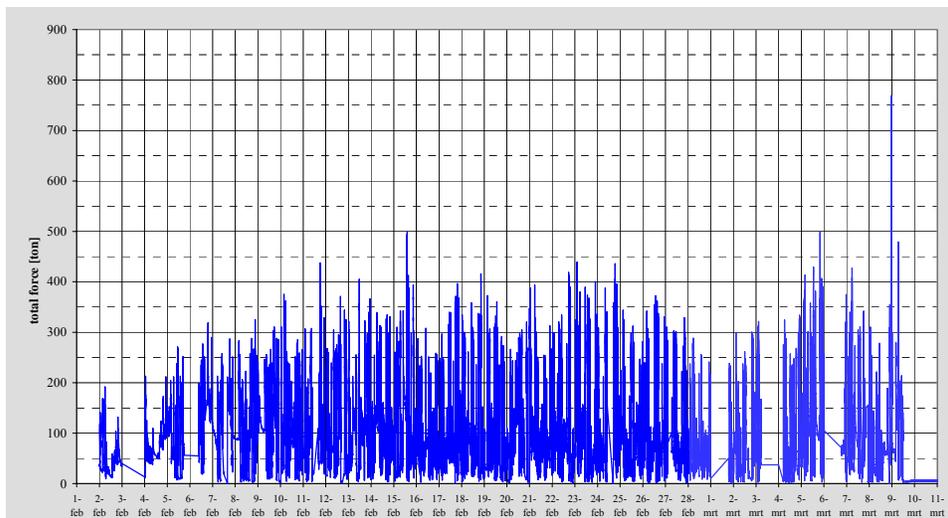
Figure 70: Logging of the total force exerted by the 20 hydraulic jacks, each peak corresponding to a forward movement of the shield. This total force was well below the nominal total force of 40000 kN.

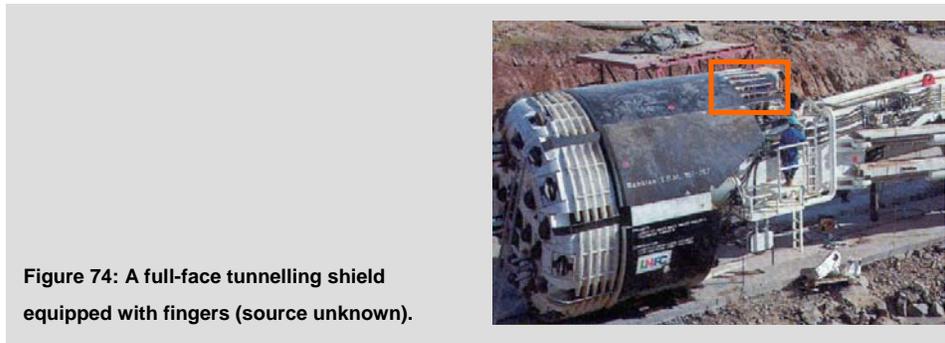
Figure 74: A full-face tunnelling shield equipped with fingers (source unknown).

Using a *full-face* tunnelling machine instead of a road header would enable a uniform and simultaneous excavation of the front and could drastically reduce the detachment of clay blocks from it. If used in combination with “*fingers*” (steel laths or rods) at the upper rear of the shield (Figure 74), such machine could also largely prevent the fall of clay blocks at the back of the shield. The fingers would be parallel to the gallery axis and in contact with the roof of the gallery. Their length should be at least that of the unsupported zone. To prevent the fingers from being in the way during ring construction, the segments would have to be provided on their outer side with longitudinal grooves, deep and wide enough to allow for steering and progression of the shield. The presence of the fingers would thus not prevent the rings from being expanded against the clay massif. Should such a technique be used, then it would be necessary to investigate whether to inject the gaps between the segments and the clay afterwards.
